# 작업결과 보고서

작업명 : 3부두 CTS Screw Motor 반출정비

작업기간	2019. 07. 29~ 2019. 08. 06	감독부서	발전본부 기술지원실 연료설비부
250HP4P	1 재권선작업 2 베어링 정비작업 6319 3 베어링 정비작업 6316 4 Housing육성가공 6316	1 1 1 1	
작업결과 확인	양호

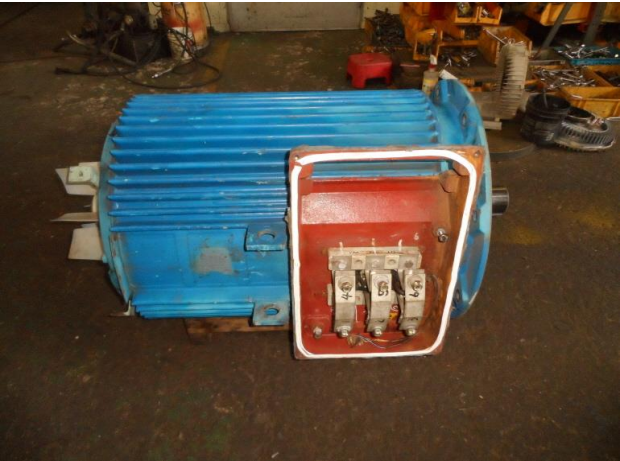
입고검사	Ass'y 분해전

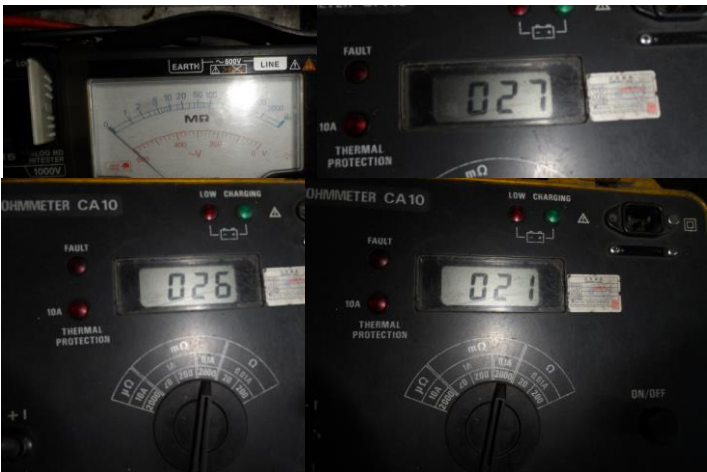
입고검사	절연저항 & 각 LINE별 권선 저항

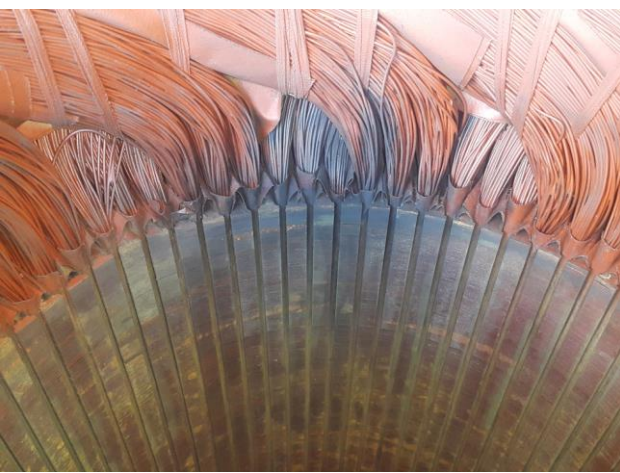
입고검사	분해후 권선 소손 부

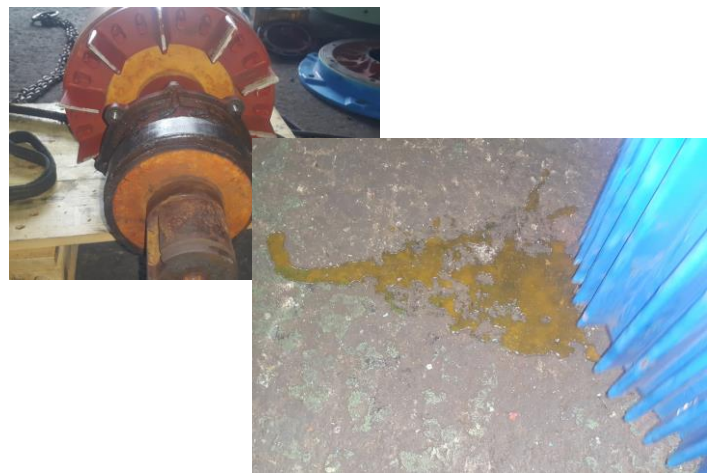
입고검사	반 부하측으로부터 물 유입 경로가 됨

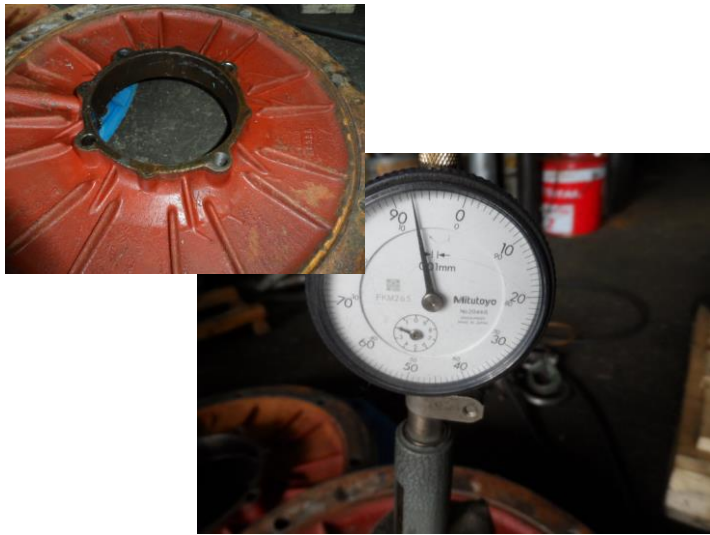
입고검사

반 부하측 측정치 7.5/100으로 불량

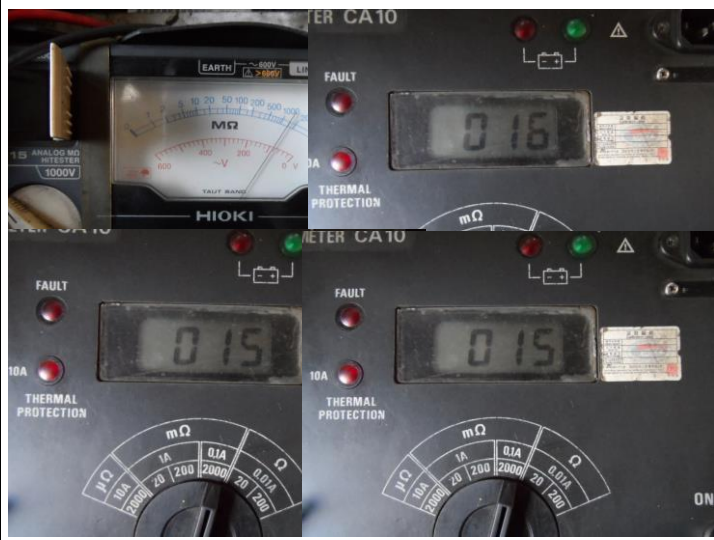
출고검사

절연저항 & △일때 각 상별 권선 저항

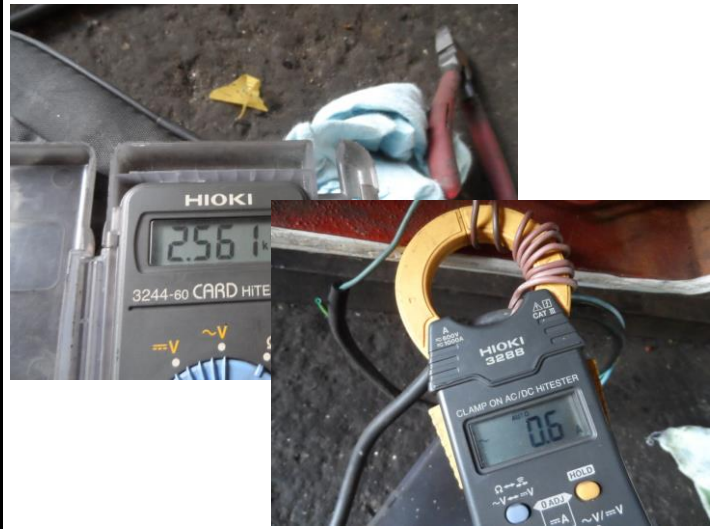
HEATER검사

9회감았을때 CURRENT=220V 0.6A

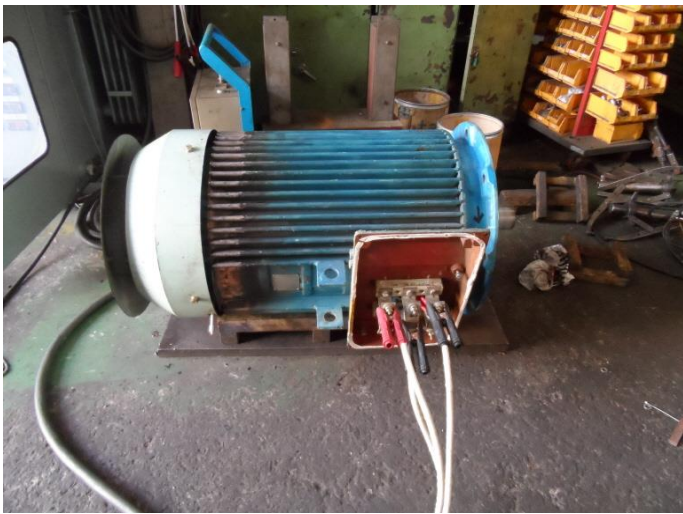
출고검사

시운전 TEST 실시

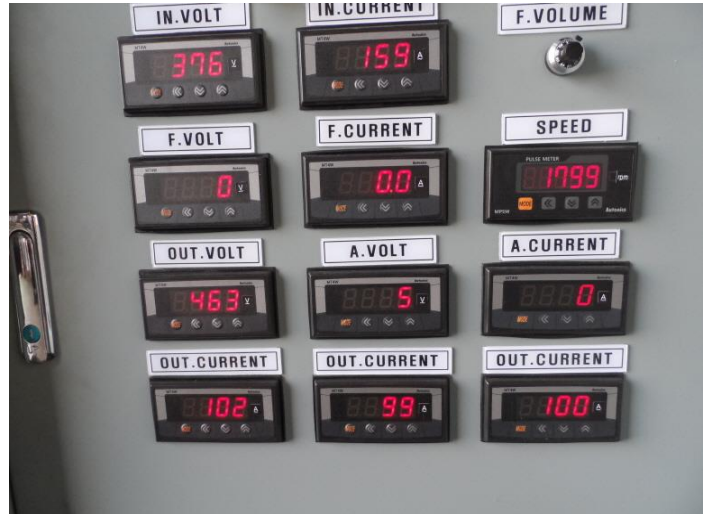
출고검사

시운전 TEST 운전 MONITORING

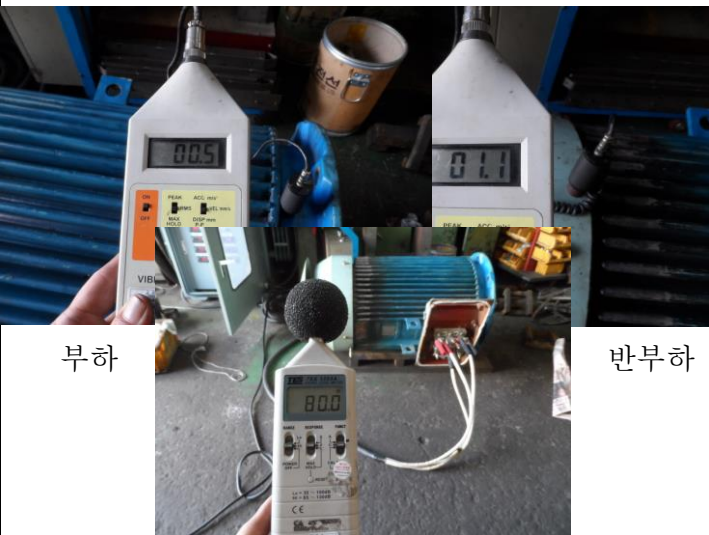
출고검사

진동 & 소음 검사

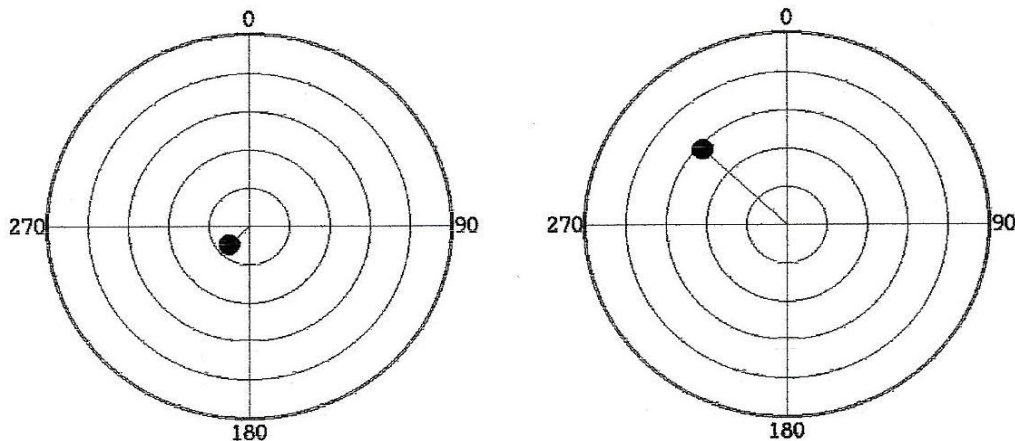
CORRECT UNBALANCE GRAPH (max = 5.0 gr )

PLANE1	PLANE2
UNBALANCE	9.6 gr	13.6 gr
ANGLE	329 deg	286 deg
RESULT	ACCEPT	ACCEPT

PLANE1	PLANE2
UNBALANCE	0.7 gr	2.9 gr
ANGLE	226 deg	313 deg
RESULT	ACCEPT	ACCEPT
