# 작업결과 보고서

작업명 : 3,4호기 Ash Slurry Pp-A MTR의 1건 반출정비 공사

작업기간	2019. 06. 19~ 2019. 06. 21	감독부서	발전본부 제1발 전기부
250HP4P	1 재권선작업	1	
	2 베어링 정비작업 6313	1	
	3 베어링 정비작업 6319	1	
	4 Housing육성가공 6319	1	
	5 계약외 추가작업	1	
작업결과 확인	양호

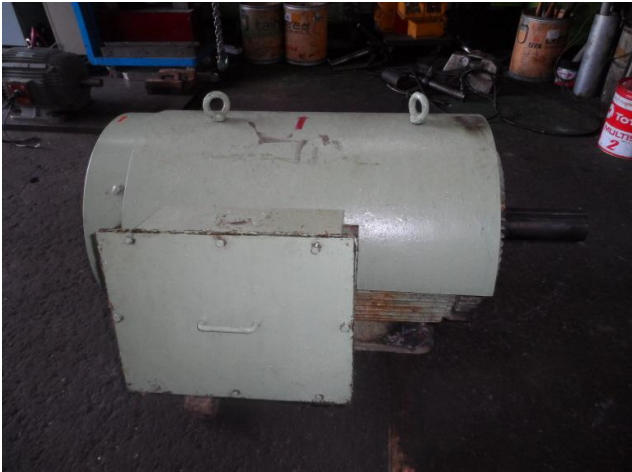
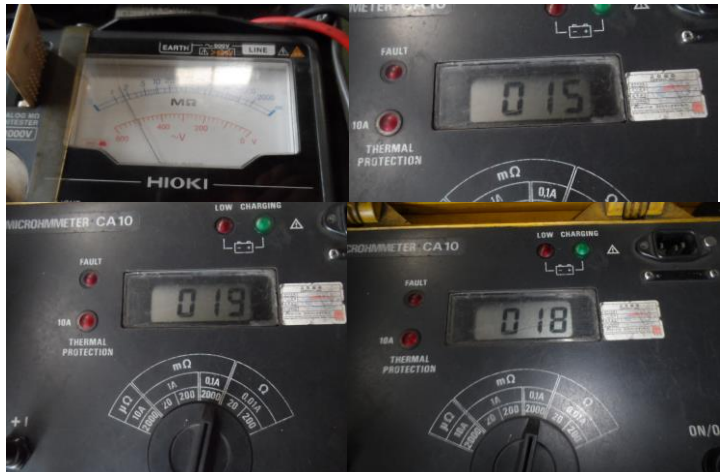
입고검사	Ass'y 분해전	입고검사	권선검사 이상

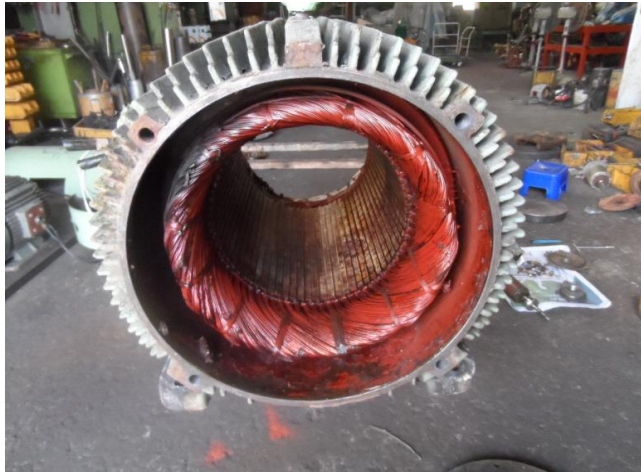
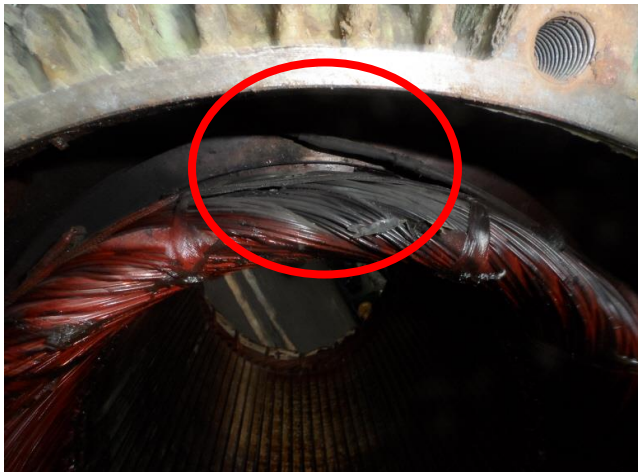
입고검사	분해후 권체	입고검사	소손부

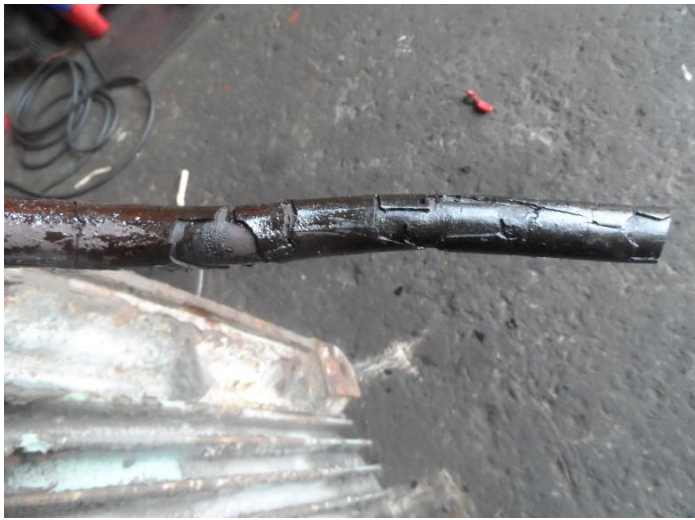
입고검사

POWER LINE 이상

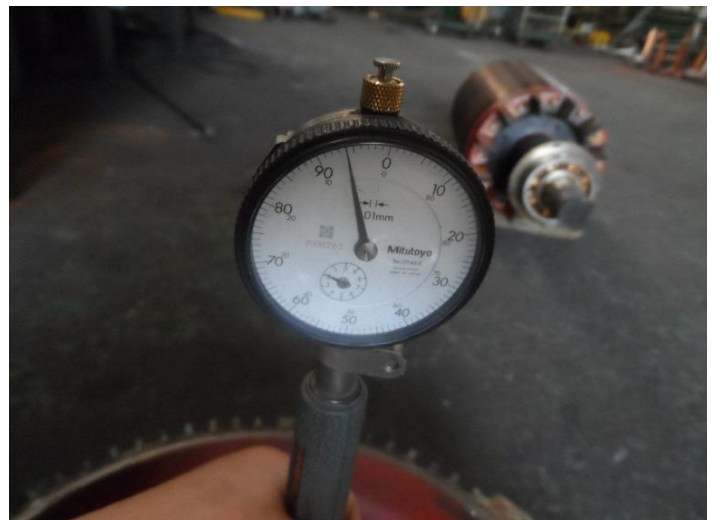
입고검사

부하측 Housing 측정치 6/100으로 불량

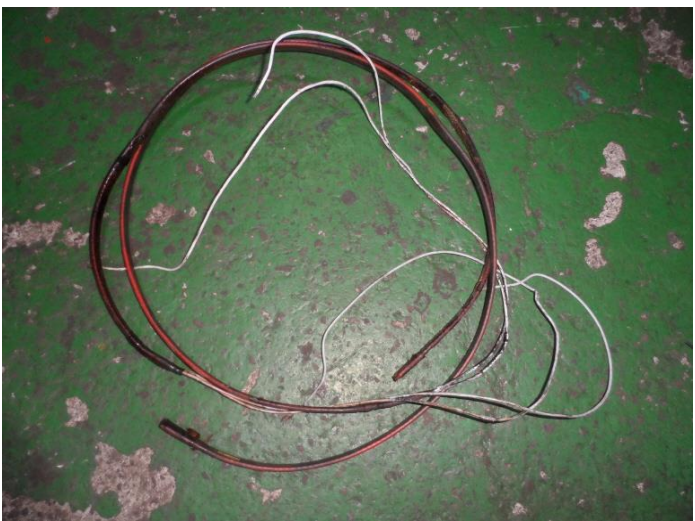
입고검사

제습 HEATER 1EA소손

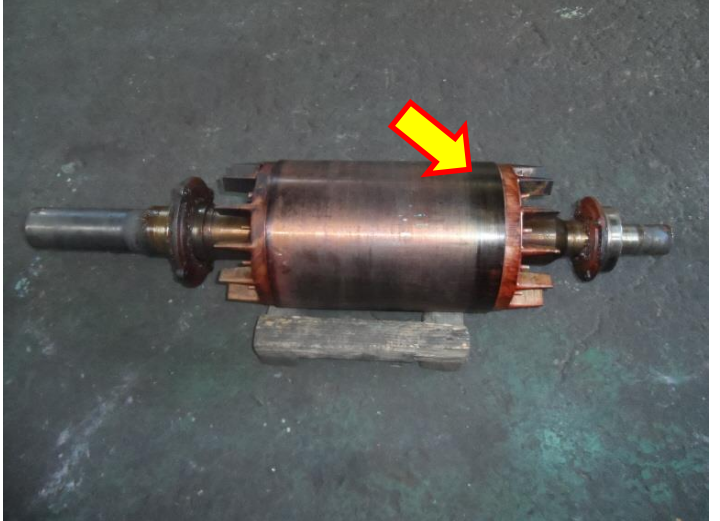
입고검사

STATOR와의 회전마찰 초기 진행

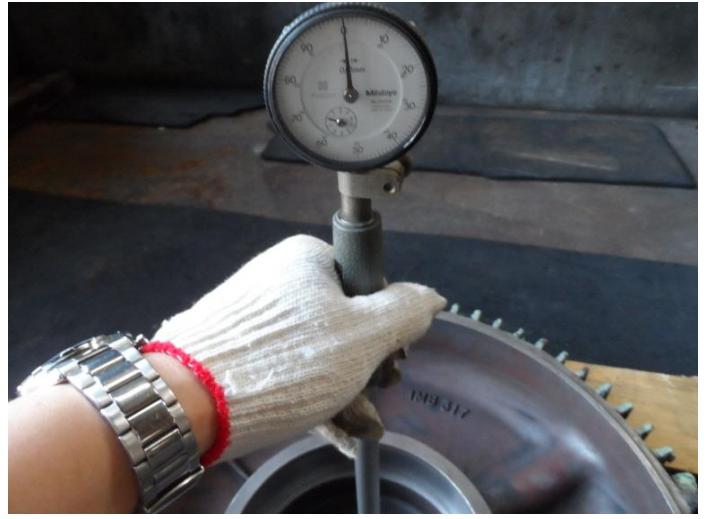
Housing

보수 후 검사 0/100

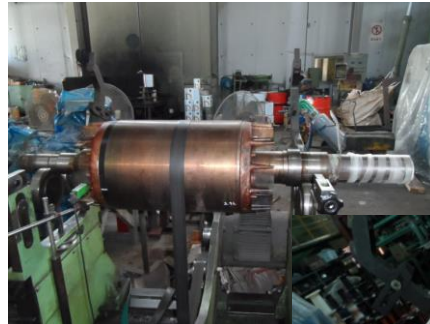
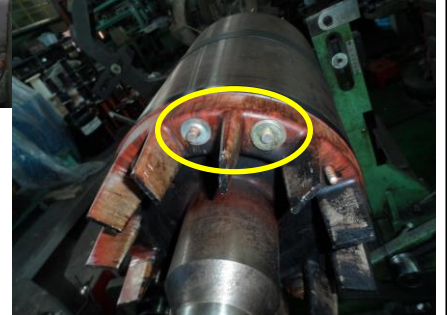
ROTOR

PLANE1	PLANE2
UNBALANCE	26.8 gr	7.0 gr
ANGLE	274 deg	310 deg
RESULT	ACCEPT	ACCEPT

PLANE1	PLANE2
UNBALANCE	6.0 gr	8.3 gr
ANGLE	231 deg	299 deg
RESULT	ACCEPT	ACCEPT

BALANCING 실시 및 UNBALANCE 교정

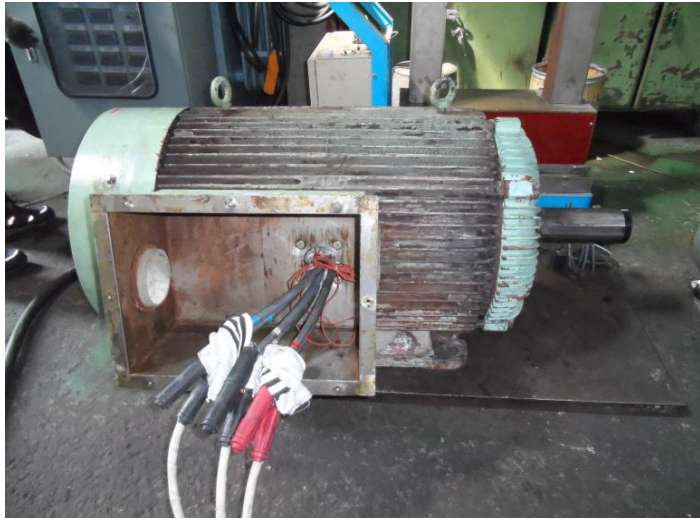
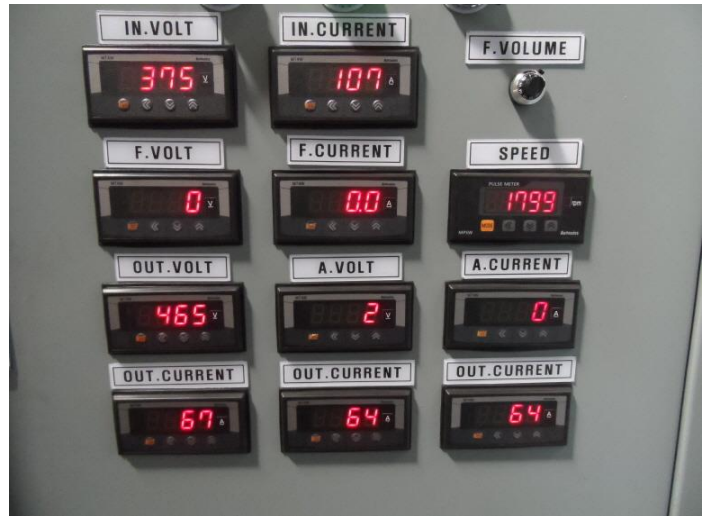
출고검사

시운전 Test 실시

시운전 Test 운전MONITORING

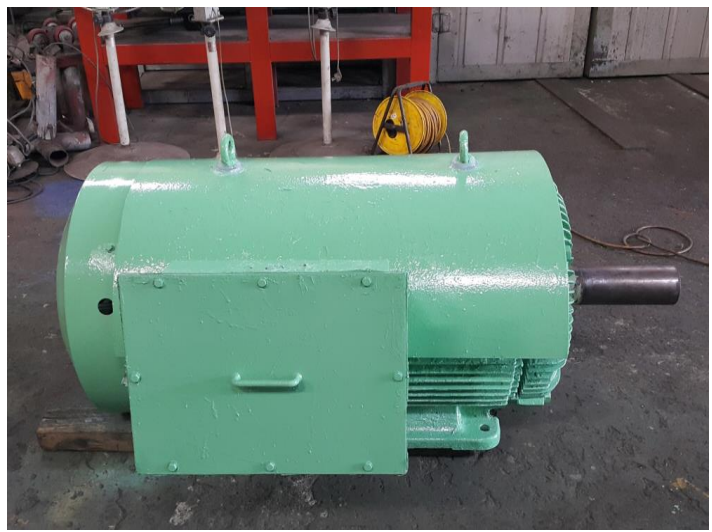
출고검사

진동 & 소음 검사
