작업공정사진철

공사명: SPINDLE MOTOR OVERHAUL

규격: AC SERVO MOTOR

REPAIR 내역: 분해 및 불순물 CLEANSING DRYING
INSULATING VARNISH DIPPING DRYING
BALANCING 및 UNBALANCE교정
BEARING교환
입 출고검사 시운전 TEST

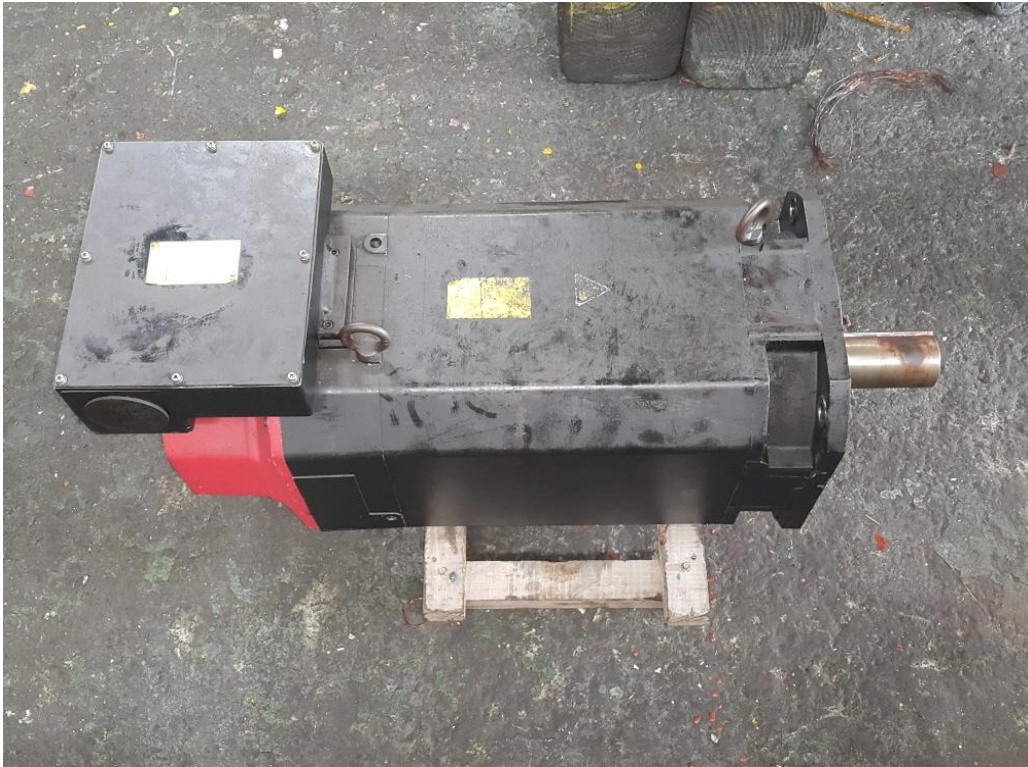
Ass'y

분해 전

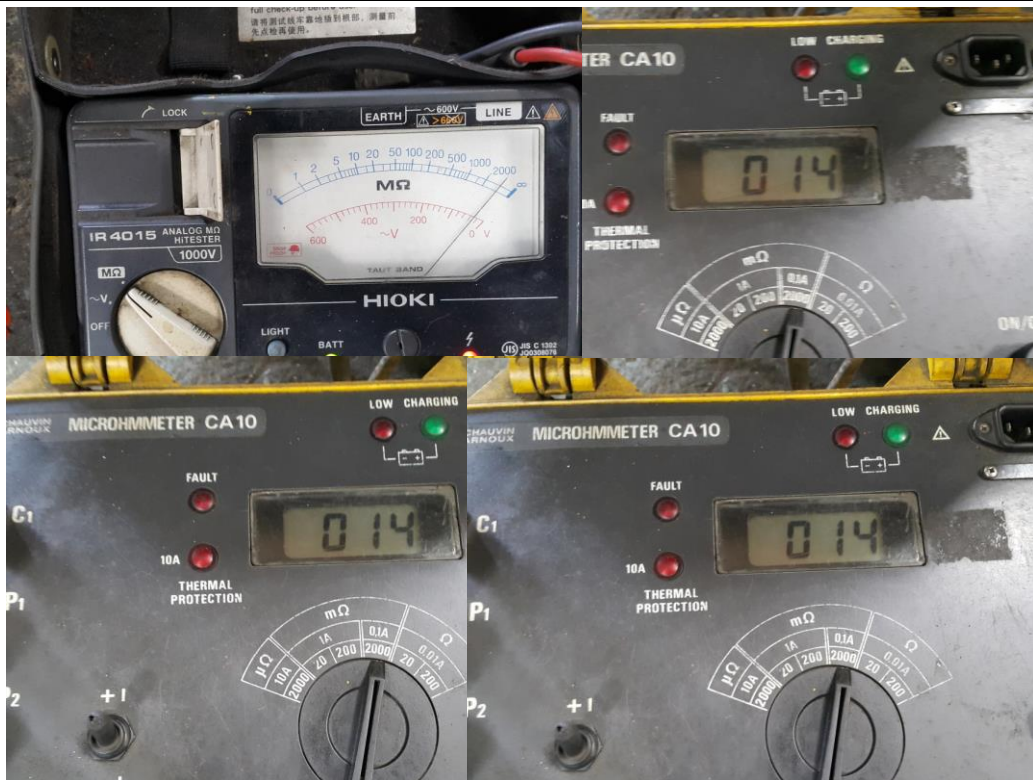
권선검사

절연저항 & 각 상별 권선저항 양호

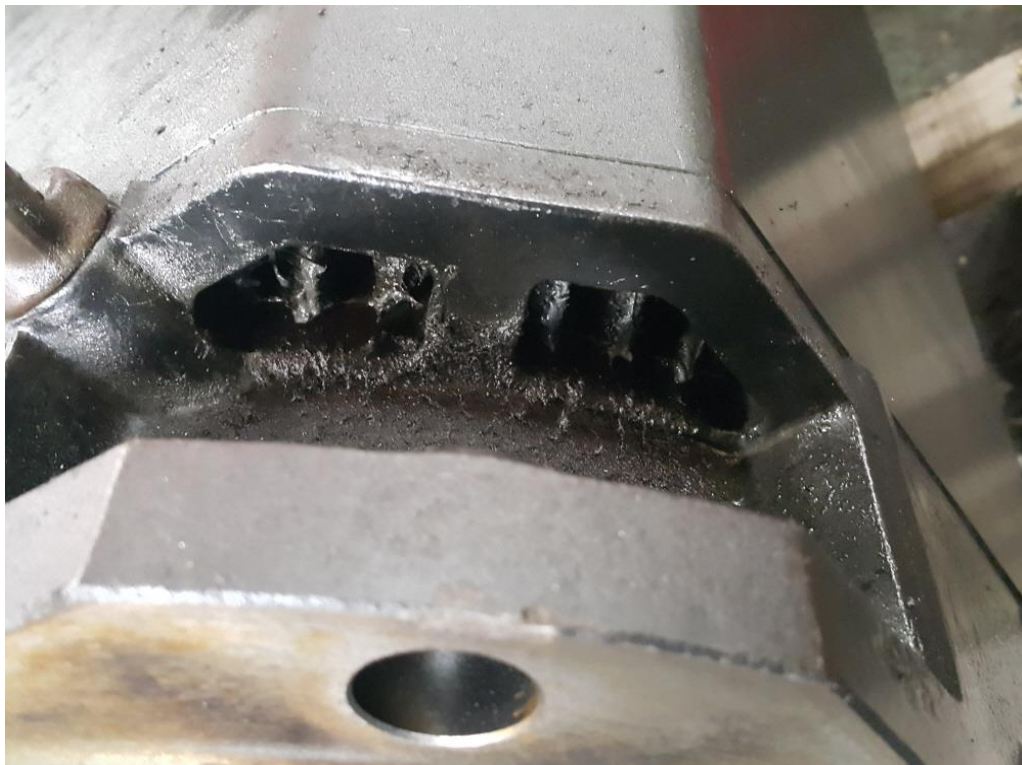
Ass'y	냉각구 불순물 고착
작업공정	AC SERVO MOTOR 입고검사

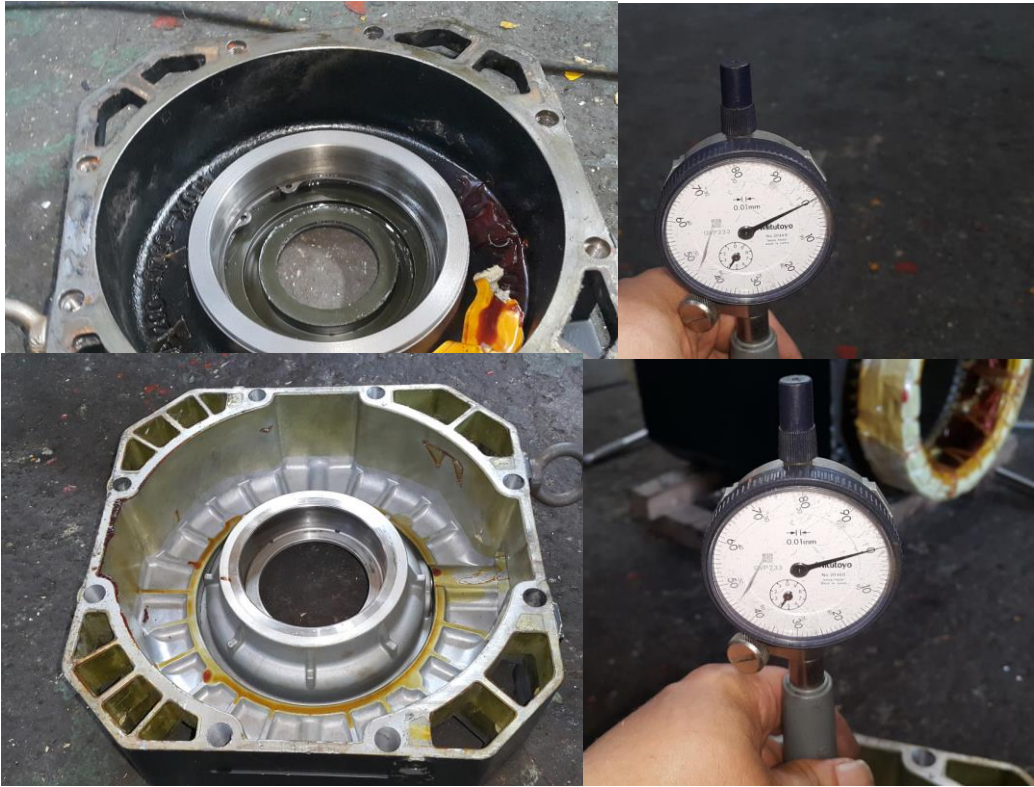
양측	HOUSING검사 0/100로 양호
작업공정	AC SERVO MOTOR 진동 정비

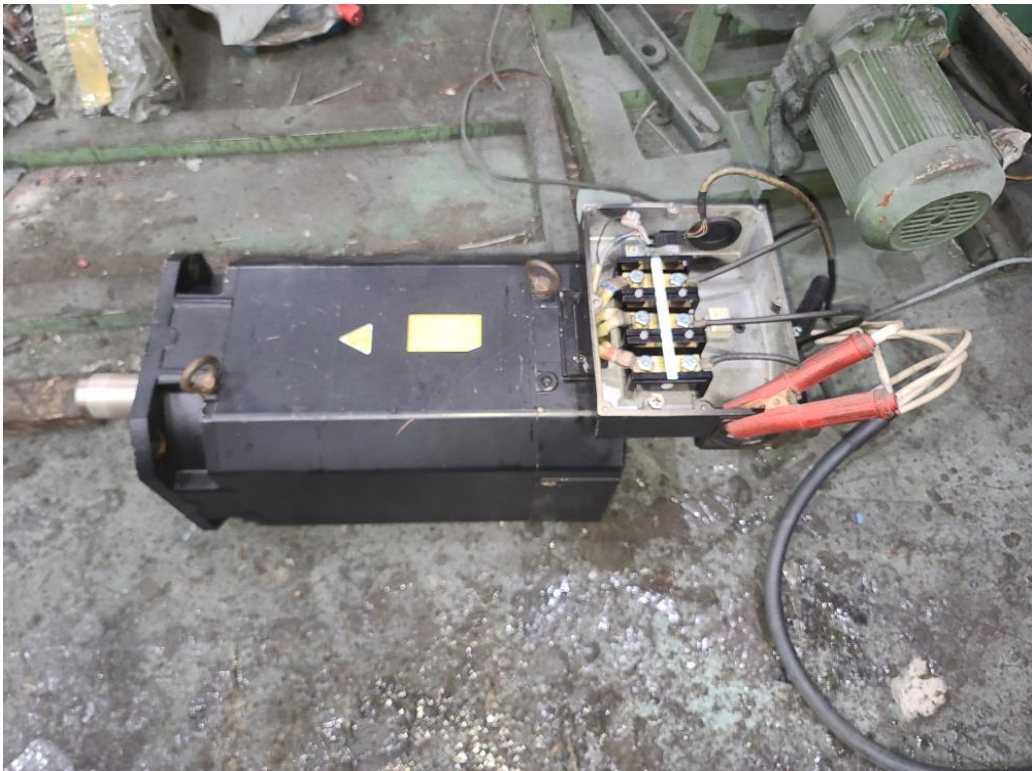
출고 검사	시운전 TEST 실시

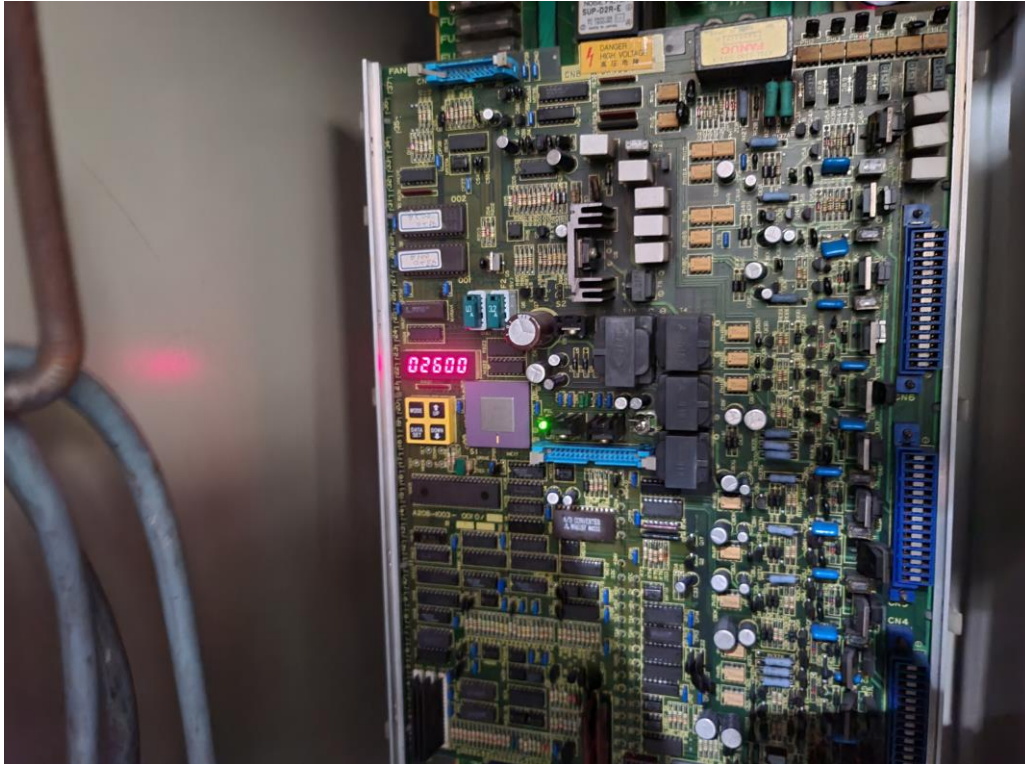
출고 검사

시운전 TEST 실시 운전 SPEED

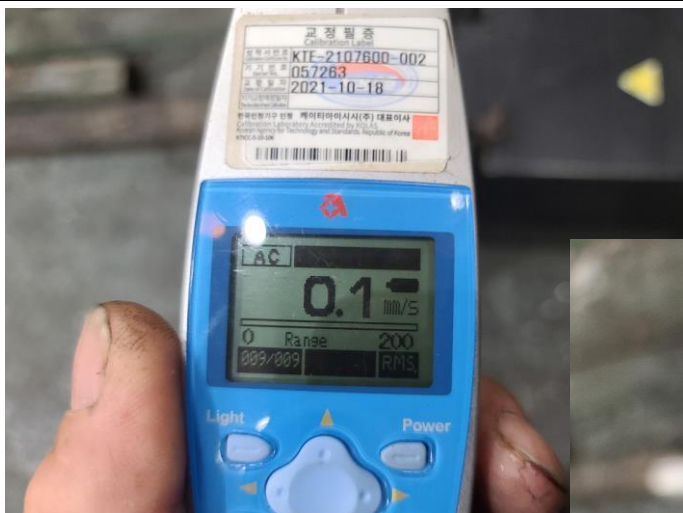
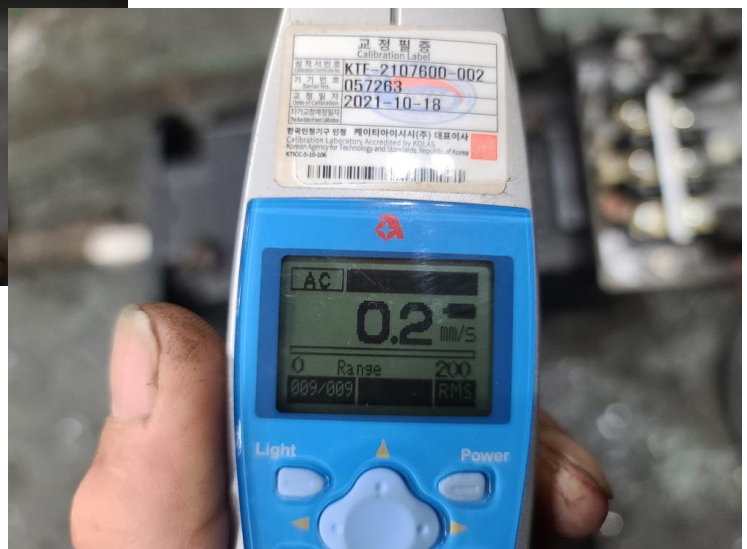
부하측

반 부하측

출고 검사

진동검사 알호

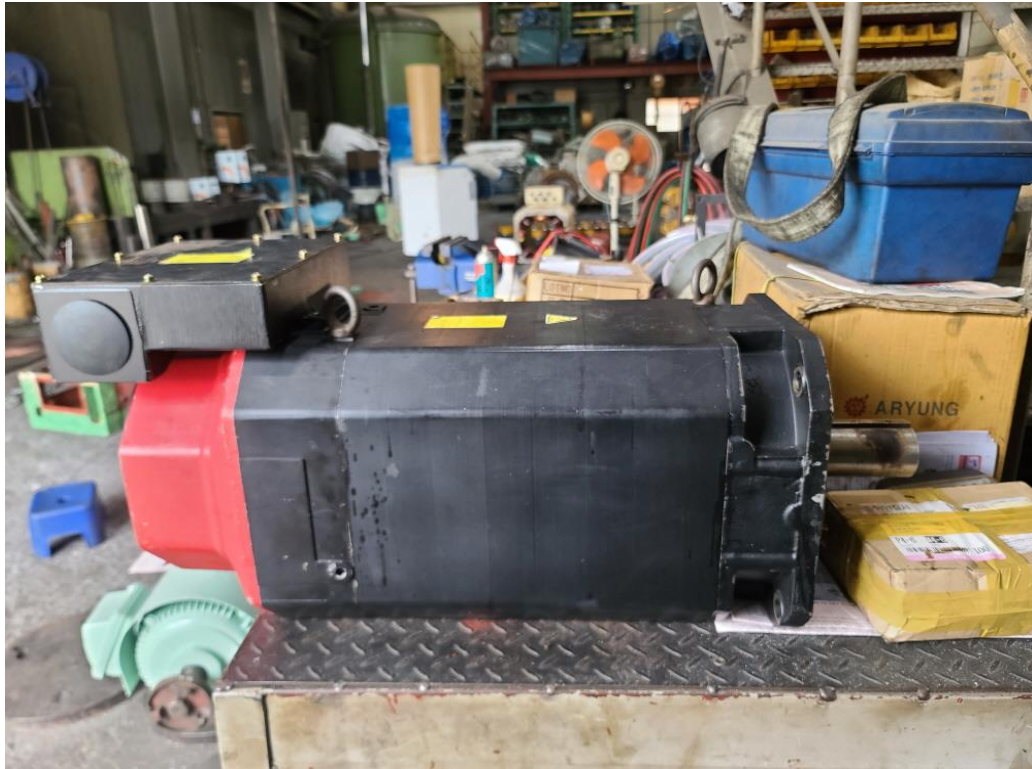
Ass'y

출고검사 후

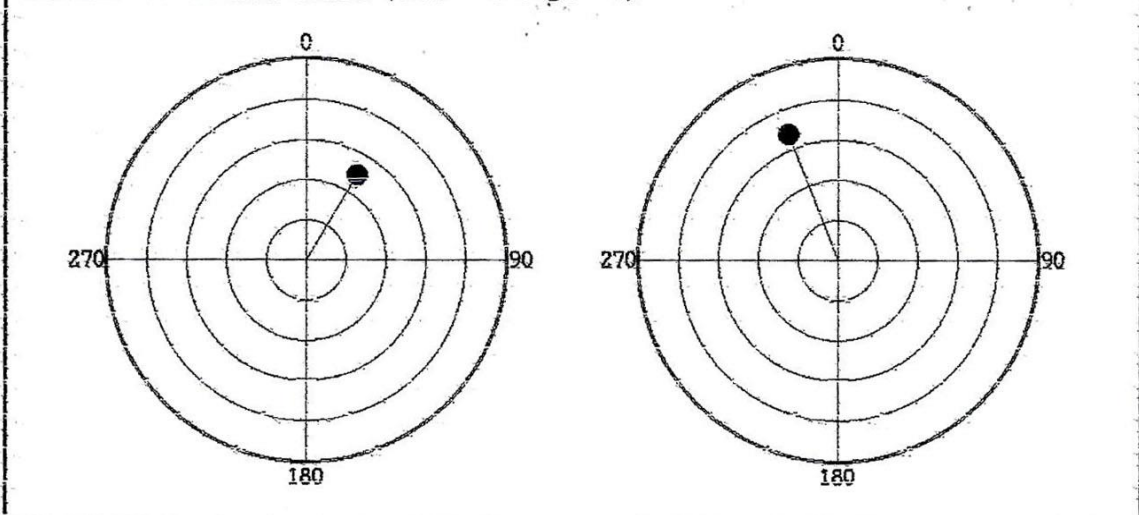
CORRECT UNBALANCE GRAPH (max = 5.0 gr)

PART NAME : SERVO ROTOR			
CUSTOMER : BNK			
TEST TIME : 2022. 7.29 14:36:43			
GRADE	: G 6.3	RATING SPEED	: 4000 rpm
WEIGHT	: 80.000 kg	TESTING SPEED	: 532 rpm
DIAMETER	: 180 mm	CORRECTION	: ADD
ACCEPTABLE UNBALANCE			
PLANE1	: 6.7 gr	PLANE2	: 6.7 gr

PLANE1	PLANE2
UNBALANCE	5.6 gr	8.6 gr
ANGLE	90 deg	346 deg
RESULT	ACCEPT	REJECT

PLANE1	PLANE2
UNBALANCE	2.5 gr	3.4 gr
ANGLE	31 deg	338 deg
RESULT	ACCEPT	ACCEPT
