작업결과 보고서

설비명:

작업기간		감독부서	제1발 전기부
	1 MOTOR COIL권선 85KW 2P 2 베어링 정비작업 6313 3	1 2	
작업결과 확인	양호

사진대장

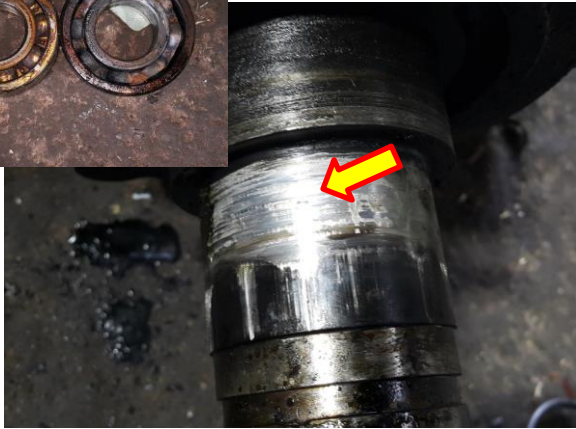
입고검사

BEARING부 SHAFT

반 부하측 BEARING 발열융합으로 보수 필요

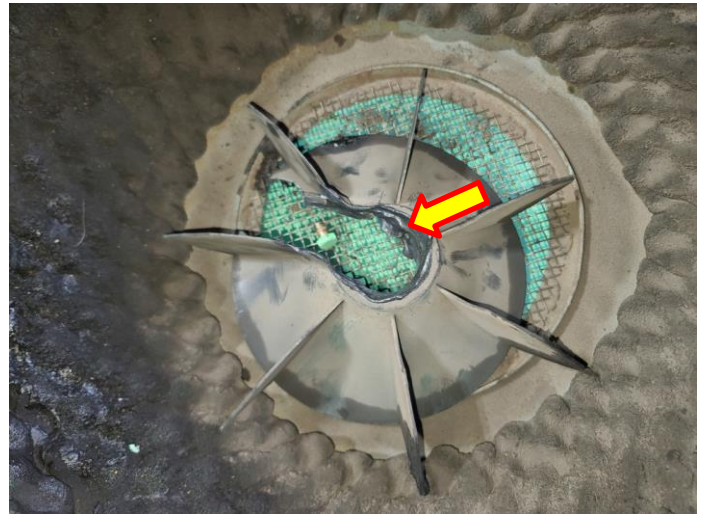
입고검사

BEARING 발열로 냉각 FAN 녹음

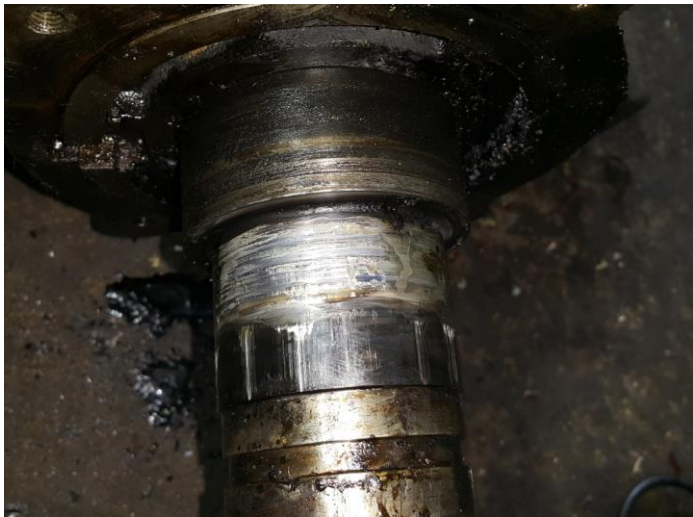
입고검사

보수 후 BALANCING 및 UNBALANCE교정 필요

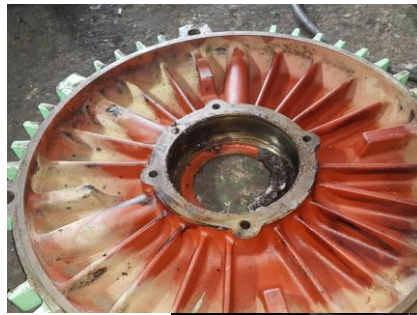
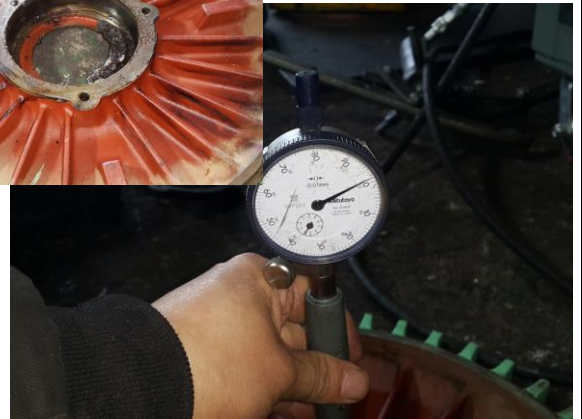
입고검사

부하측 HOUSING검사 1/100로 양호

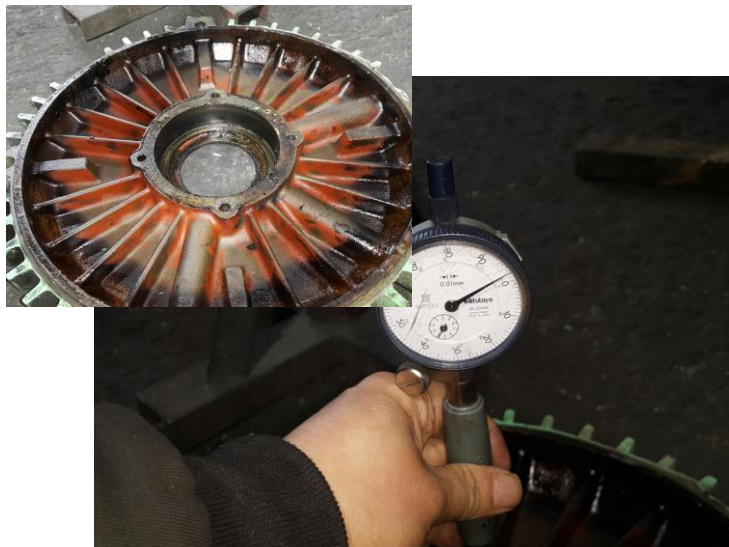
입고검사

반 부하측 HOUSING검사 2/100로 양호

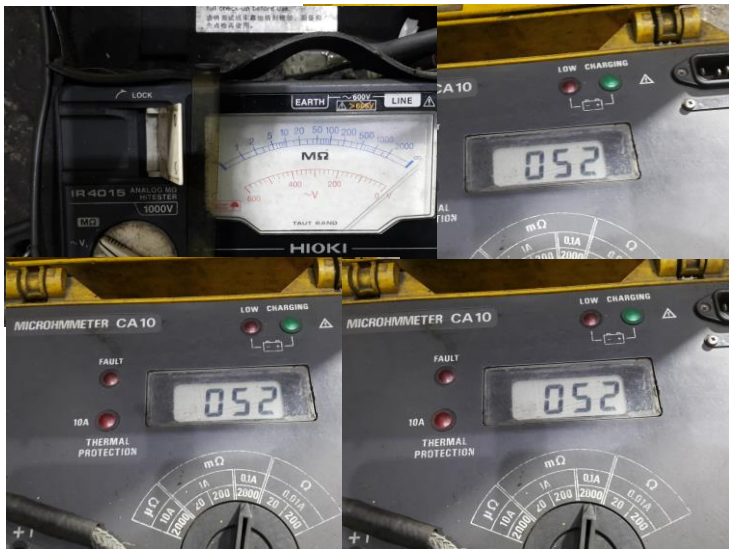
출고 검사

MOTOR 절연저항 & 각 상별 권선저항

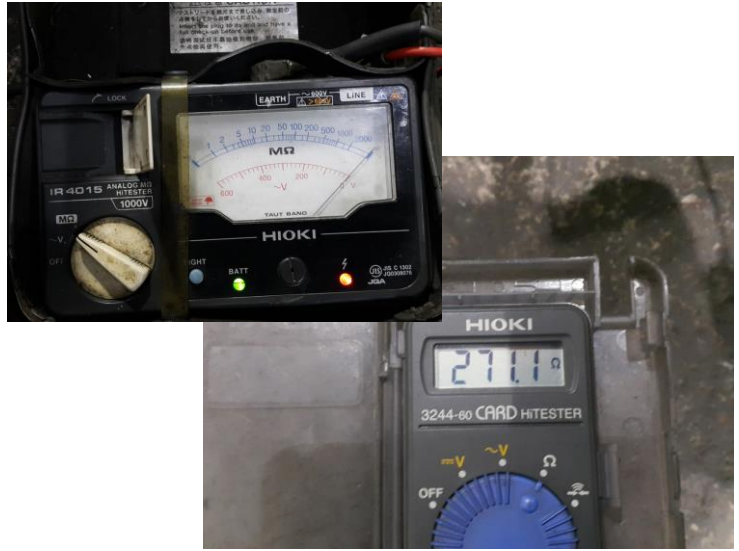
출고 검사

제습 HEATER 절연저항 & 병렬 권선저항

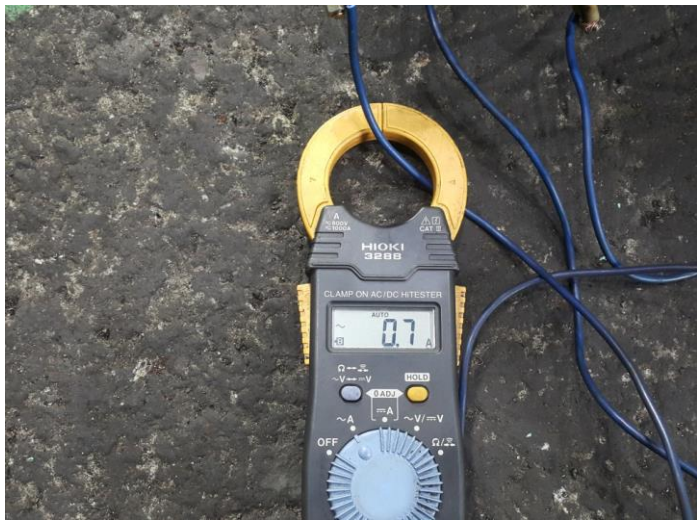
출고 검사

제습 HEATER 220V병렬일때 1.7A

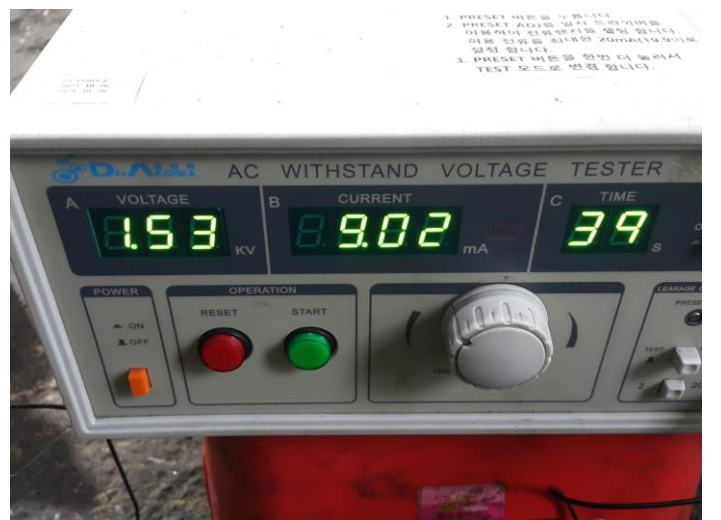
출고 검사

절연내력 시험

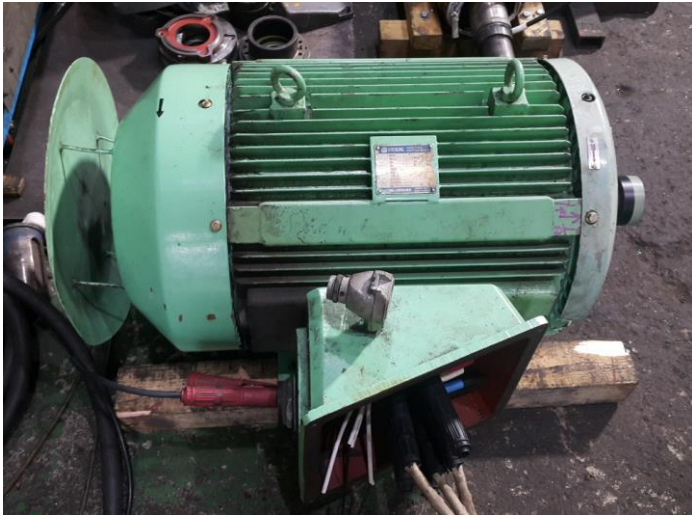
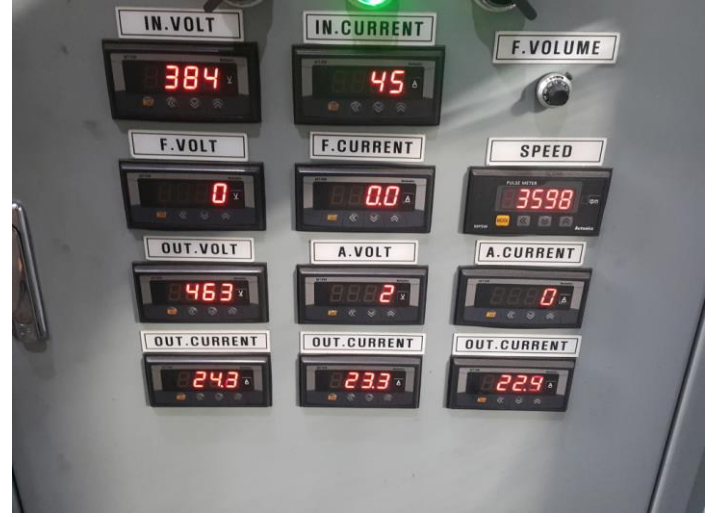
출고 검사

시운전 TEST 실시

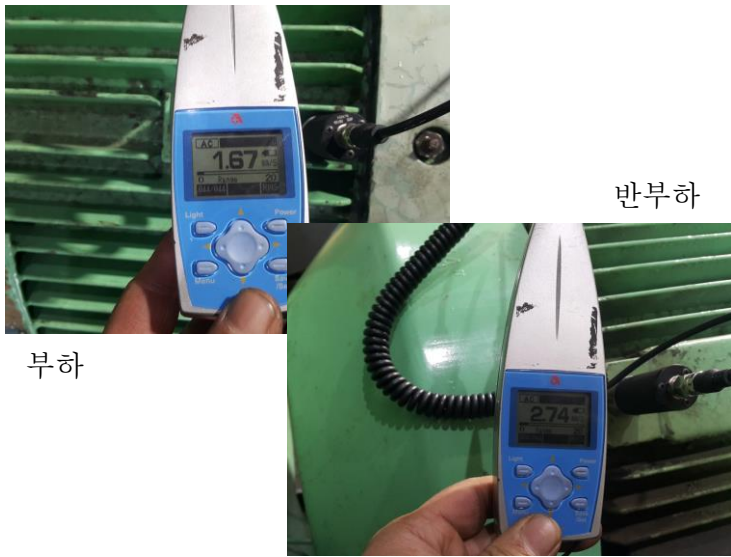
출고 검사

시운전 TEST 운전 CURRENT

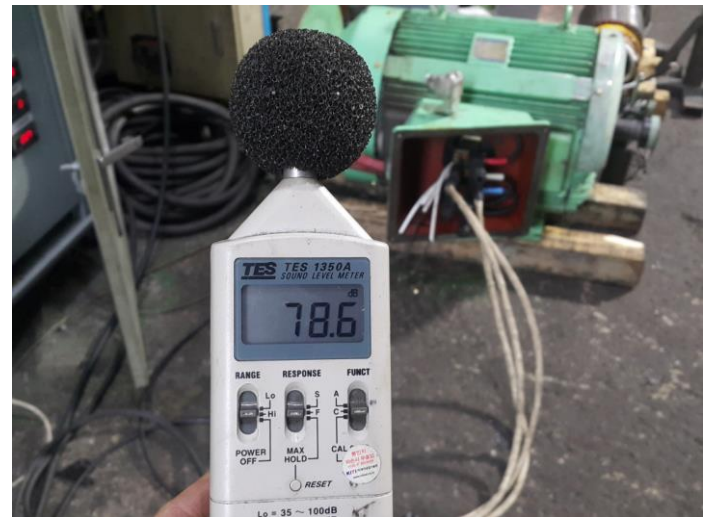
출고 검사

진동검사

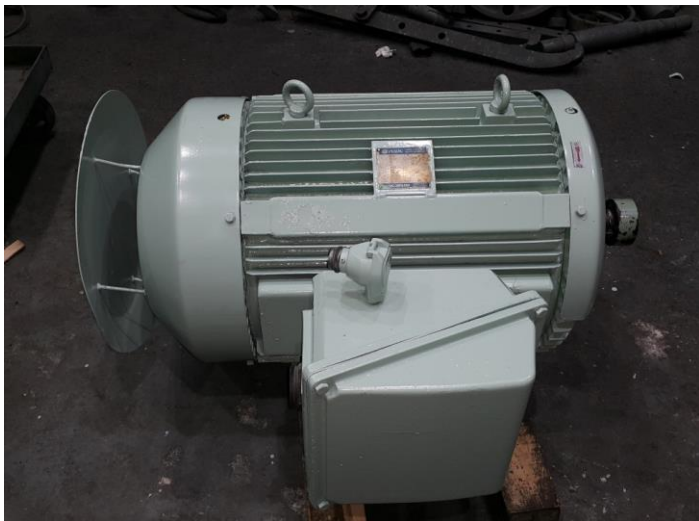
출고 검사

소음검사

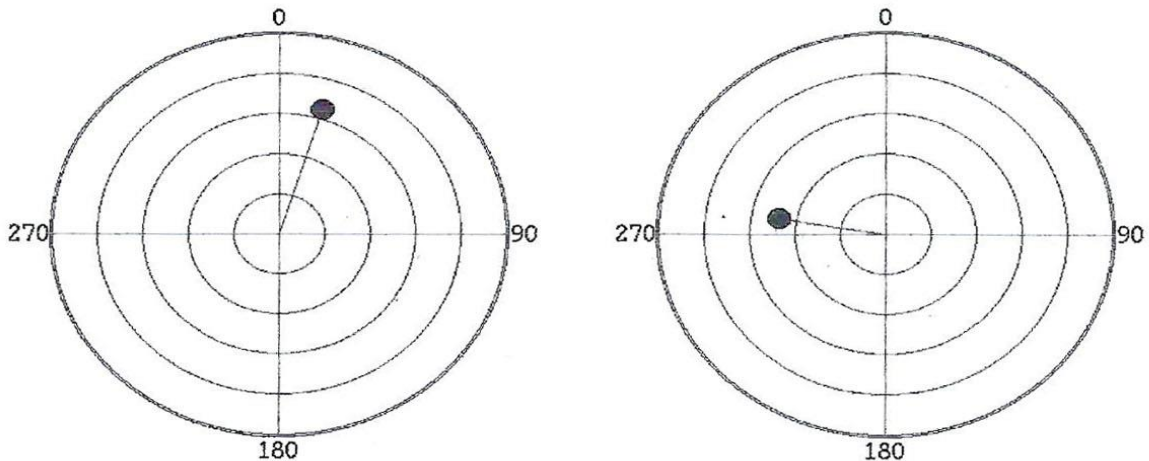
CORRECT UNBALANCE GRAPH (max = 10.0 gr)

PART NAME : AC ROTOR 2P			
CUSTOMER :			
TEST TIME : 2024. 2.29 10:49:40			
GRADE	: G 6.3	RATING SPEED	: 3600 rpm
WEIGHT	: 94.000 kg	TESTING SPEED	: 532 rpm
DIAMETER	: 230 mm	CORRECTION	: ADD
ACCEPTABLE UNBALANCE			
PLANE1	: 6.8 gr	PLANE2	: 6.8 gr

PLANE1	PLANE2
UNBALANCE	11.8 gr	6.3 gr
ANGLE	12 deg	215 deg
RESULT	REJECT	ACCEPT

PLANE1	PLANE2
UNBALANCE	6.5 gr	4.8 gr
ANGLE	17 deg	280 deg
RESULT	ACCEPT	ACCEPT
