# 작업결과 보고서

공 사 명 : MOTOR보수의 건

| | 1 MOTOR COIL권선 110KW4P (BEARINGNU318/6316포함)<br>2 부하HOUSING METALLIZING 연마(육성가공)<br>3 BALANCING 및 UNBALACE교정 | | |

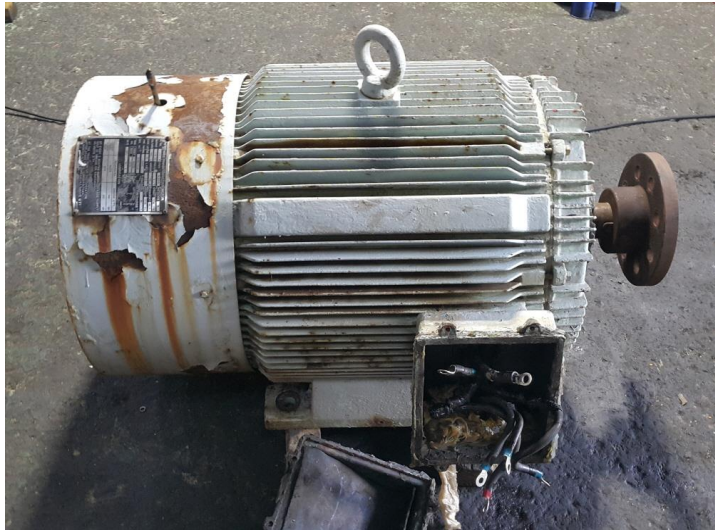
입고검사

분해 전

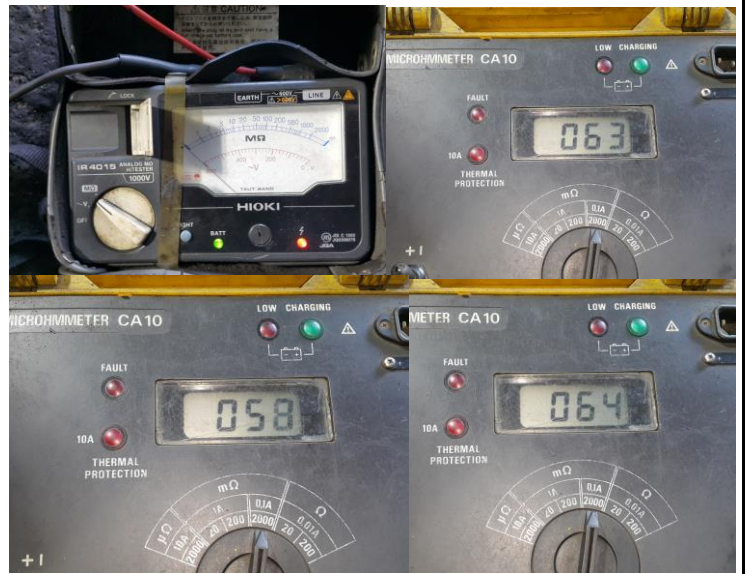
입고검사

절연저항 & 각상 LINE별 권선저항

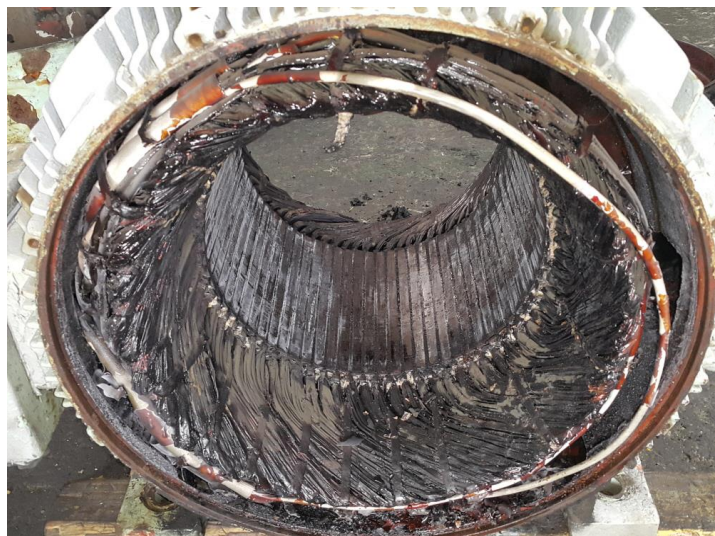
입고검사

권선 소손

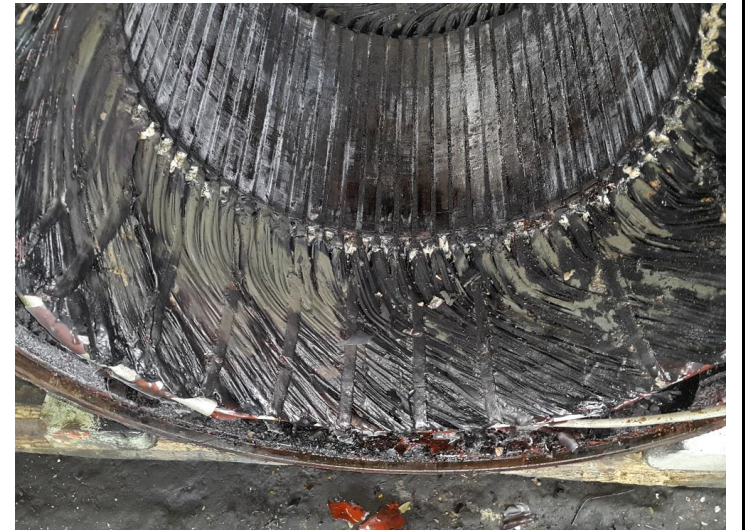
입고검사

과부하 발열 소손으로 예상 짐작됨

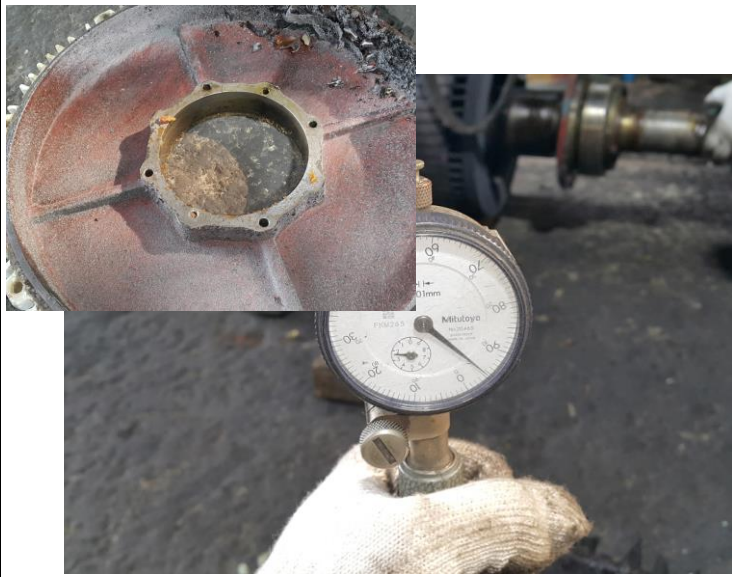
입고검사

부하측 HOUSING 검사 5/100로 불량

METALLIZING 연마 후 검사 0/100

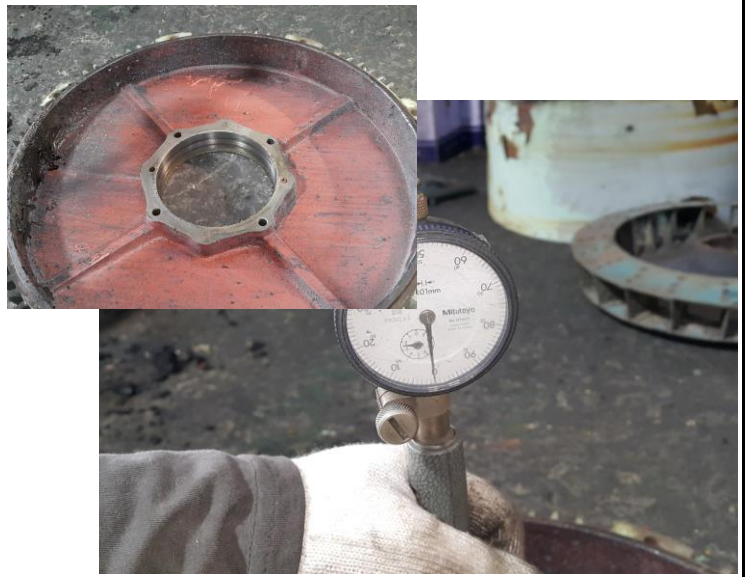
입고검사

반 부하측 HOUSING 검사 0/100 양호

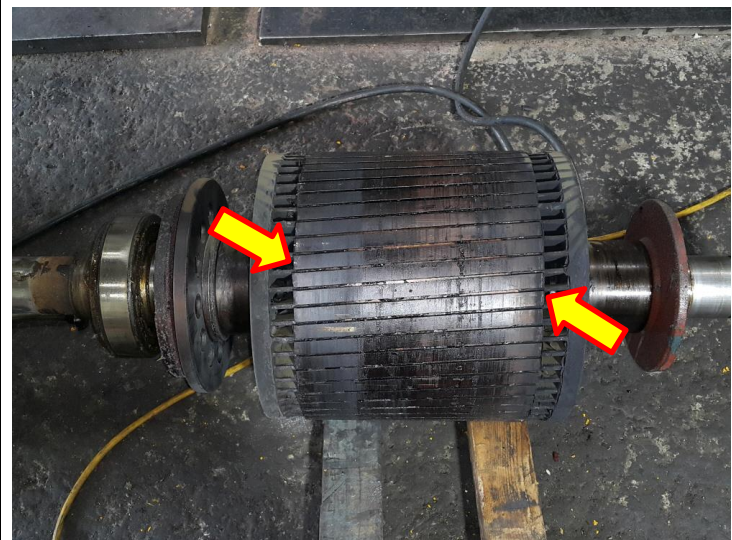
입고검사

CORE양면 산화현상 진행

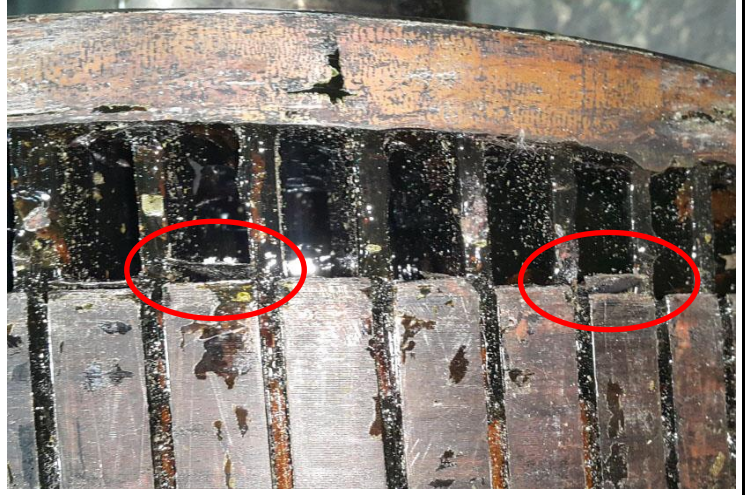
입고검사

CORE가 산화되어 떨어지면 권선 이상 소손의 원인이 됨

장기간 사용등 피로 누적으로 판단 됨

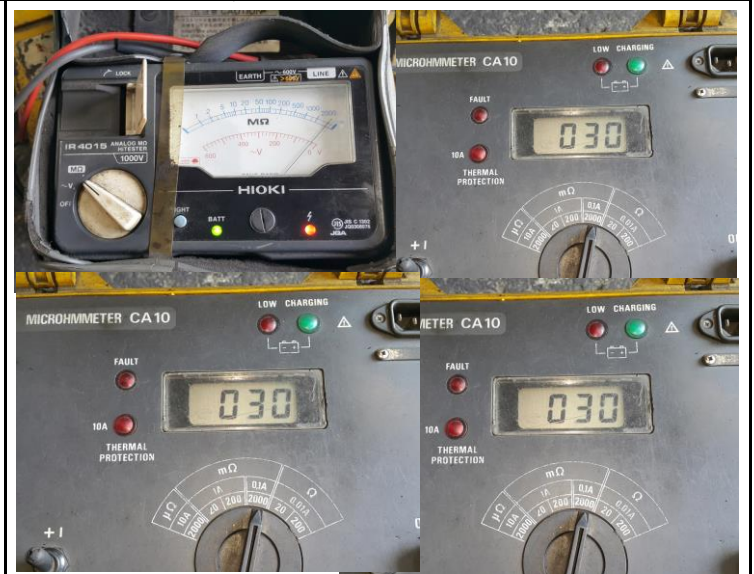
출고검사

절연저항 & 각상 △시 권선저항

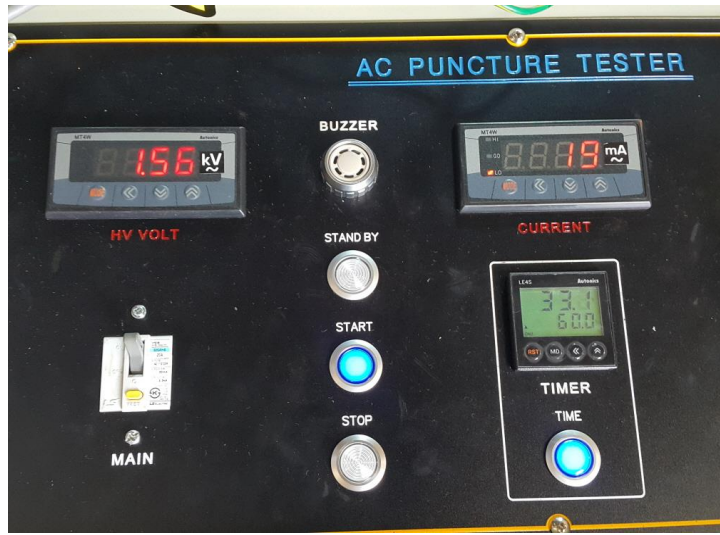
출고검사

MOTOR 절연내력 시험

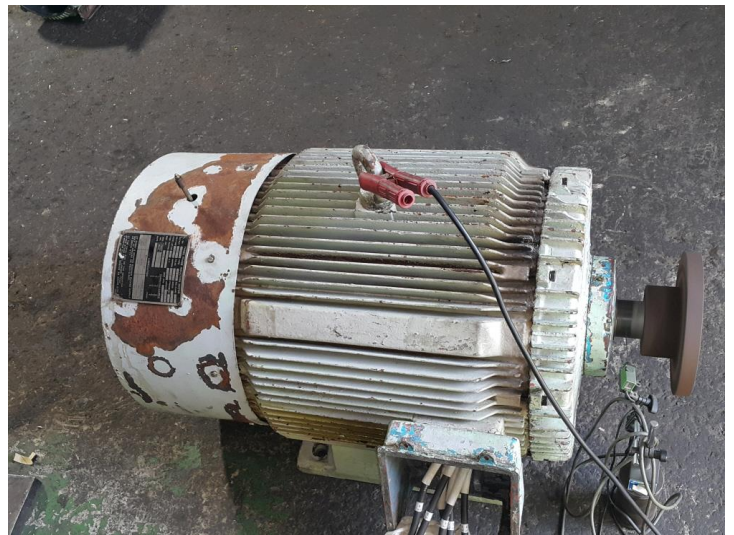
출고검사

시운전 TEST 실시

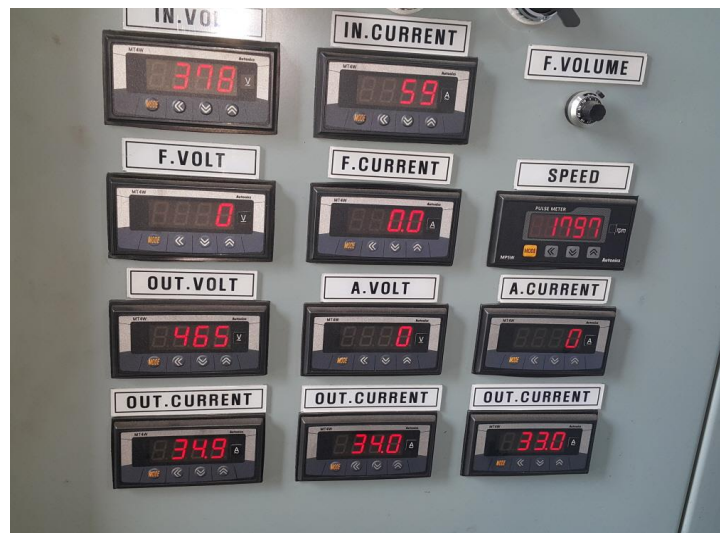
출고검사

시운전 TEST 실시 운전 CURRENT

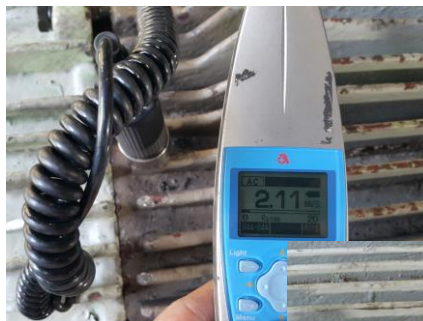
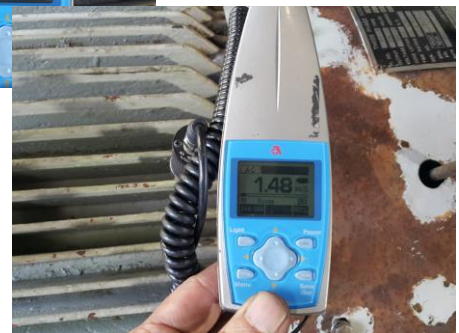
출고검사

진동 검사

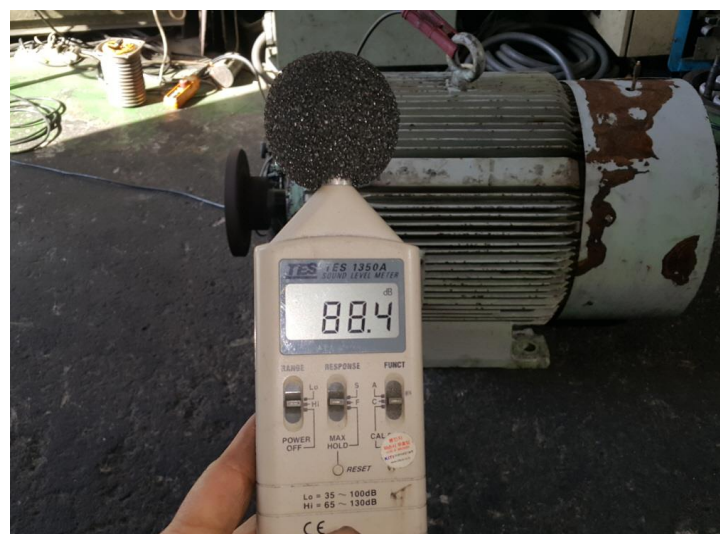
출고검사

소음 검사

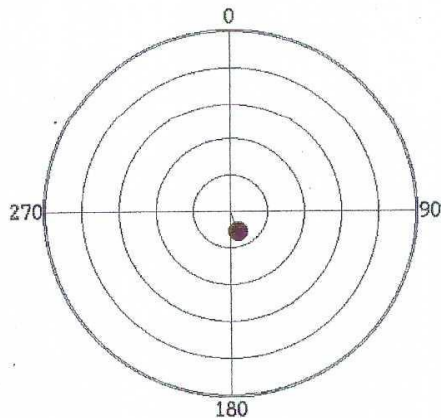
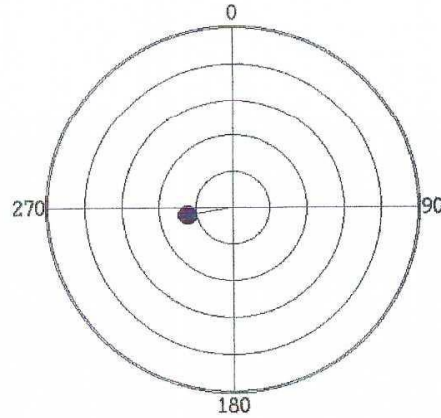
CORRECT UNBALANCE GRAPH (max = 50.0 gr )

| | PLANE1 | PLANE2 |
|---|---|---|
| UNBALANCE | 6.0 gr | 12.6 gr |
| ANGLE | 158 deg | 260 deg |
| RESULT | ACCEPT | ACCEPT |
