작업공정사진철

고객명: (주)
공사명: COOLING TOWER MOTOR OVERHAUL

규격: AC MOTOR 175HP(132KW) 4P 440V

REPAIR 내역: 분해 조립 및 조립부품 불순물 CLEANSING
INSULATING VARNISH DIPPING DRYING
2번 SHAFT BEARING부 METALLIZING 연마
BALANCING 및 UNBALANCE교정
BEARING 교환
입 출고검사 시운전 TEST 및 COLOR PAINTING

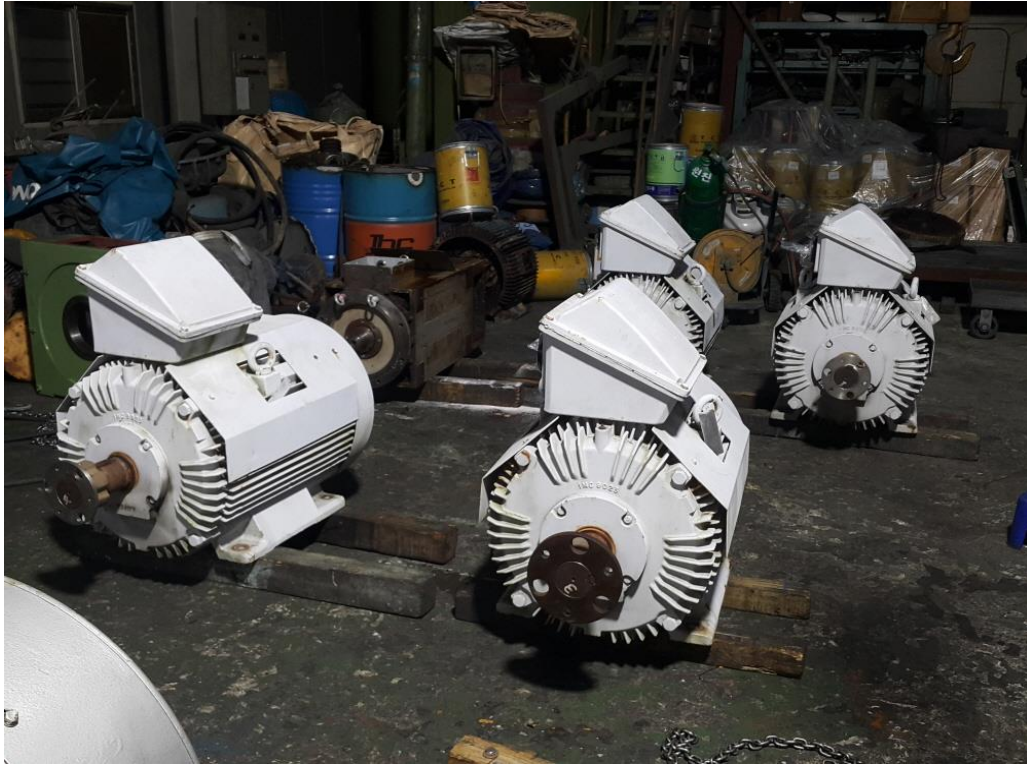
Ass'y

분해 전

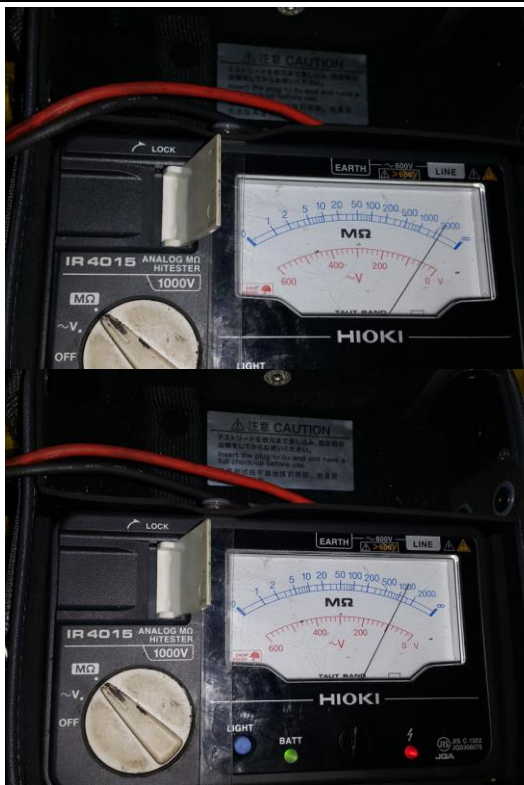
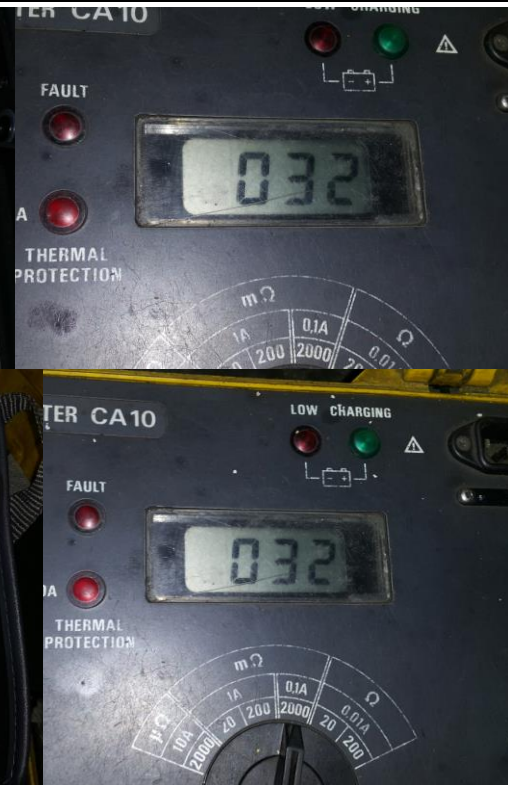
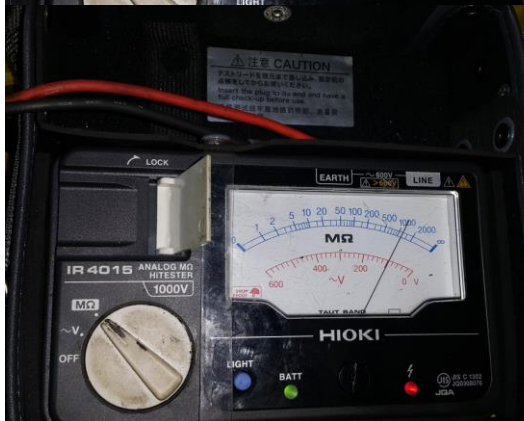
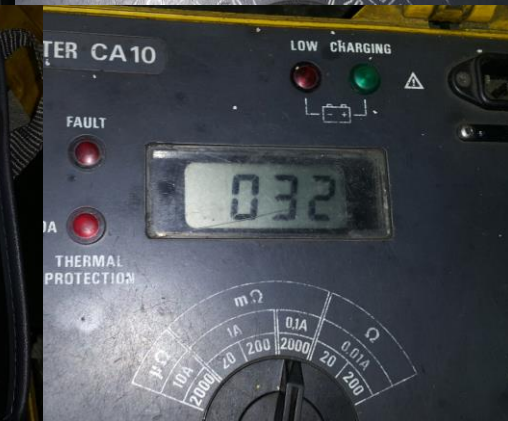
권선검사

절연저항 & 각 상별 권선저항 동일

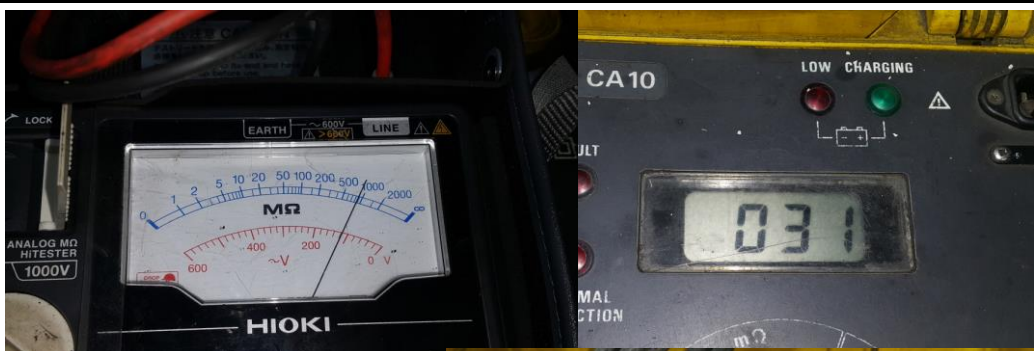
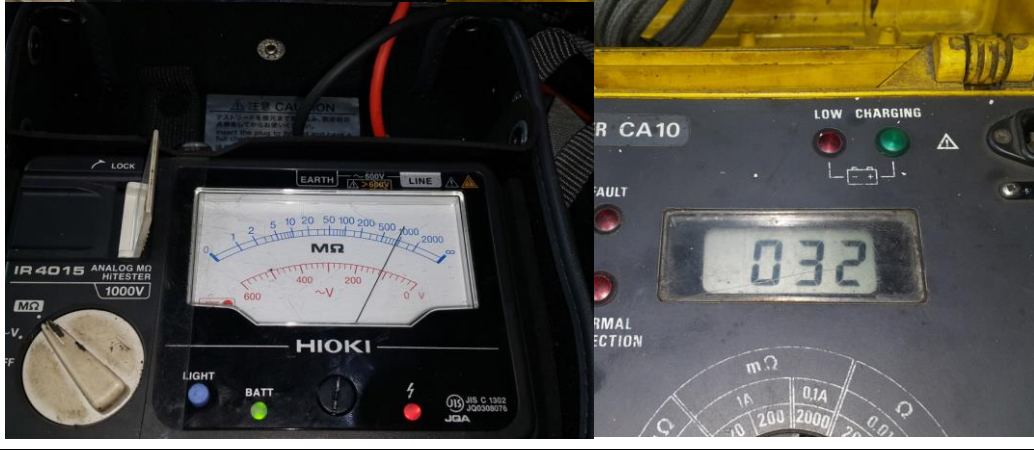
No.3
No.4

No.4
권선검사	절연저항 & 각 상별 권선저항 동일	
작업공정	AC MOTOR 175HP 입고검사

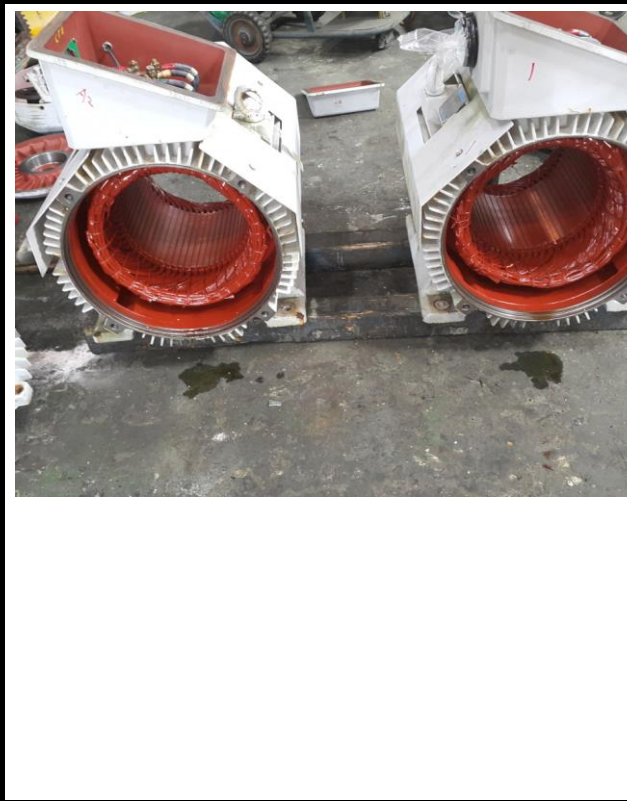
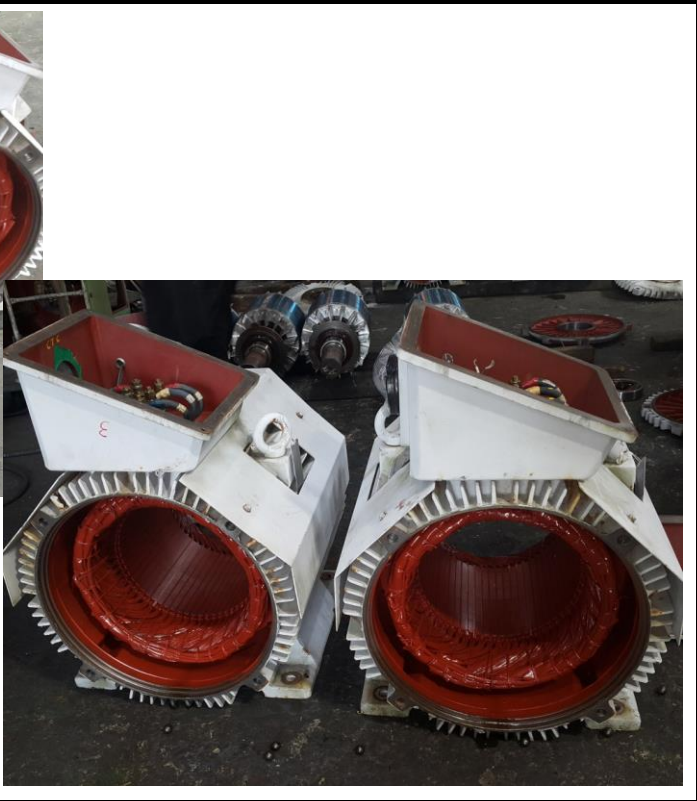
STATOR권체	분해 실시

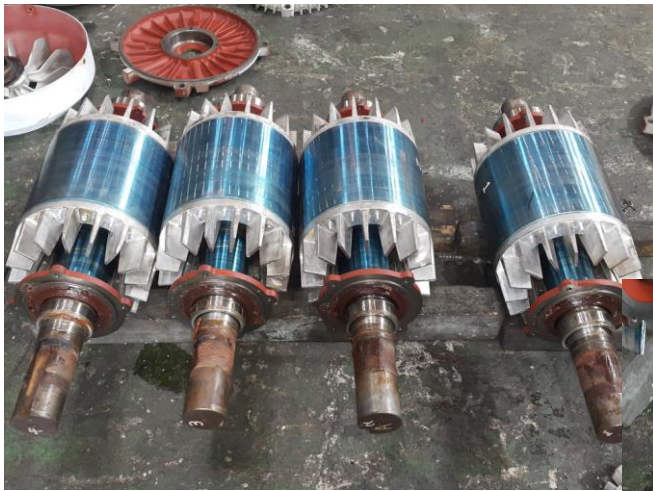
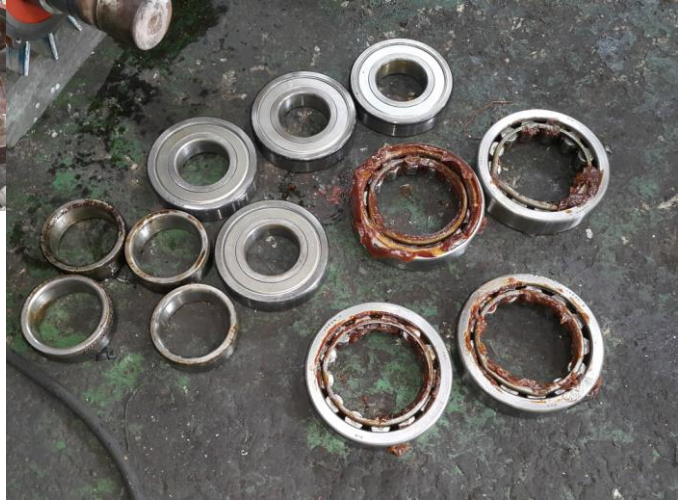
ROTOR	분해 후 BEARING 취외
-------	-----------------

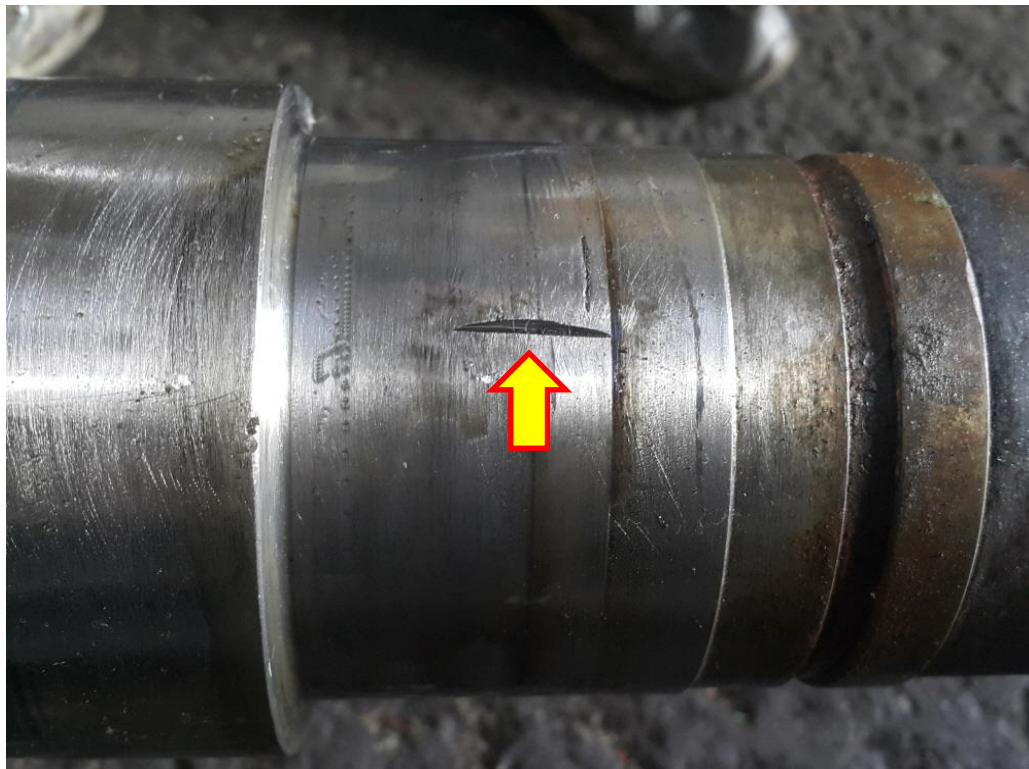
ROTOR 2번	부하측 BEARING부 이상으로 인하여 BALANCING을 실시할수 없음
----------	--

METALLIZING 연마 복원이 필요	
-----------------------	--

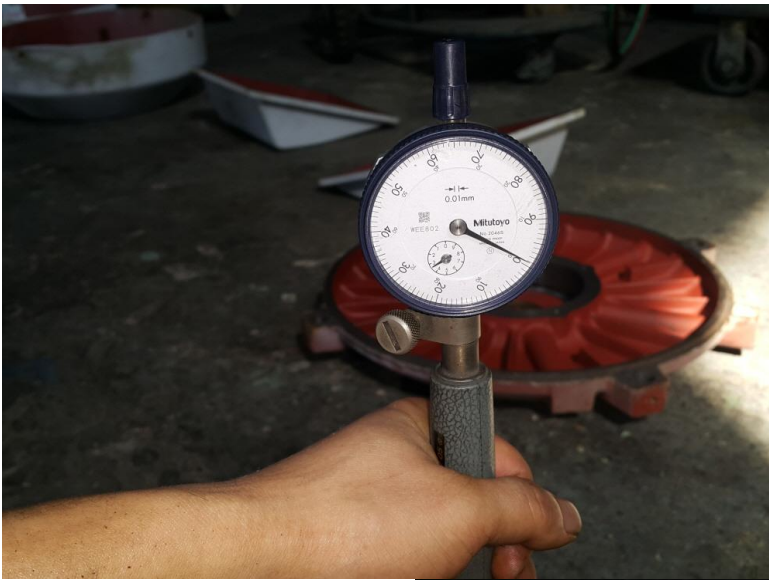
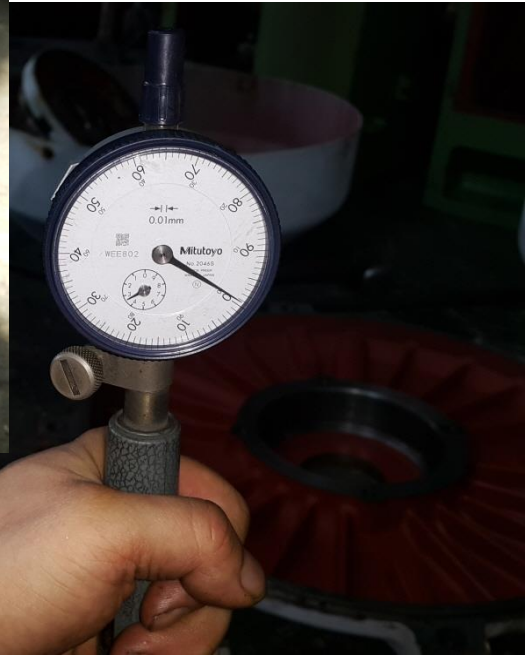
BRACKET

양측 HOUSING검사 8면 모두 1/100이내로 양호

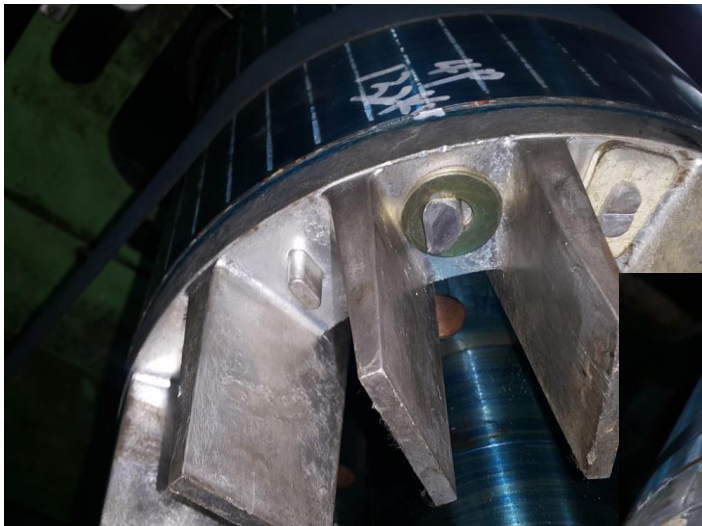
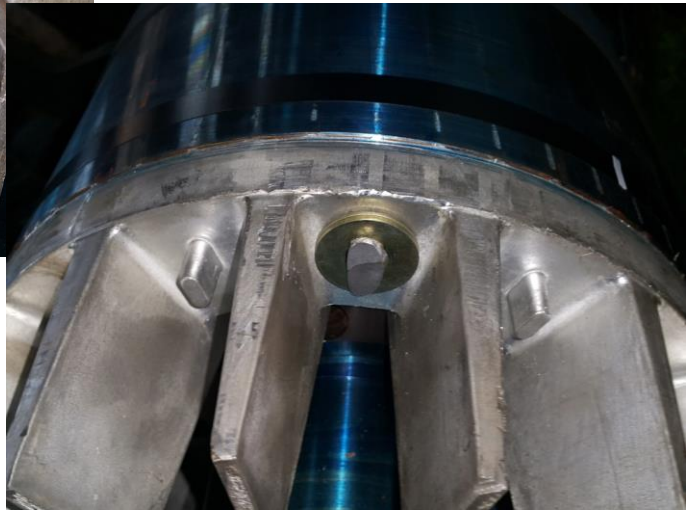
ROTOR No.1	교정된 UNBALACE REPORT참조
------------	-----------------------

4대 동등한 조건으로 BALANCING실시 하였슴으로 REPORT참조

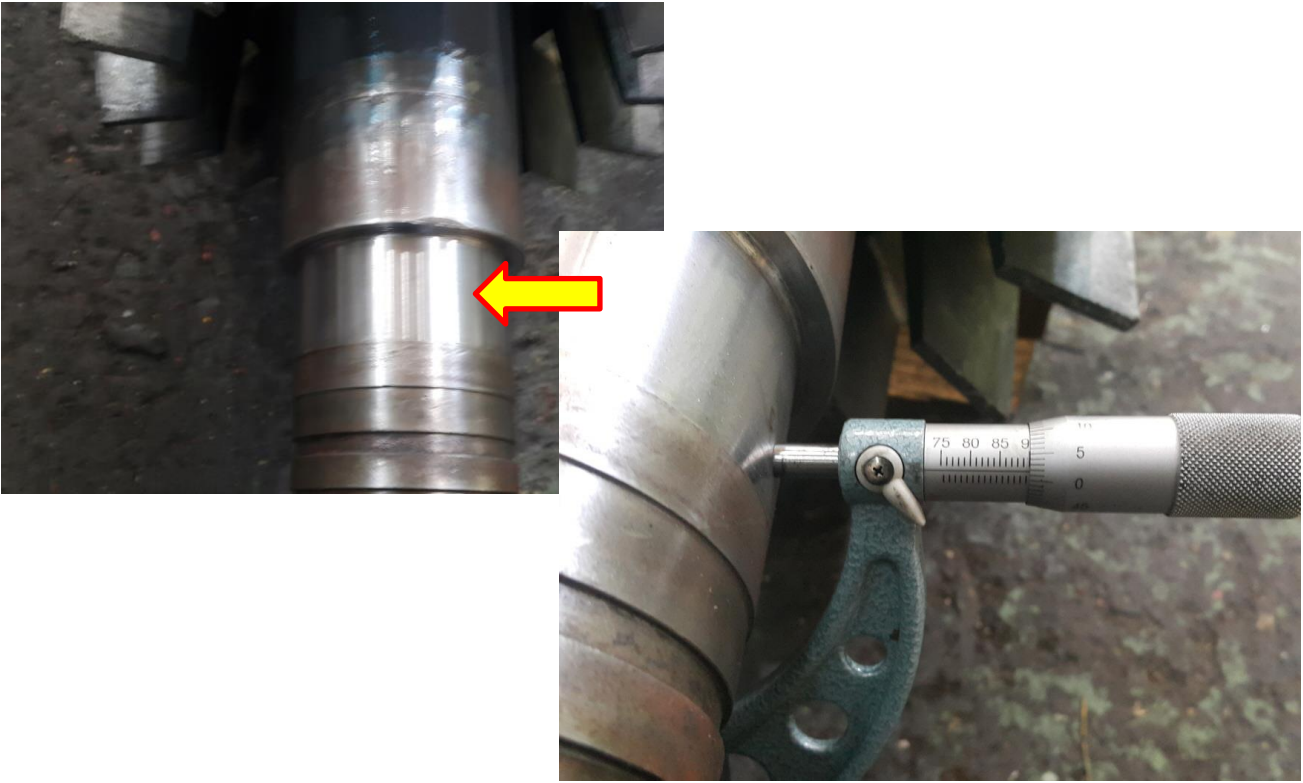
ROTOR 2번	부하측 BEARING부 METALLIZING 연마 복원 후 검사 2/100
작업공정	AC MOTOR 175HP 4P OVERHAUL

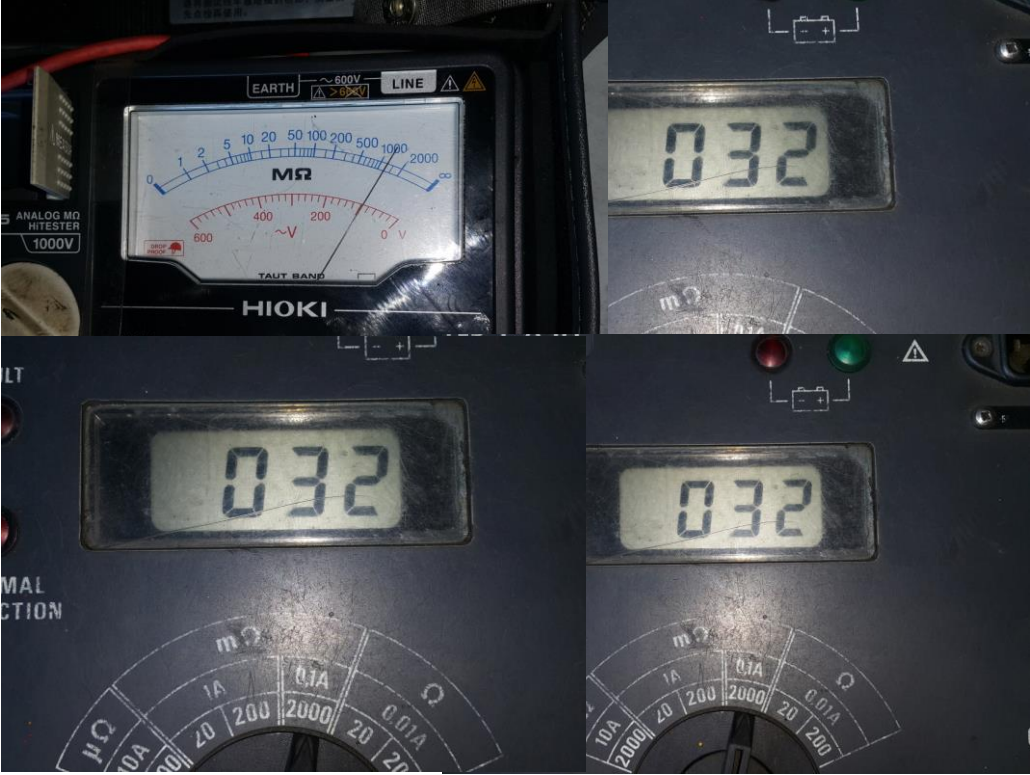
출고검사 No.2	절연저항 & 각 상별 권선저항

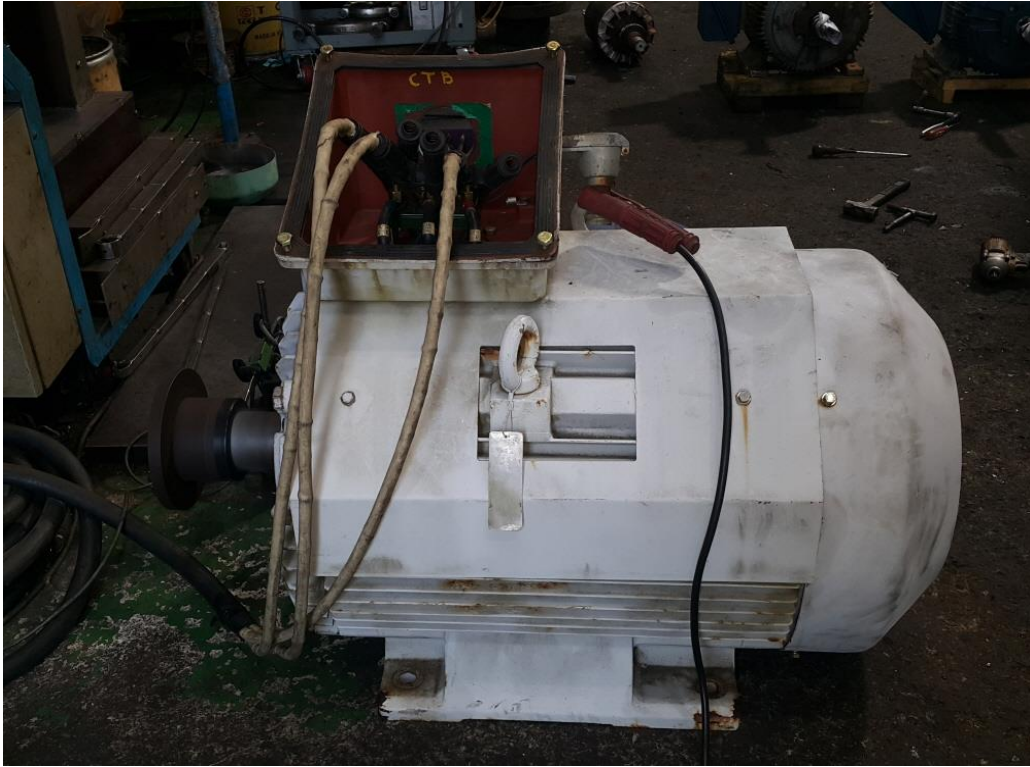
출고검사 No.2

시운전 TEST 실시

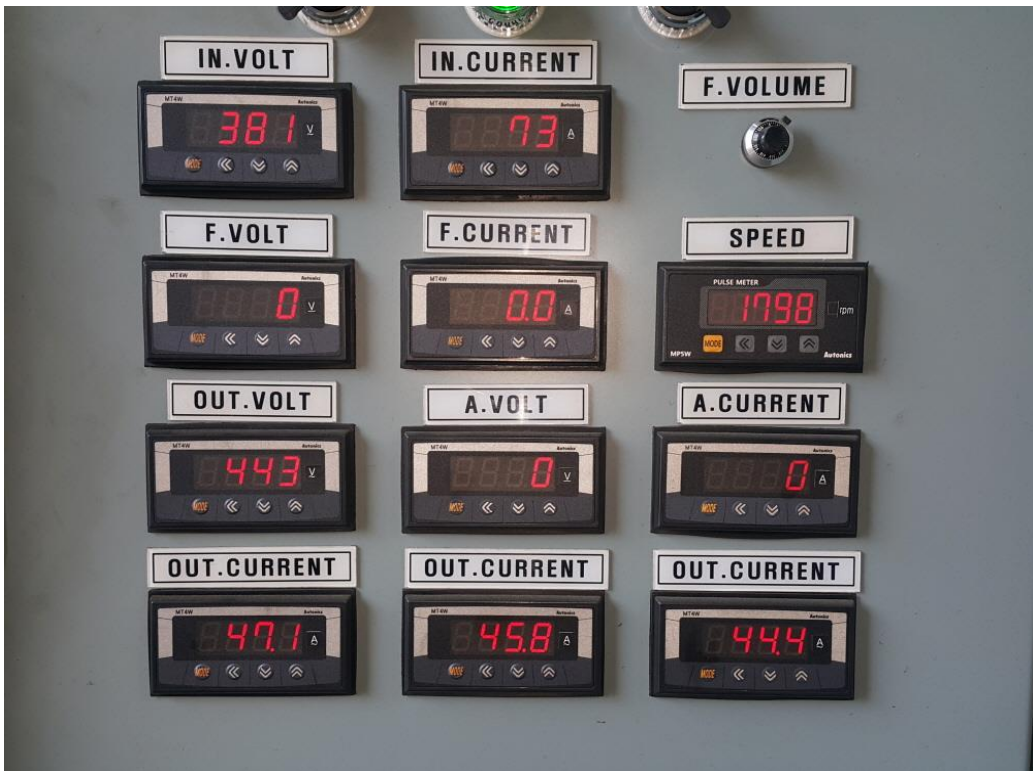
출고검사 No.2

시운전 TEST 실시 CURRENT

4대 동등한 조건으로 출고검사 완료 됨으로 CHECK LIST를 참조 하십시오

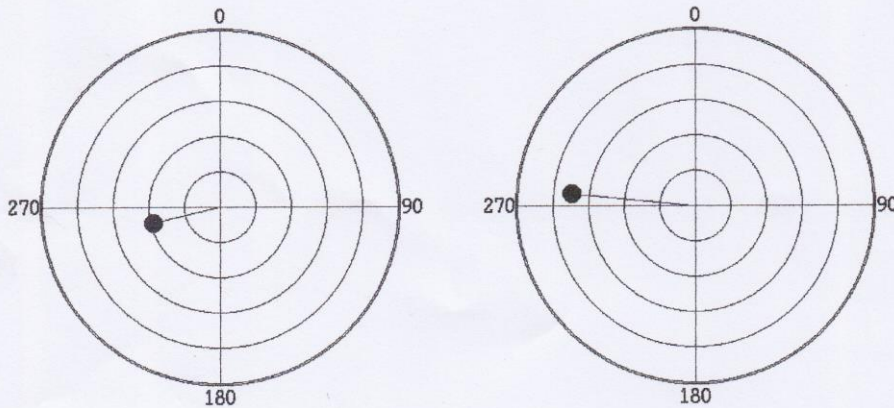
CORRECT UNBALANCE GRAPH (max = 10.0 gr)

PART NAME : AC ROTOR 4P A			
CUSTOMER :			
TEST TIME : 2024. 8.28 8:28:31			
GRADE :	G 6.3	RATING SPEED :	1800 rpm
WEIGHT :	132.000 kg	TESTING SPEED :	511 rpm
DIAMETER :	310 mm	CORRECTION :	ADD
ACCEPTABLE UNBALANCE			
PLANE1 :	14.2 gr	PLANE2 :	14.2 gr

PLANE1	PLANE2
UNBALANCE	11.5 gr	4.9 gr
ANGLE	350 deg	273 deg
RESULT	ACCEPT	ACCEPT

PLANE1	PLANE2
UNBALANCE	3.9 gr	7.0 gr
ANGLE	256 deg	276 deg
RESULT	ACCEPT	ACCEPT

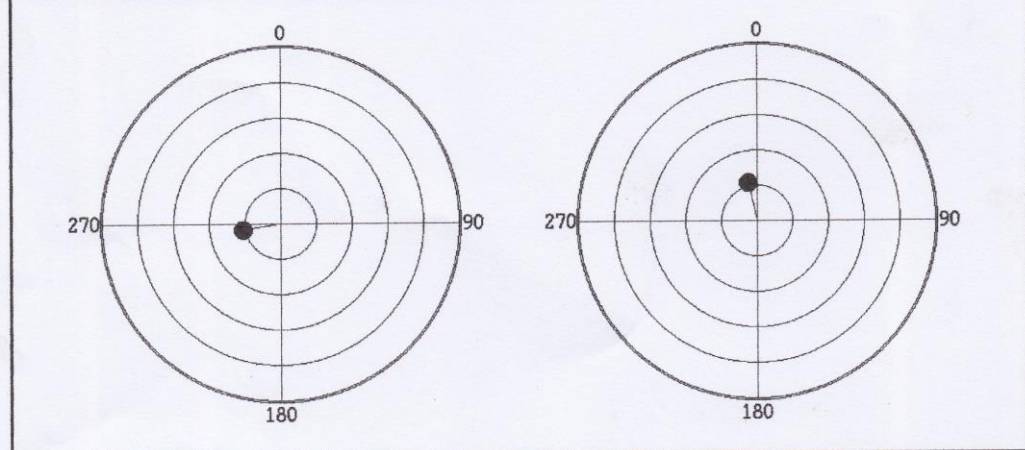
CORRECT UNBALANCE GRAPH (max = 50.0 gr)

PART NAME : AC ROTOR 4P B			
CUSTOMER :			
TEST TIME : 2024. 8.31 11:53: 4			
GRADE :	G 6.3	RATING SPEED :	1800 rpm
WEIGHT :	132.000 kg	TESTING SPEED :	511 rpm
DIAMETER :	310 mm	CORRECTION :	ADD
ACCEPTABLE UNBALANCE			
PLANE1 :	14.2 gr	PLANE2 :	14.2 gr

PLANE1	PLANE2
UNBALANCE	45.8 gr	39.1 gr
ANGLE	307 deg	89 deg
RESULT	REJECT	REJECT

PLANE1	PLANE2
UNBALANCE	10.7 gr	11.2 gr
ANGLE	260 deg	347 deg
RESULT	ACCEPT	ACCEPT

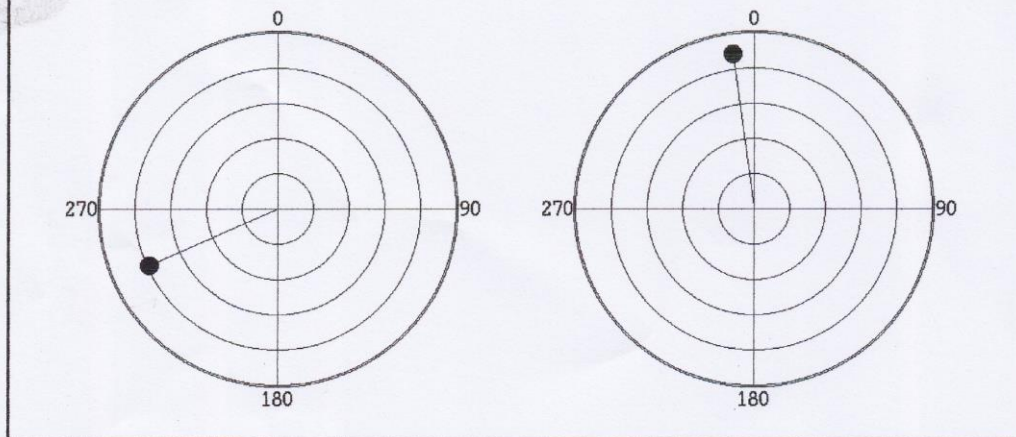
CORRECT UNBALANCE GRAPH (max = 10.0 gr)

PART NAME : AC ROTOR 4P C			
CUSTOMER :			
TEST TIME : 2024. 8.28 9:55:55			
GRADE :	G 6.3	RATING SPEED :	1800 rpm
WEIGHT :	132.000 kg	TESTING SPEED :	508 rpm
DIAMETER :	310 mm	CORRECTION :	ADD
ACCEPTABLE UNBALANCE			
PLANE1 :	14.2 gr	PLANE2 :	14.2 gr

PLANE1	PLANE2
UNBALANCE	7.9 gr	8.9 gr
ANGLE	246 deg	352 deg
RESULT	ACCEPT	ACCEPT

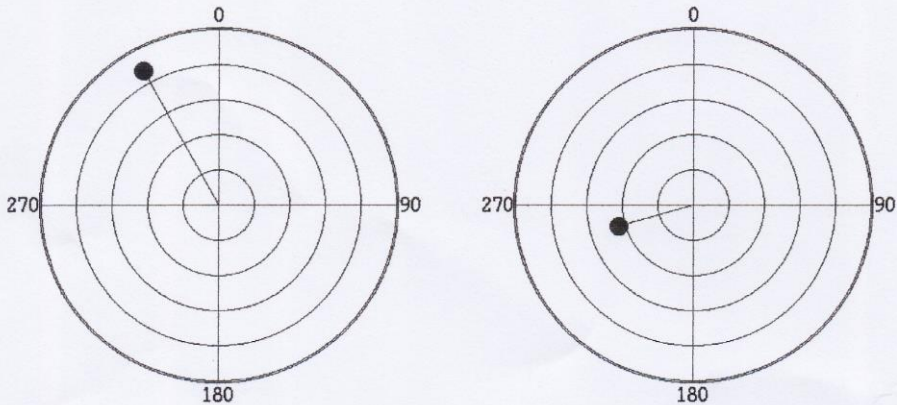
CORRECT UNBALANCE GRAPH (max = 5.0 gr)

PART NAME : AC ROTOR 4P D			
CUSTOMER :			
TEST TIME : 2024. 8.28 10:25:55			
GRADE	: G 6.3	RATING SPEED	: 1800 rpm
WEIGHT	: 132.000 kg	TESTING SPEED	: 508 rpm
DIAMETER	: 310 mm	CORRECTION	: ADD
ACCEPTABLE UNBALANCE			
PLANE1	: 14.2 gr	PLANE2	: 14.2 gr

PLANE1	PLANE2
UNBALANCE	24.6 gr	59.4 gr
ANGLE	176 deg	15 deg
RESULT	REJECT	REJECT

PLANE1	PLANE2
UNBALANCE	4.4 gr	2.2 gr
ANGLE	331 deg	254 deg
RESULT	ACCEPT	ACCEPT
