## 작업공정사진철

공사명: SIEMENS VECTOR MOTOR OVERHAUL

규격: 113~147KW 340~460V 34~46Hz 1000~1360RPM

REPAIR 내역: 분해 조립 및 조립부품 불순물 CLEANSING  
INSULATING VARNISH DIPPING DRYING  
양측 HOUSING METALLIZING 연마  
BEARING 교환  
BALANCING 및 UNBALANCE교정  
BLOWER BEARING교환  
입 출고검사 및 시운전 TEST

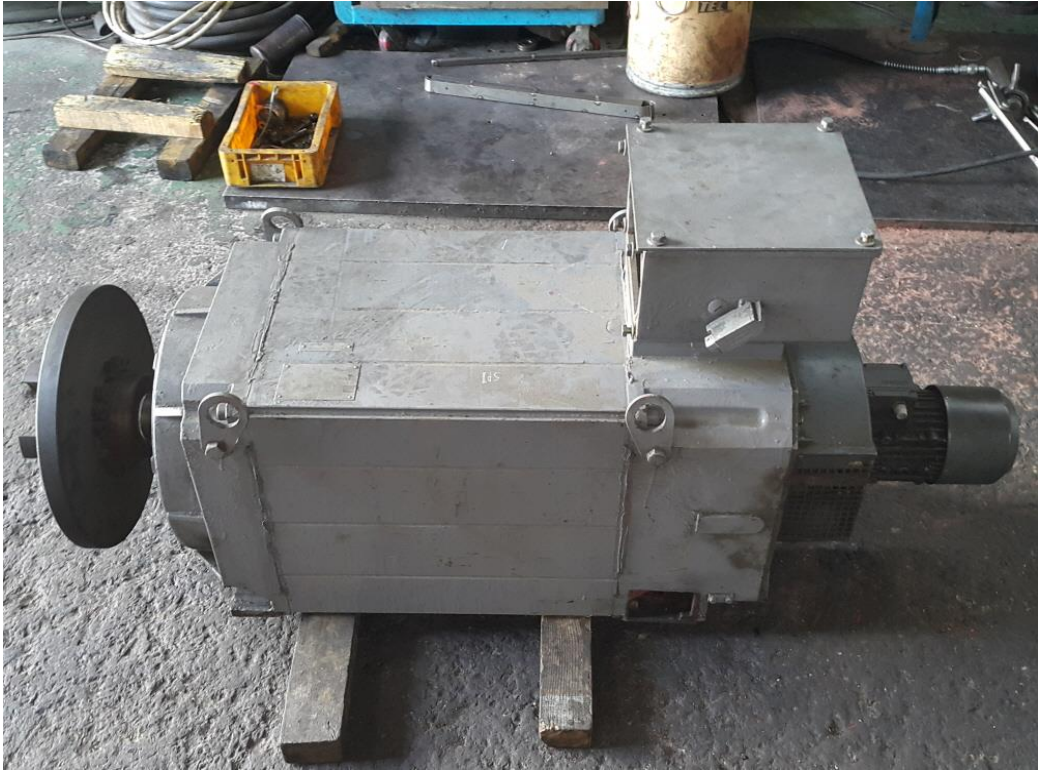
| Ass'y | 분해 전 |

| 작업공정 | 147KW VECTOR MOTOR 입고검사 |

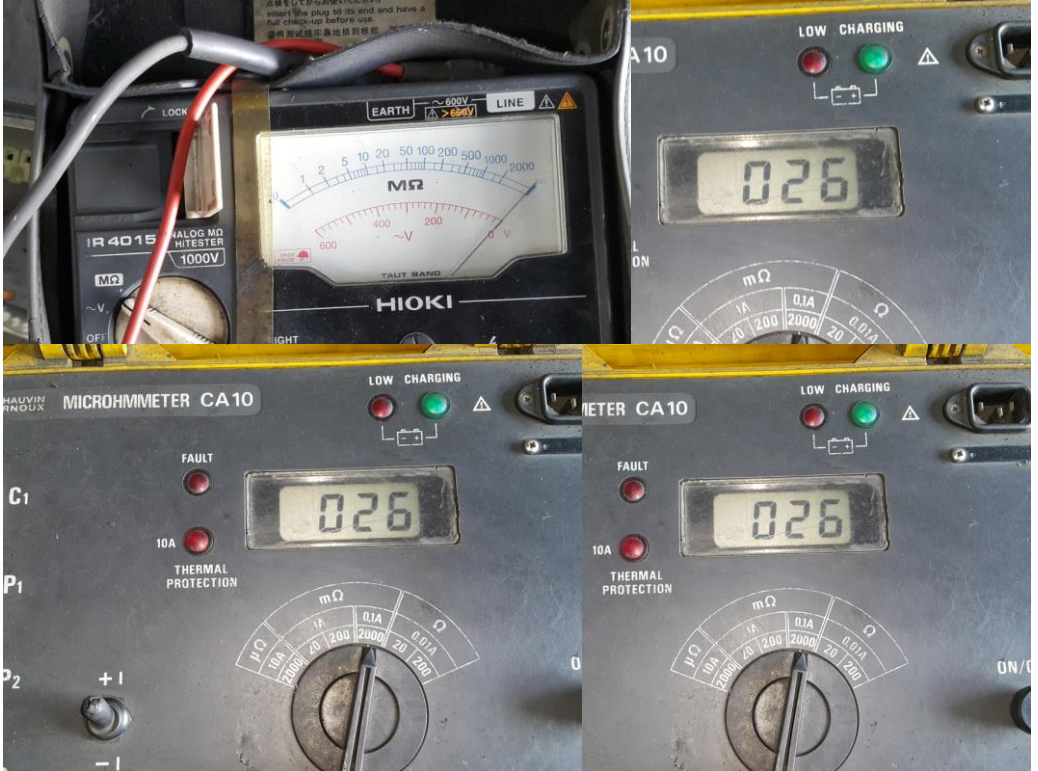
| 권선검사 | 절연저항 이상 & 각 상별 권선저항 |

| 작업공정 | 147KW VECTOR MOTOR 입고검사 |

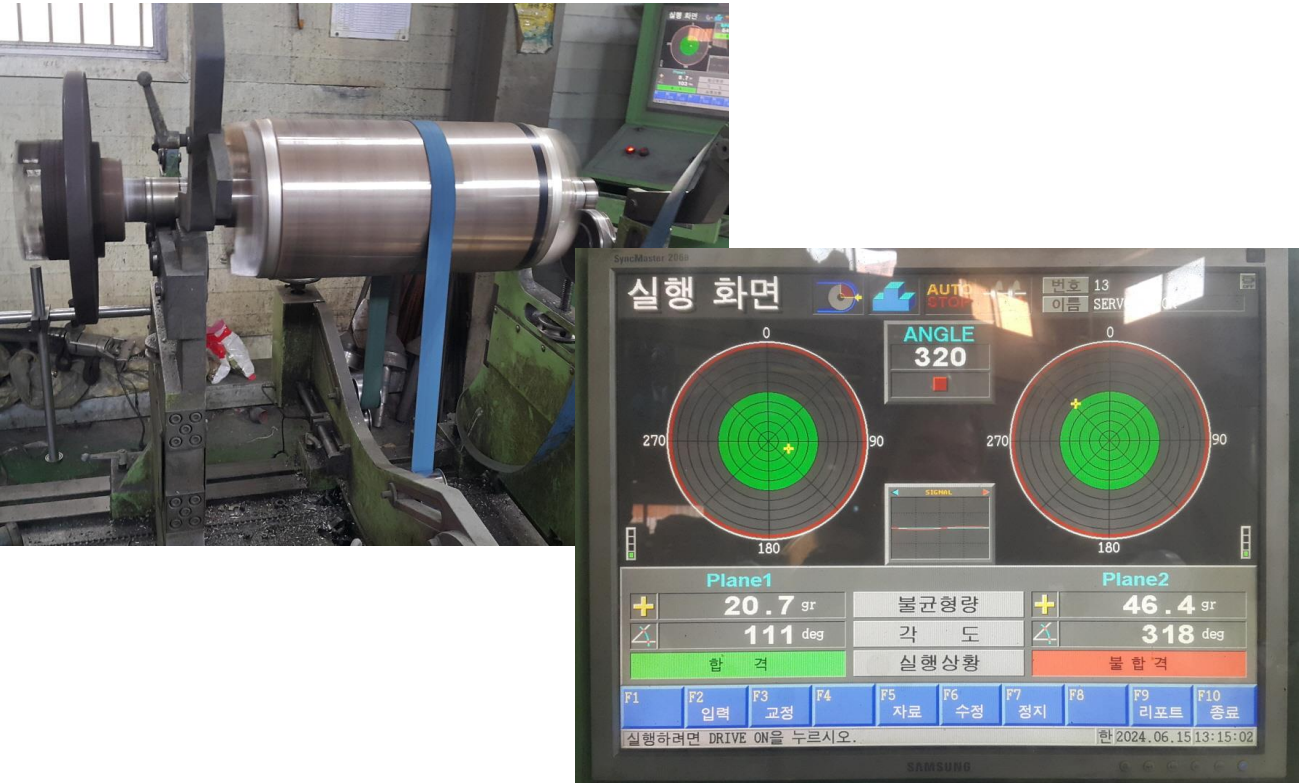
| ROTOR | BALANCING 실시 및 초기UNBALACE |

| | PLANE1 | PLANE2 |
|---|---|---|
| UNBALANCE | 20.7 gr | 46.4 gr |
| ANGLE | 111 deg | 318 deg |
| RESULT | ACCEPT | REJECT |

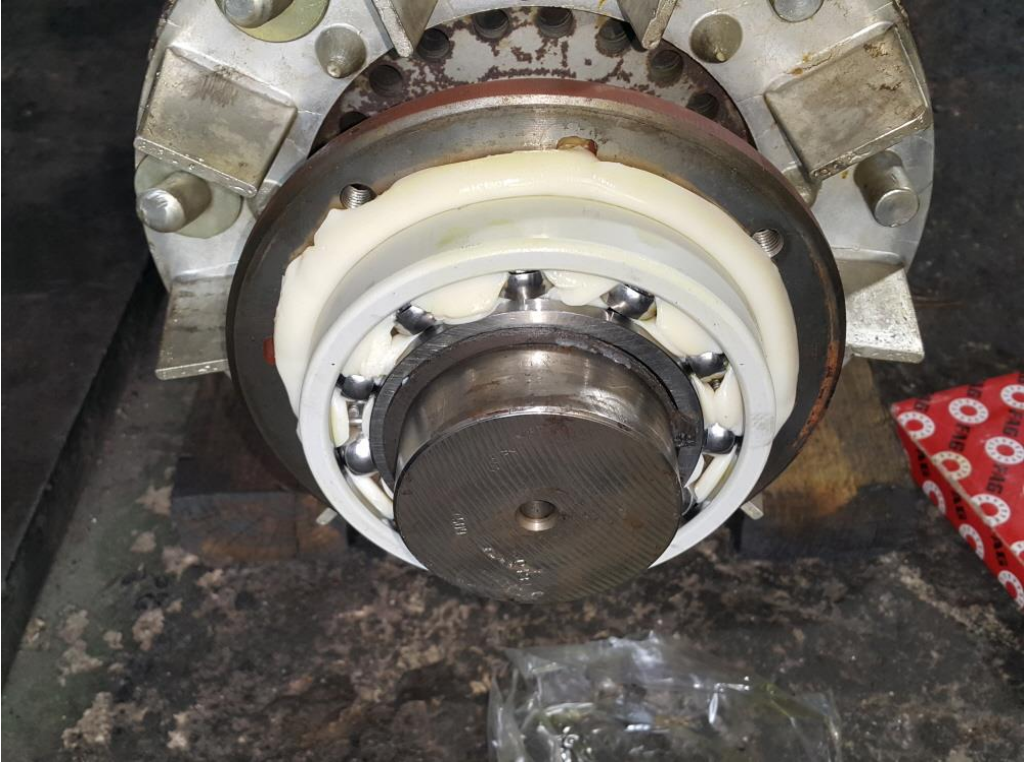
| ROTOR | BEARING 예열삽입 및 GREASE CHARGING 조립실시 |

| 반 부하측<br>절연 BEARING | |

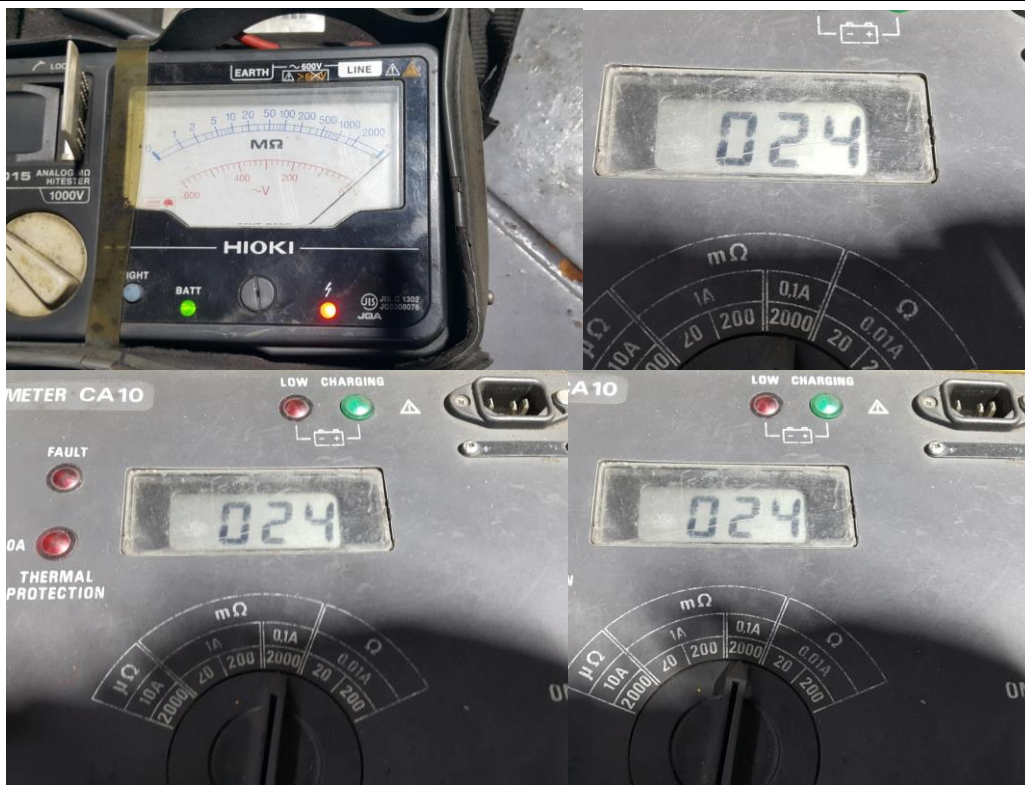
권선검사

절연저항 & 각 상별 권선저항

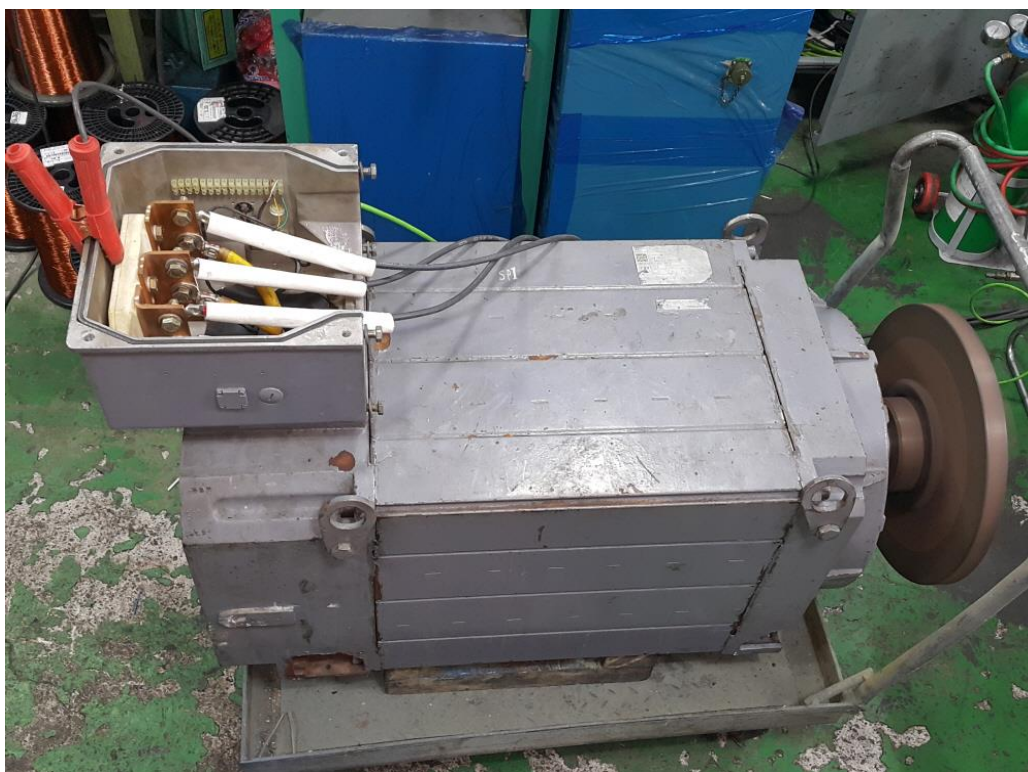
Ass'y

시운전 TEST 실시
