# 작업공정사진철

공사명: AC SPINDLE VECTOR MOTOR OVERHAUL

규격: AC 105KW 1500~6000RPM

REPAIR 내역: 분해 및 불순물 CLEANSING DRYING  
INSULATING VARNISH DIPPING DRYING  
반 부하측 HOUSING METALLIZING 연마  
BEARING교환 조립  
BLOWER 보수  
출고검사 시운전 TEST

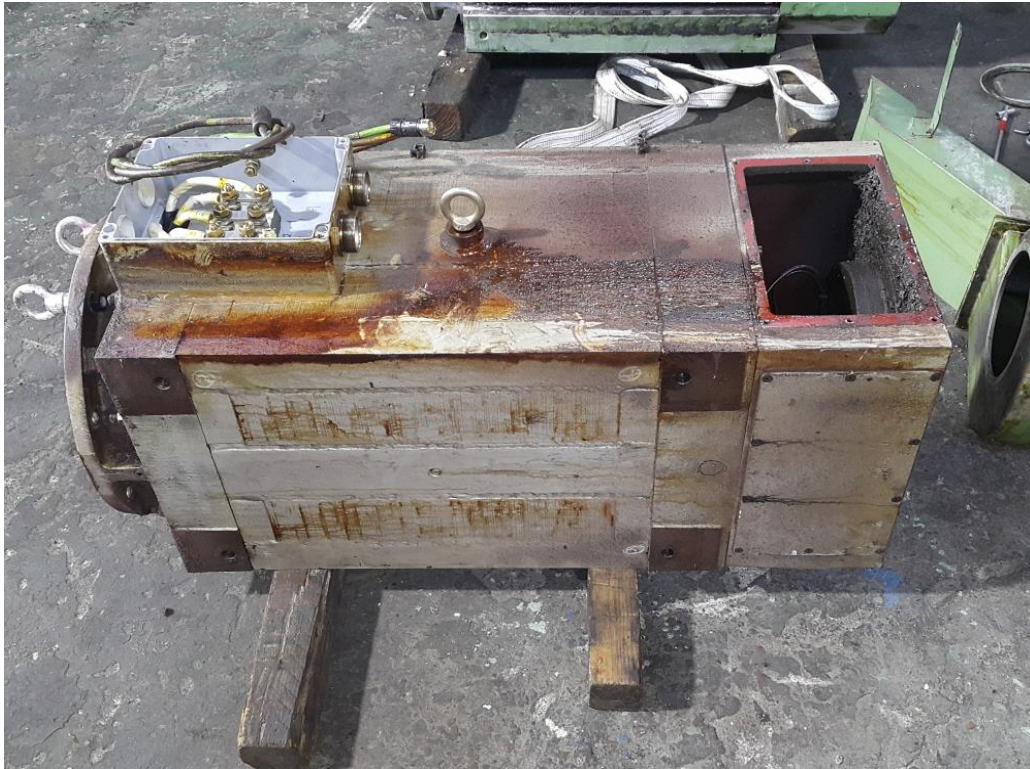
Ass'y

분해 전

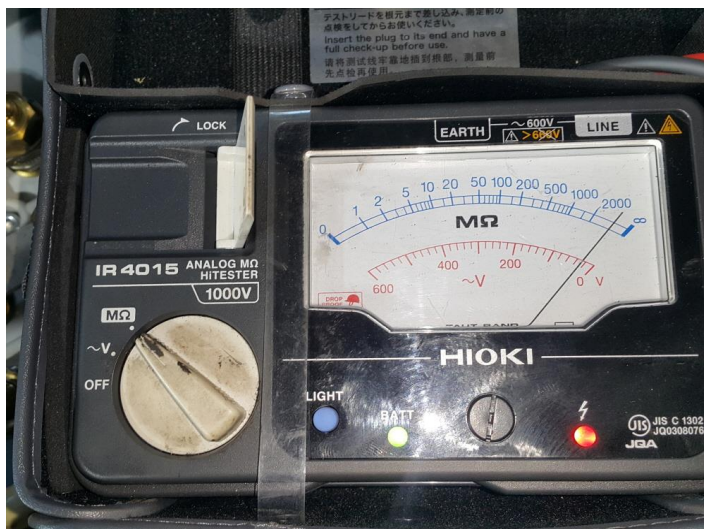
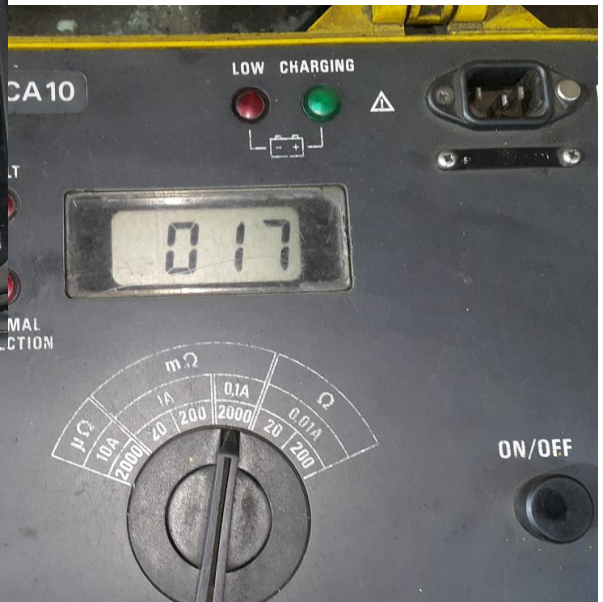
권선 검사

절연저항 & 각 상 Δ시 권선저항 동일

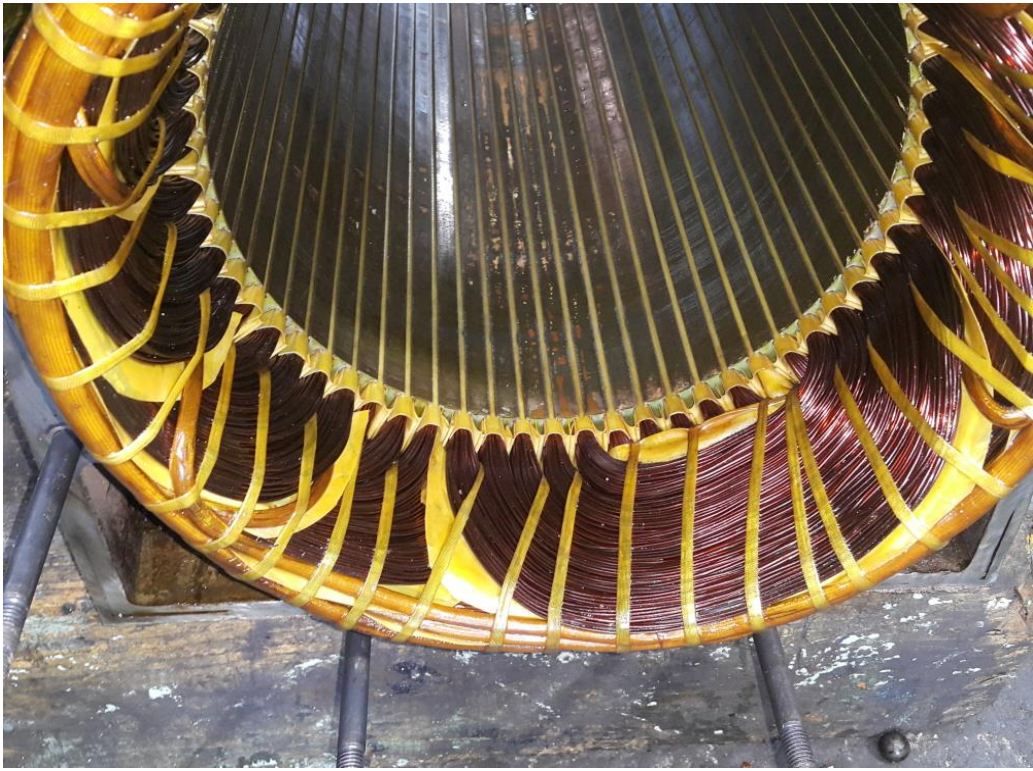
권체	권선상태 양호

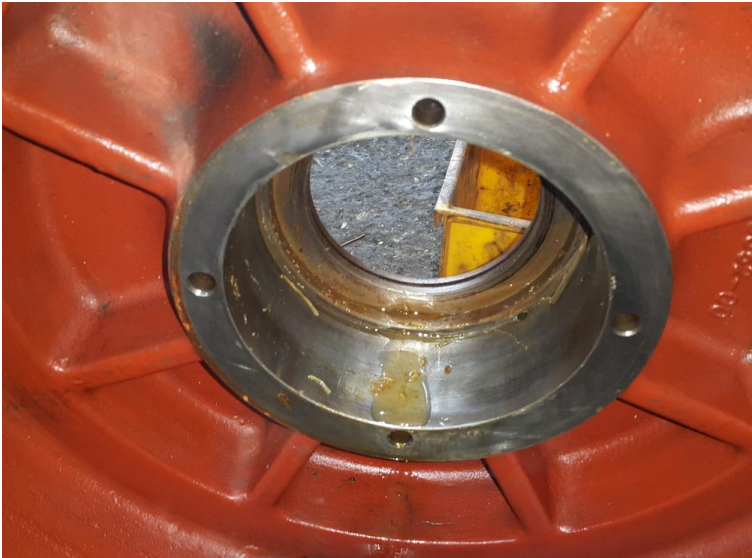
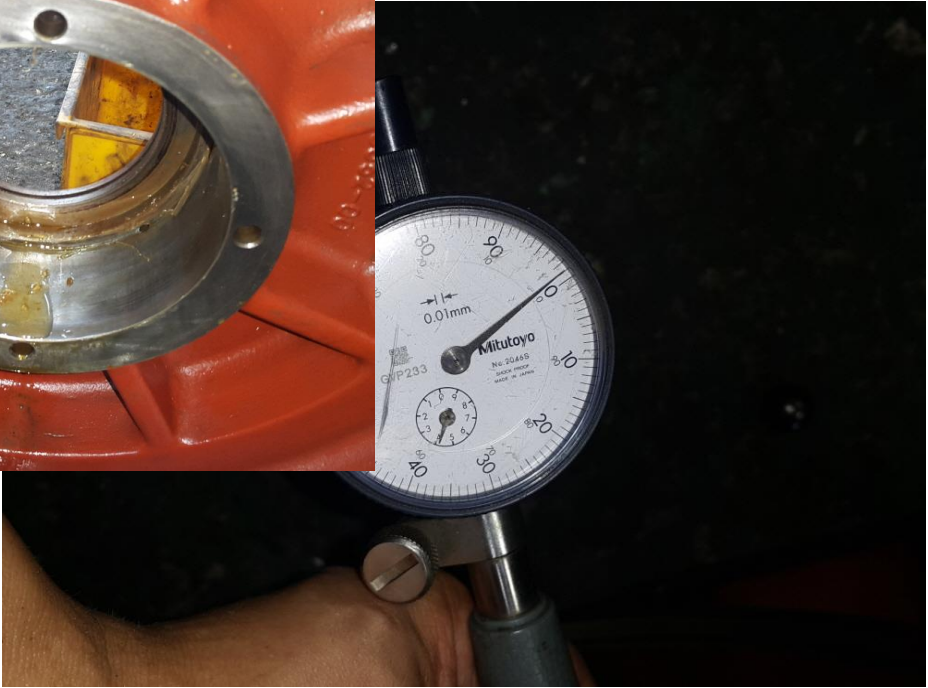
BRACKET	부하측 HOUSING검사 측정치 1/100로 양호
작업공정	VECTOR MOTOR 예방정비

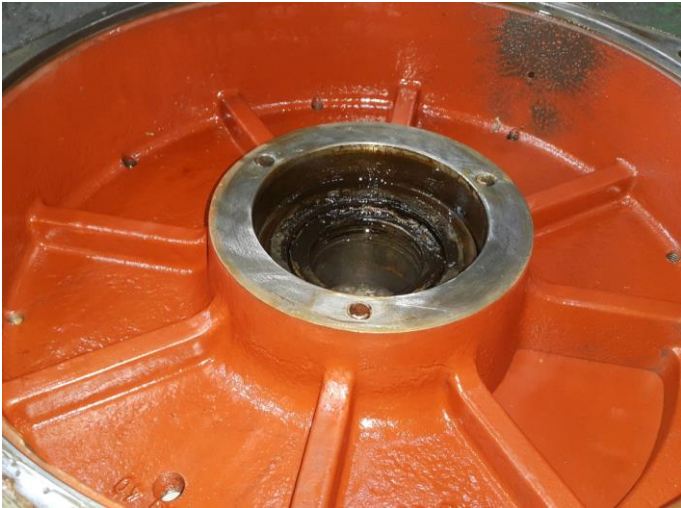
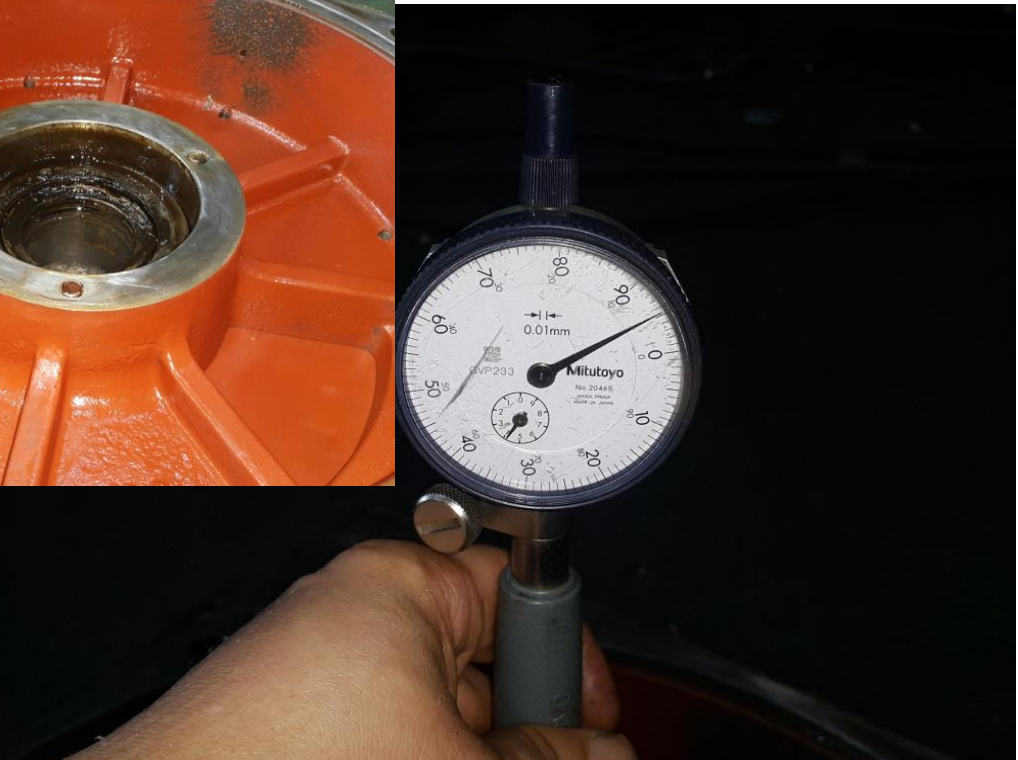
BRACKET	반 부하측 HOUSING검사 측정치 5/100로 불량

BRACKET	반 부하측 HOUSING METALLIZING 연마 후 검사 1/100

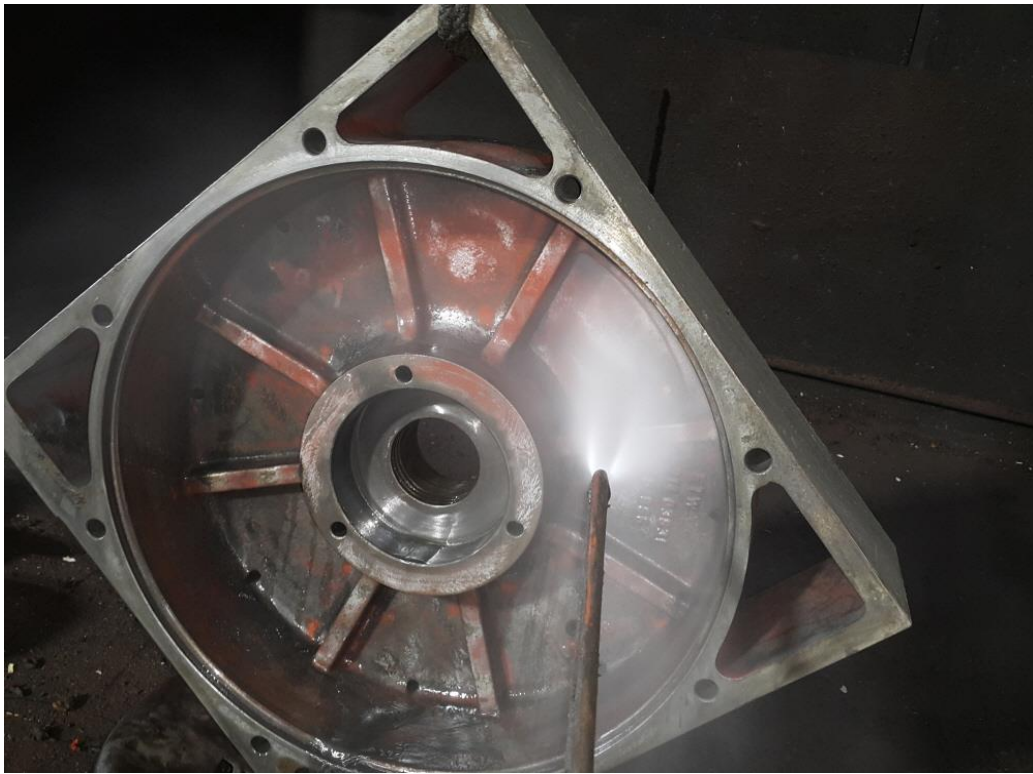
조립부품

세척 실시

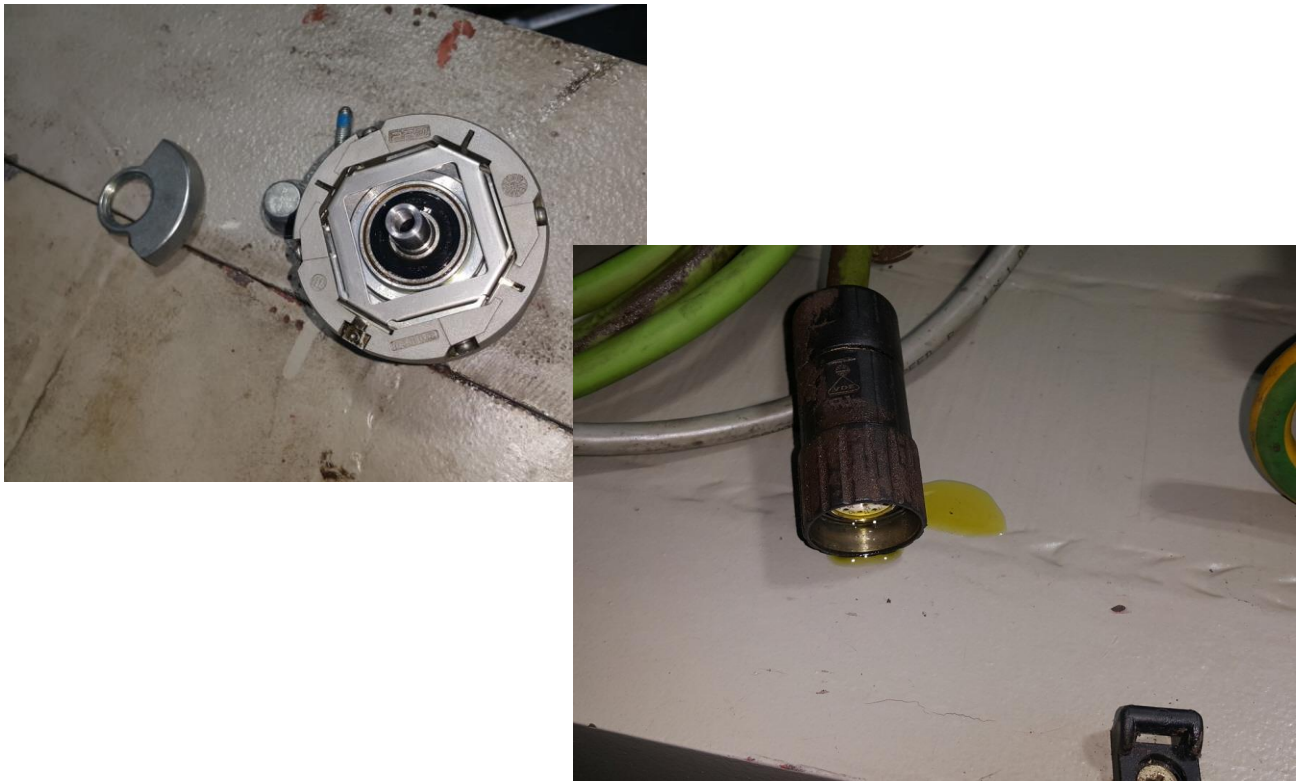
조립부품	ENCODER 와 CABLE이 기름을 먹어 흘러나뎀
작업공정	VECTOR MOTOR 예방정비

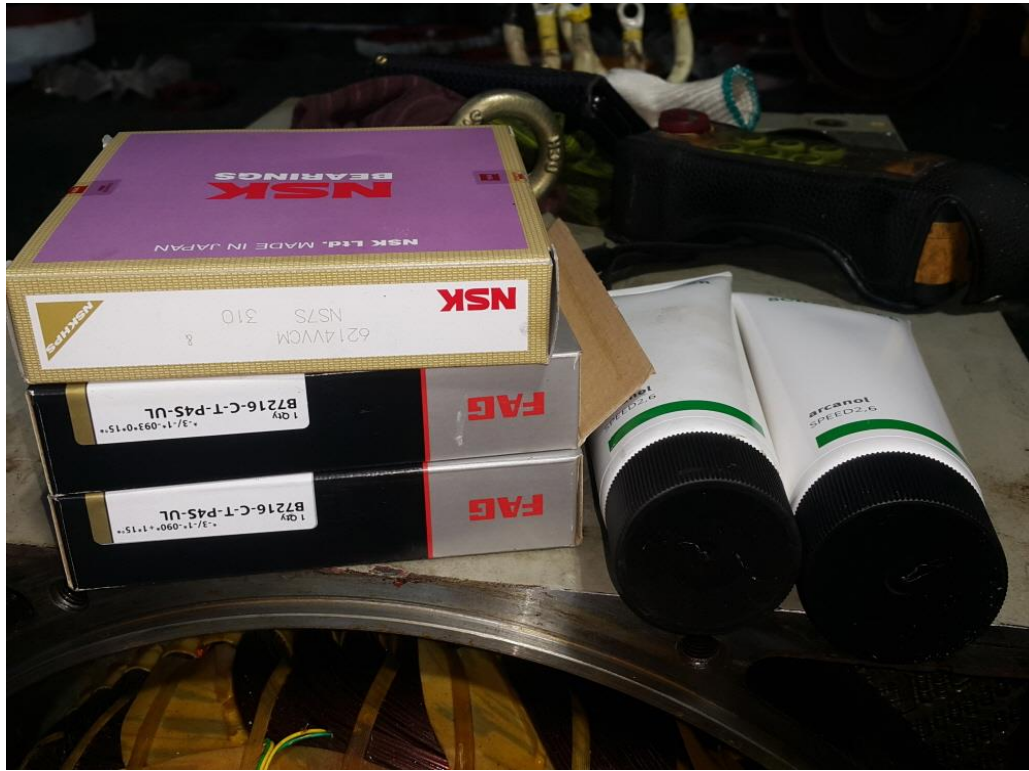
소모품	교환될 BEARING 및 BEARING전용 GREASE
작업공정	VECTOR MOTOR 예방정비

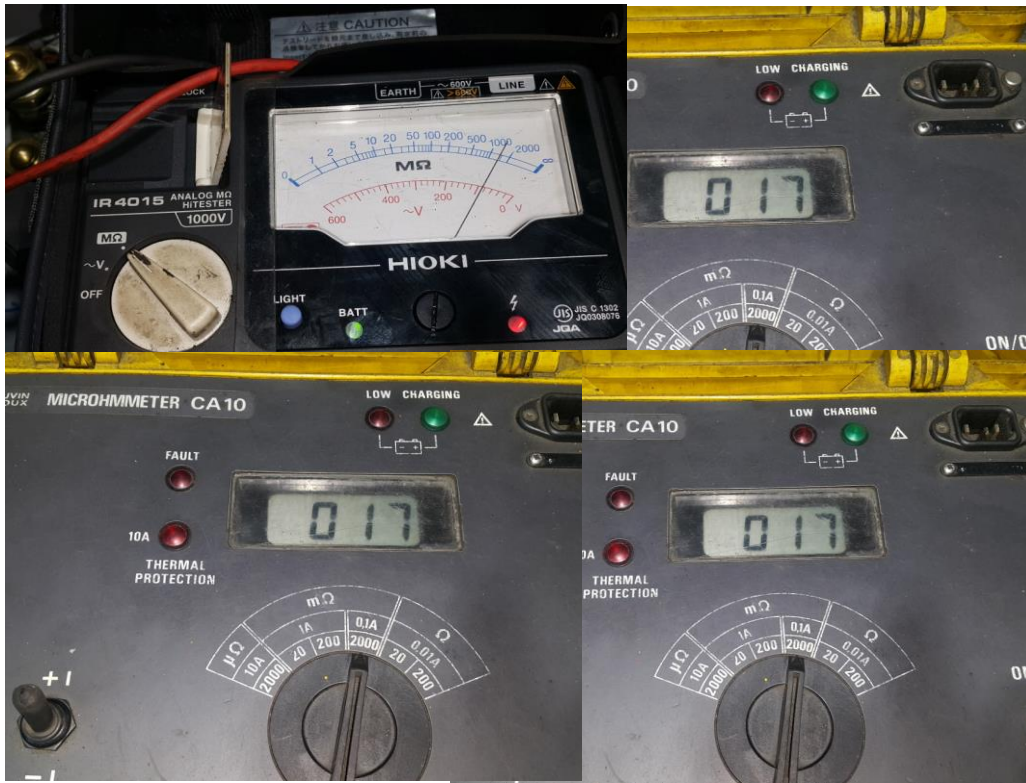
출고 검사

절연저항 & 각 상 Δ시 권선저항

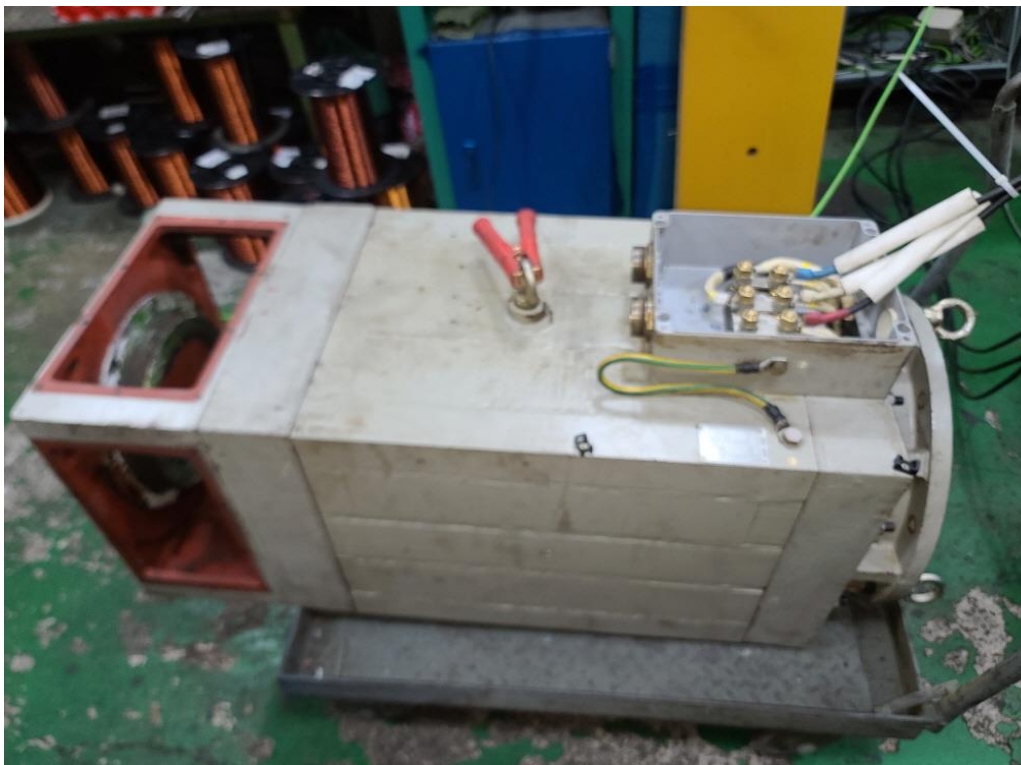
Ass'y

시운전 TEST 실시

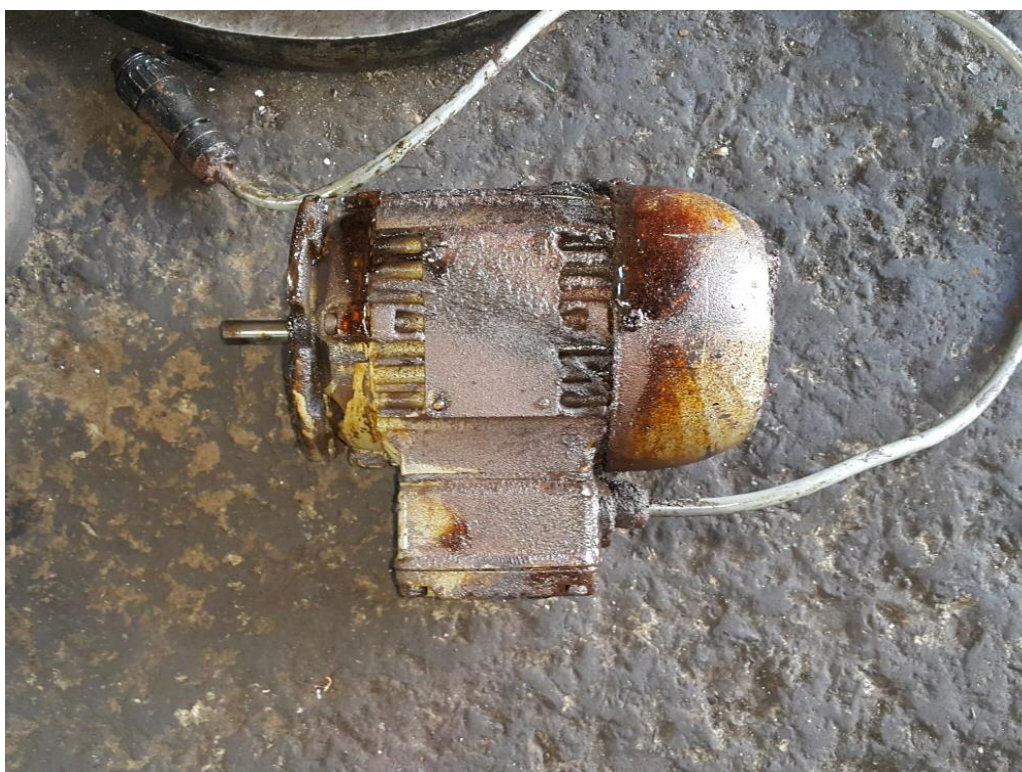
FAN MOTOR

분해 전

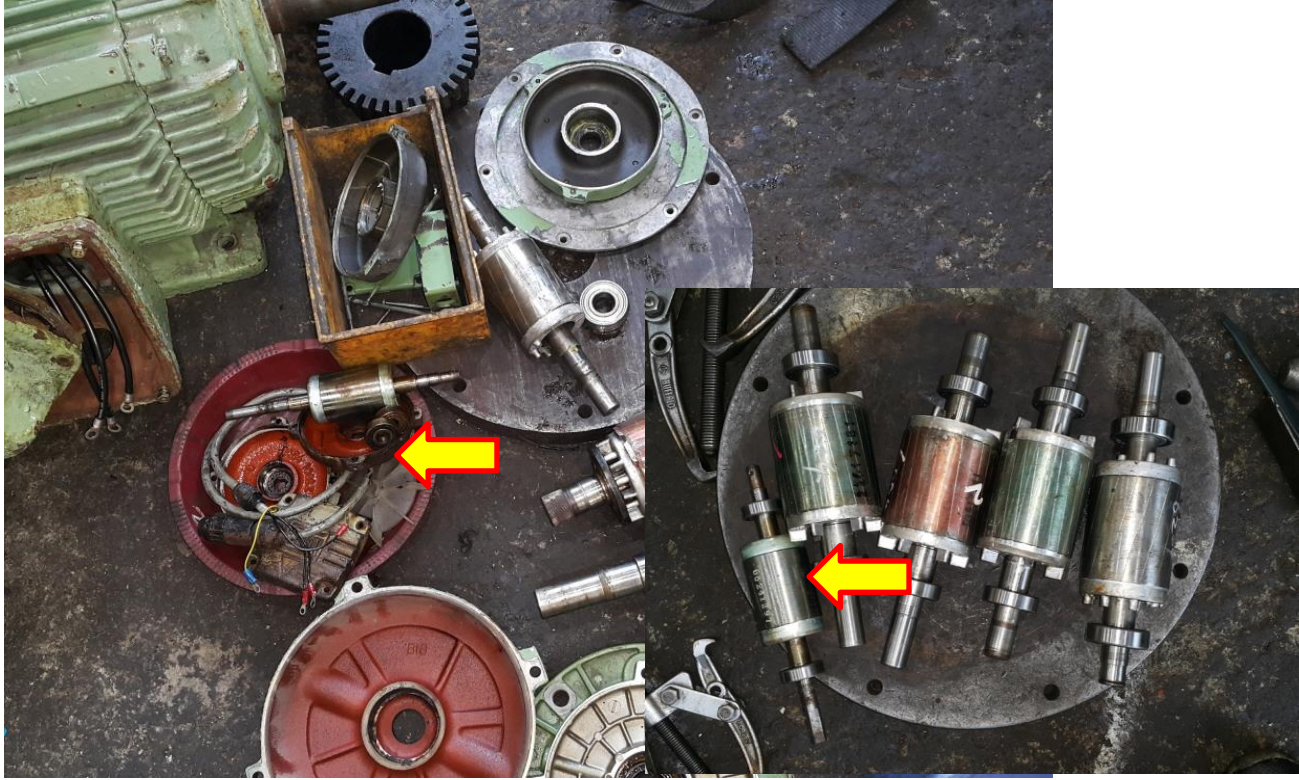
FAN MOTOR	분해 BEARING교환 실시
작업공정	VECTOR MOTOR 예방정비

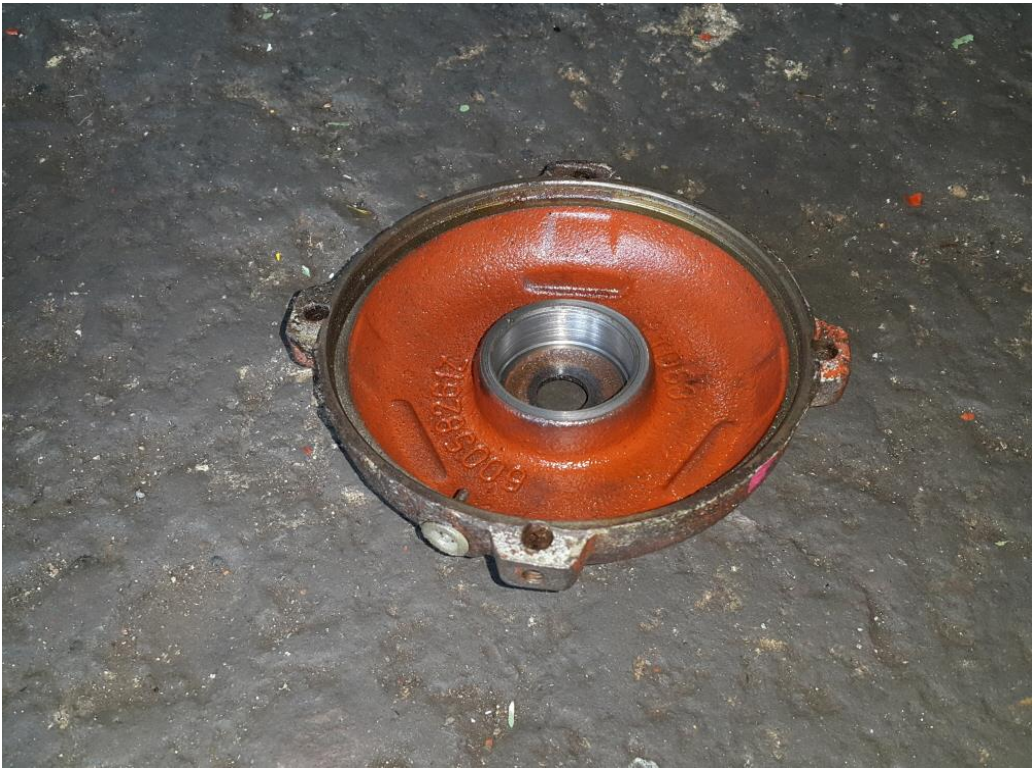
부하 측	마모된 HOUSING 보수 후

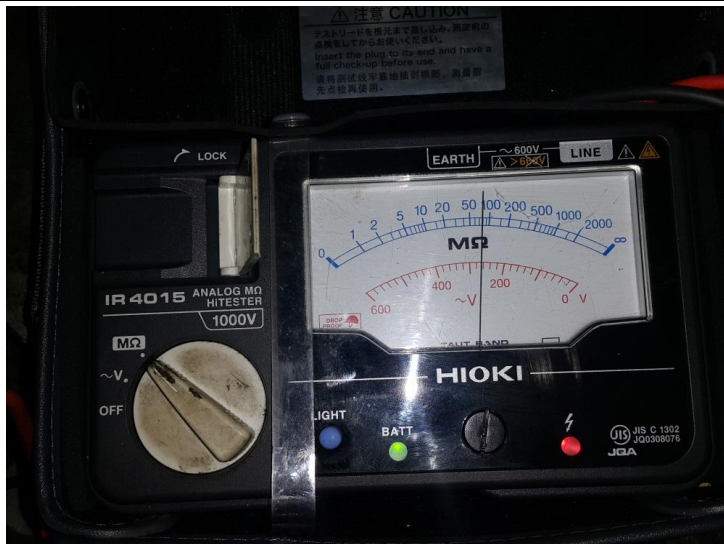
FAN MOTOR

절연저항 & 각 상별 권선저항 동일

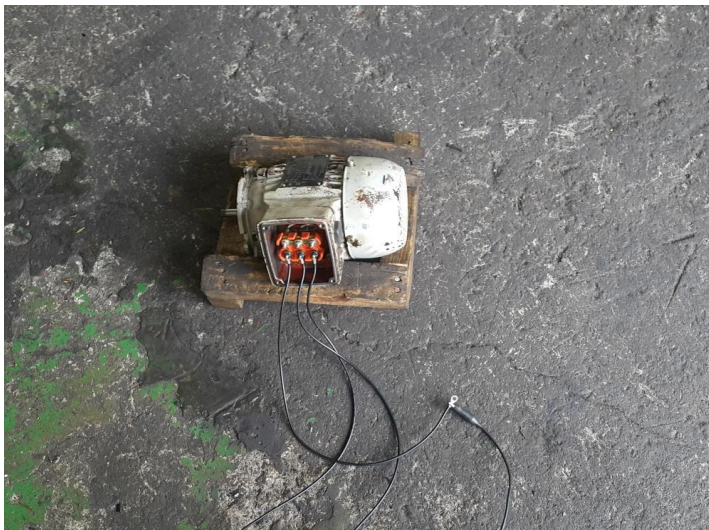
5회감아 440V 실 CURRENT 0.44A

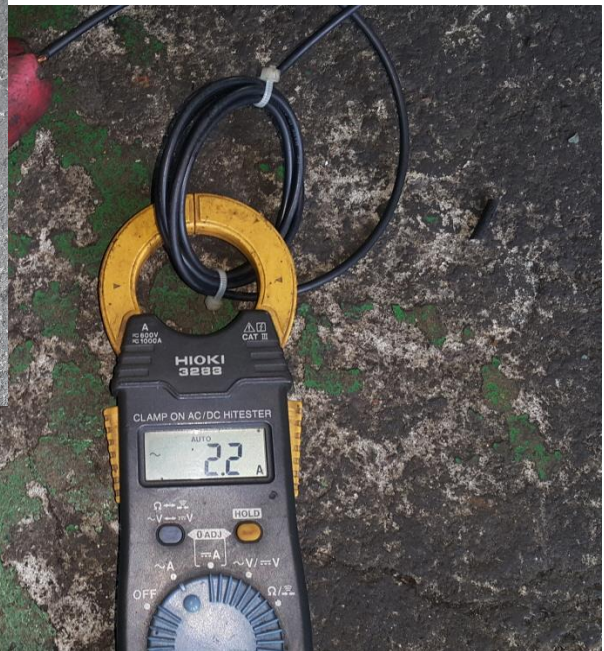
FAN MOTOR

시운전 TEST 실시
