작업공정사진철

고객명: (주)
공사명: 풍력공장 OHC(TEI6) MOTOR 예방정비

규격: 권선형 440V 60HP 6P 외 4대

REPAIR 내역: 분해 조립 및 불순물 CLEANSING DRYING
INSULATING VARNISH DIPPING DRYING
HOUSING METALLIZING 연마 3면
BALANCING작업 UNBALANCE교정
BEARING 및 BRUSH교환
입 출고검사 시운전 TEST

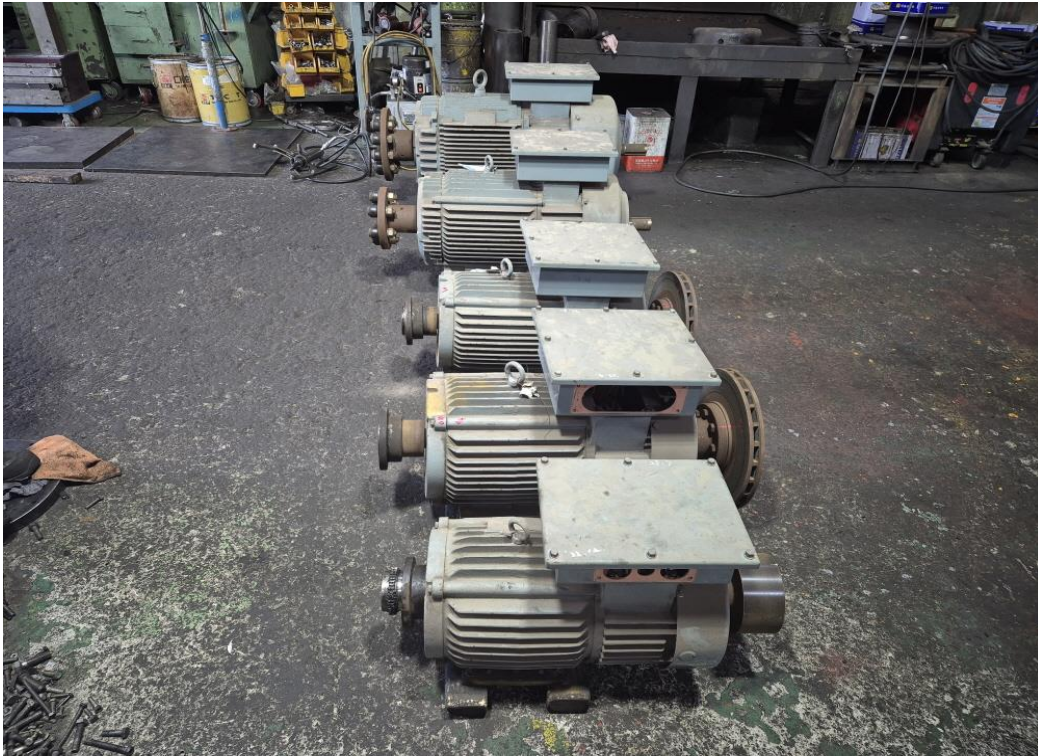
Ass'y

권선형 MOTOR 60HP 6P의 4대 입고검사

분해 전

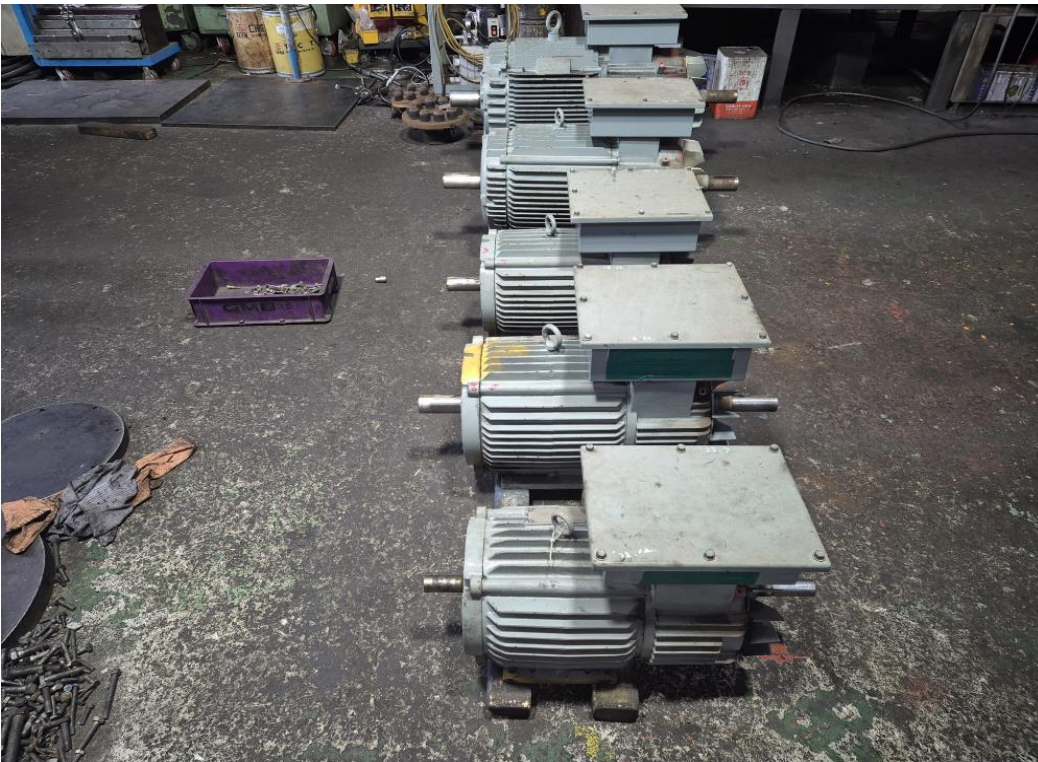
Ass'y

불순물제거 스팀세척 후 분해 실시

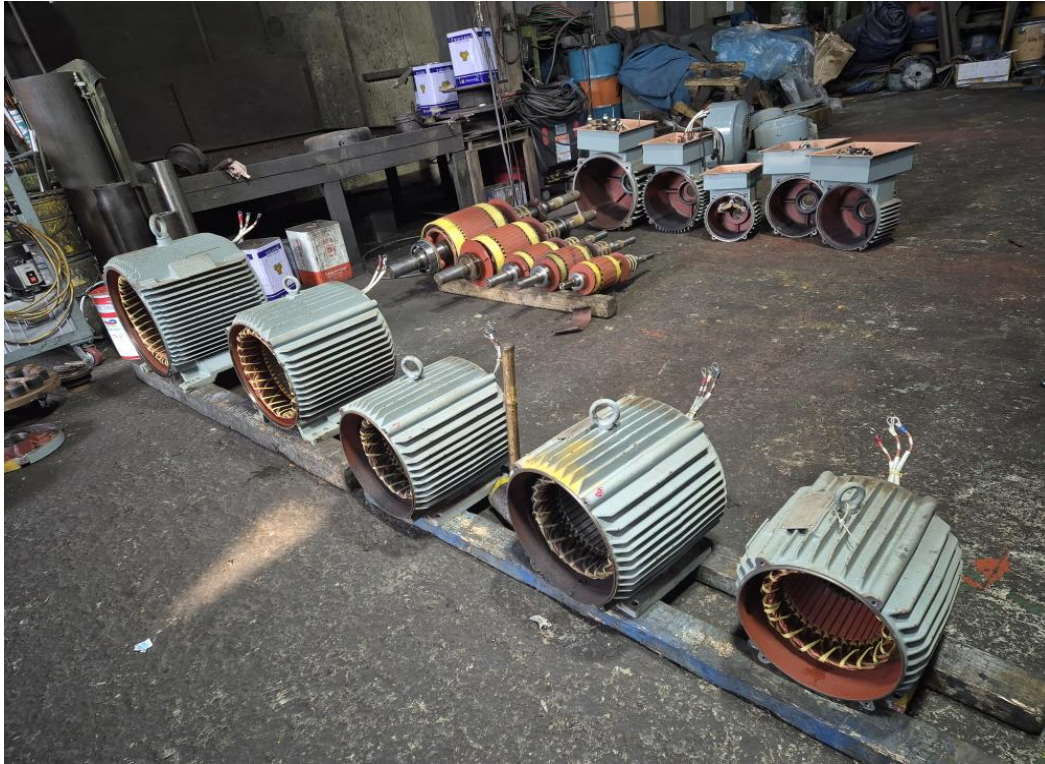
Ass'y

분해 후

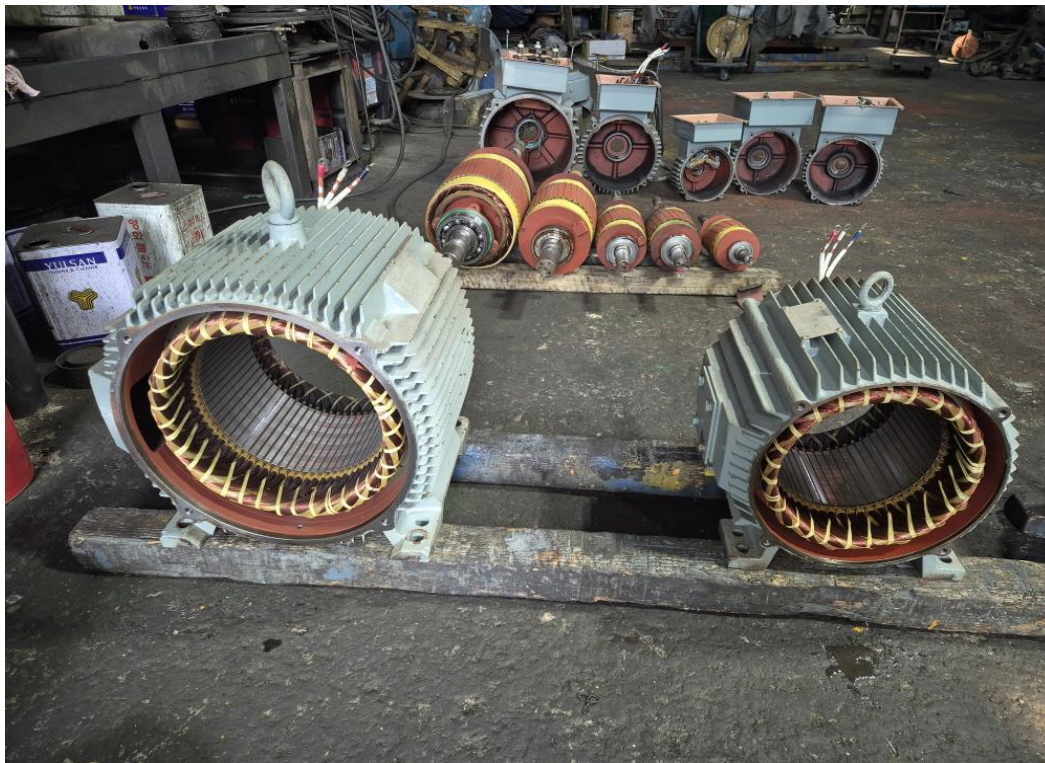
권체

분해 후 권선상태 양호

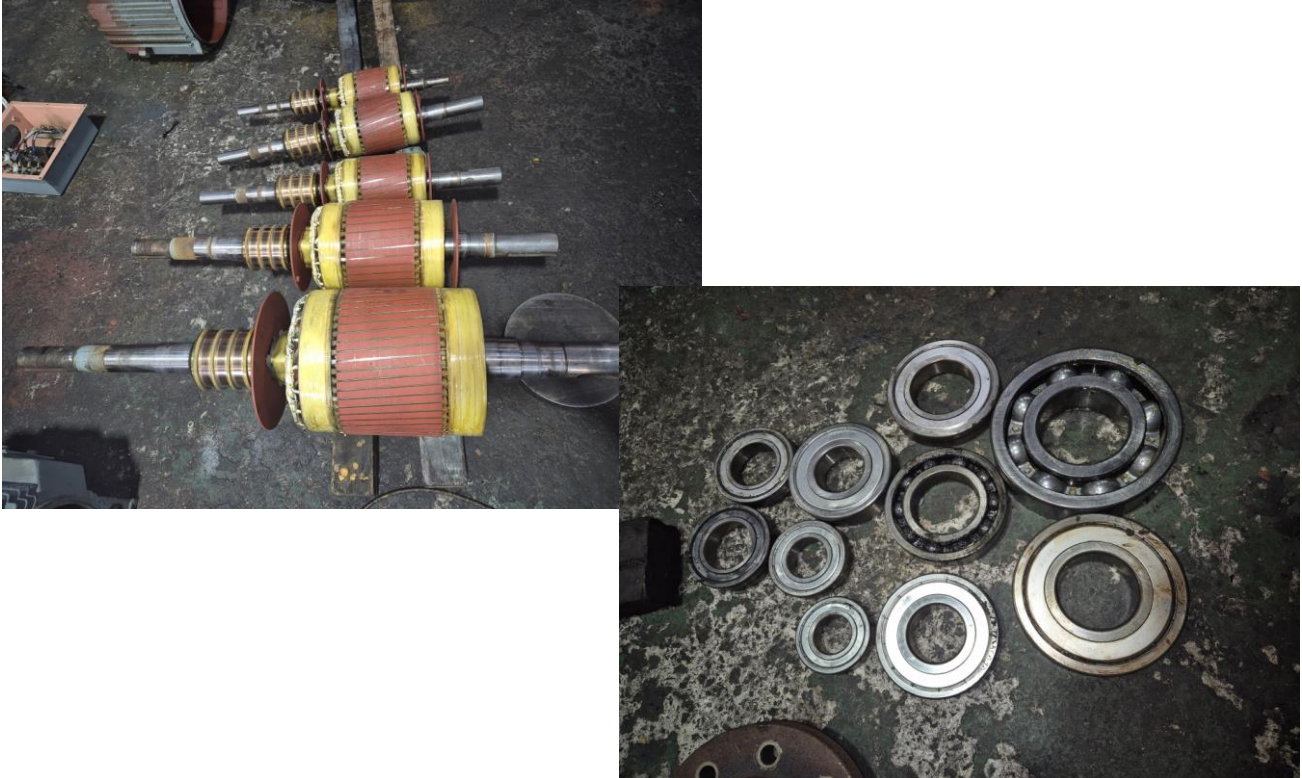
ROTOR 권체	BEARING 하체 실시
작업공정	권선형 MOTOR 60HP 6P의 4대 입고검사

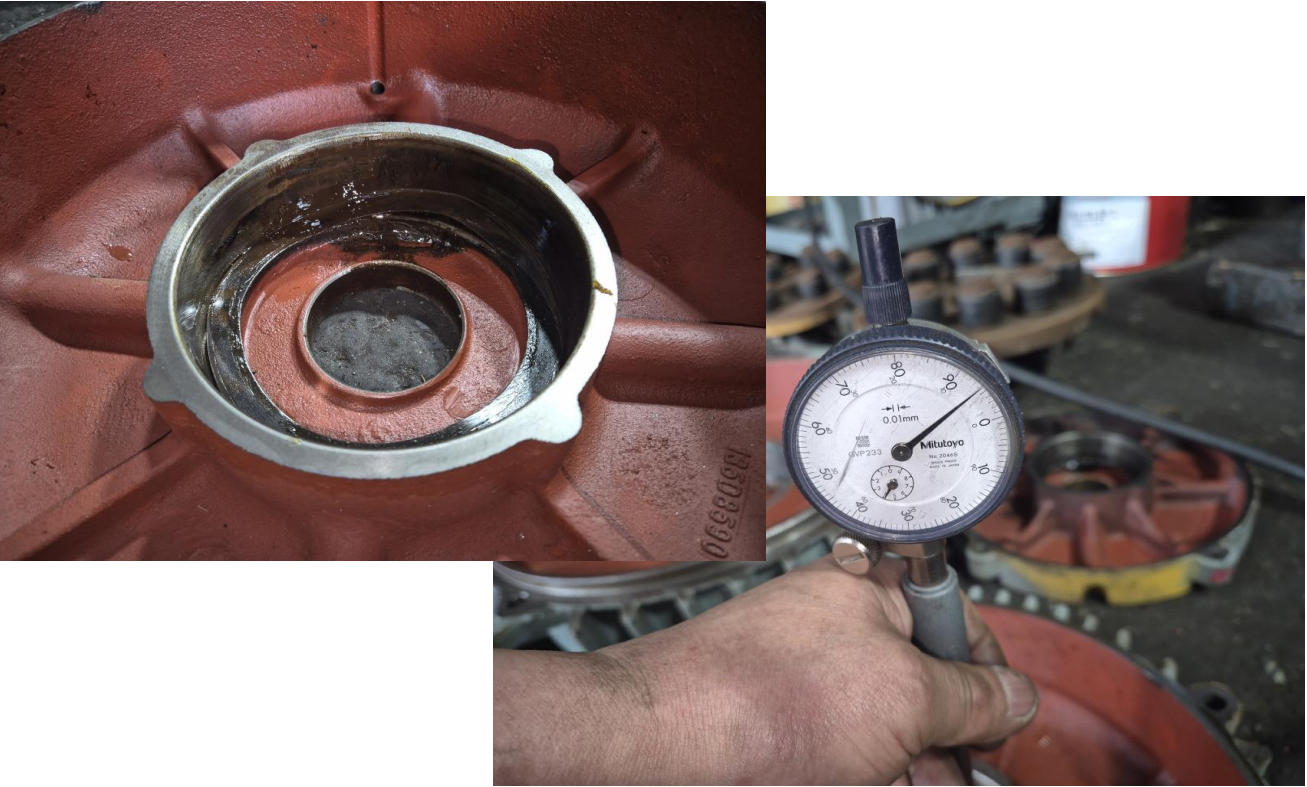
BRACKET	AUX 부하측 HOUSING 검사 6/100로 불량

AUX 부하측 HOUSING METALLIZING 연마 후 검사 0/100

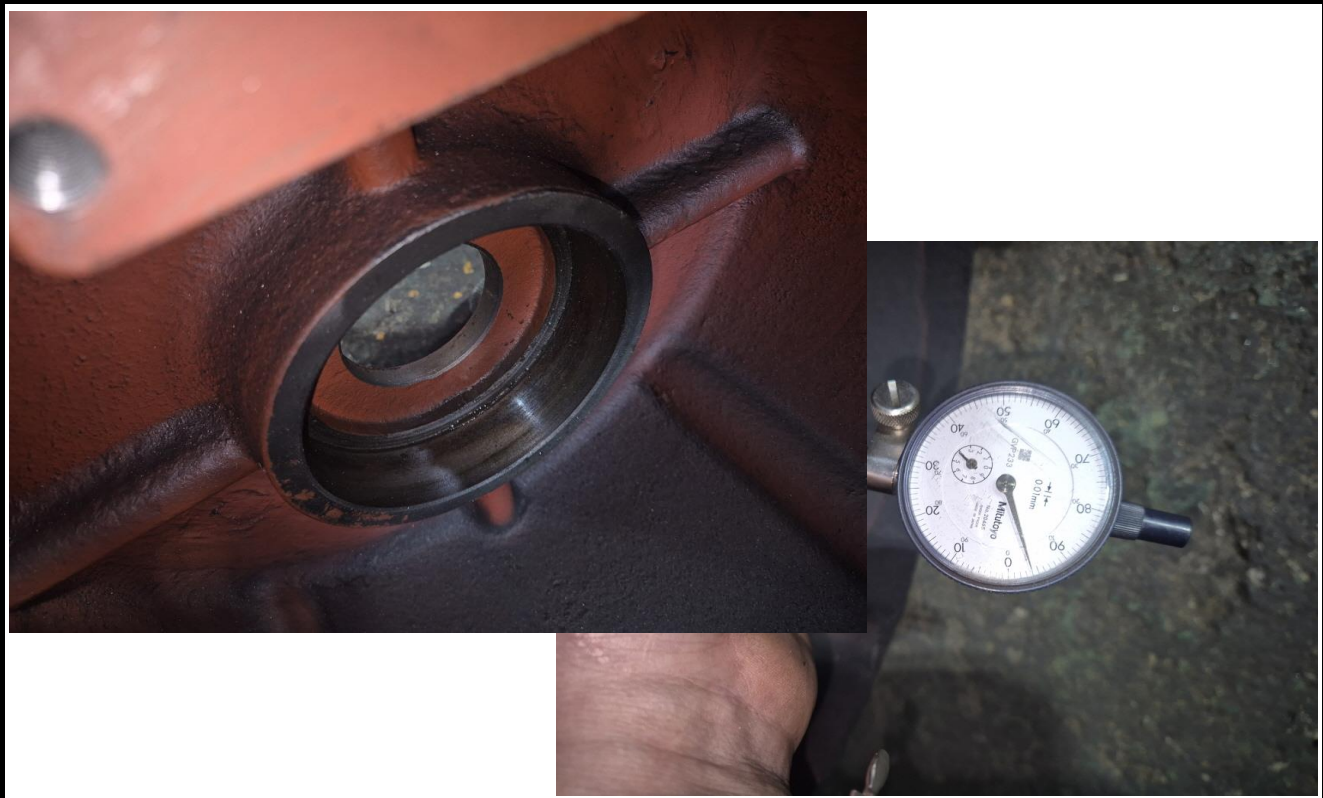
<p>The image shows a close-up of a motor housing inspection. A hand is holding a dial indicator against a circular opening in the housing. The dial indicator has a white face with black markings and a needle. The needle is pointing to approximately 40 on the scale. The housing is dark and appears to be made of cast iron or steel.</p>	
BRACKET	AUX 반 부하측 HOUSING 마모검사 4/100로 불량
작업공정	권선형 MOTOR 60HP 6P의 4대 입고검사

AUX 반 부하측 HOUSING METALLIZING 연마 후 검사 0/100

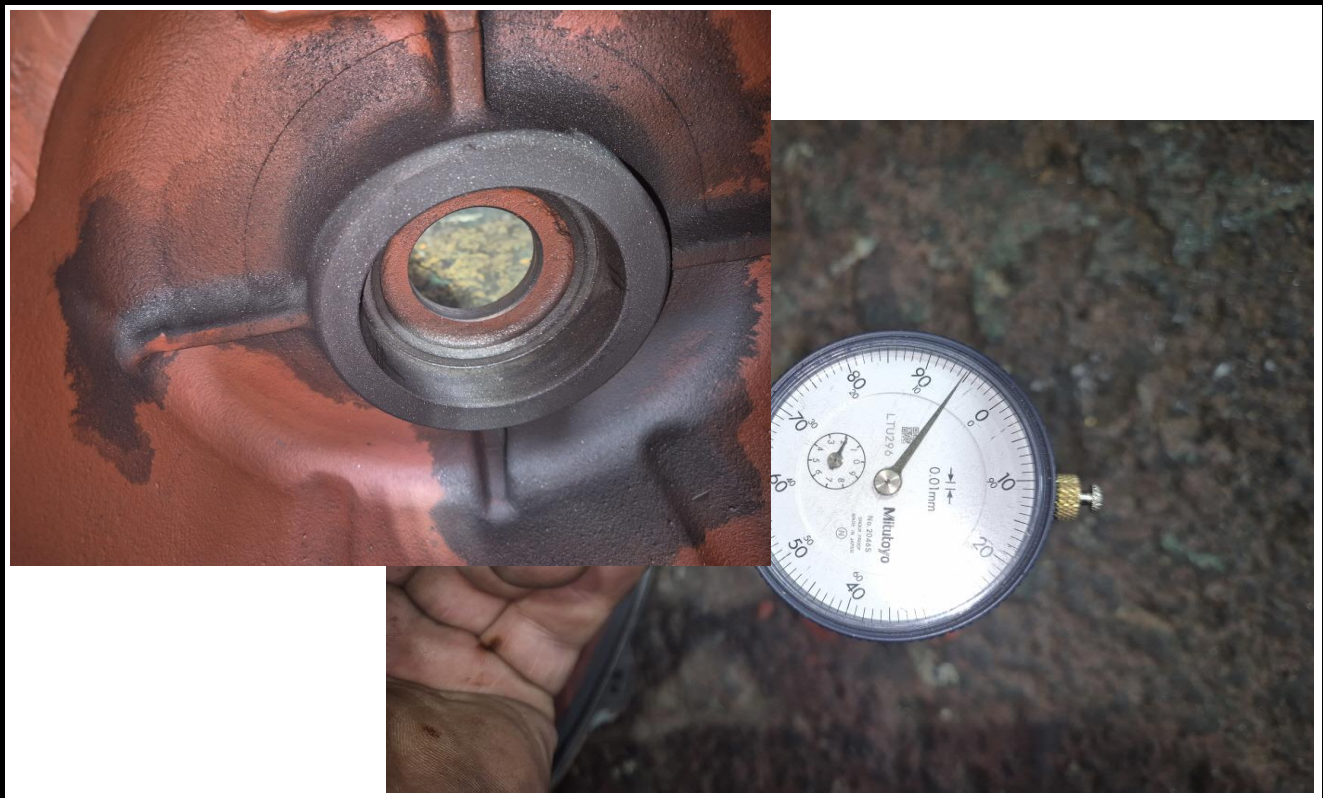
<p>The image shows a close-up of a motor housing inspection. A hand is holding a dial indicator against a circular opening in the housing. The dial indicator has a white face with black markings and a needle. The needle is pointing to approximately 50 on the scale. The housing is dark and appears to be made of cast iron or steel.</p>	
BRACKET	BRIDGE서편 반 부하측 HOUSING 마모검사 5/100로 불량

BRACKET	BRIDGE서편 HOUSING METALLIZING 연마 후 검사 0/100
작업공정	권선형 MOTOR 60HP 6P의 4대 OVERHAUL

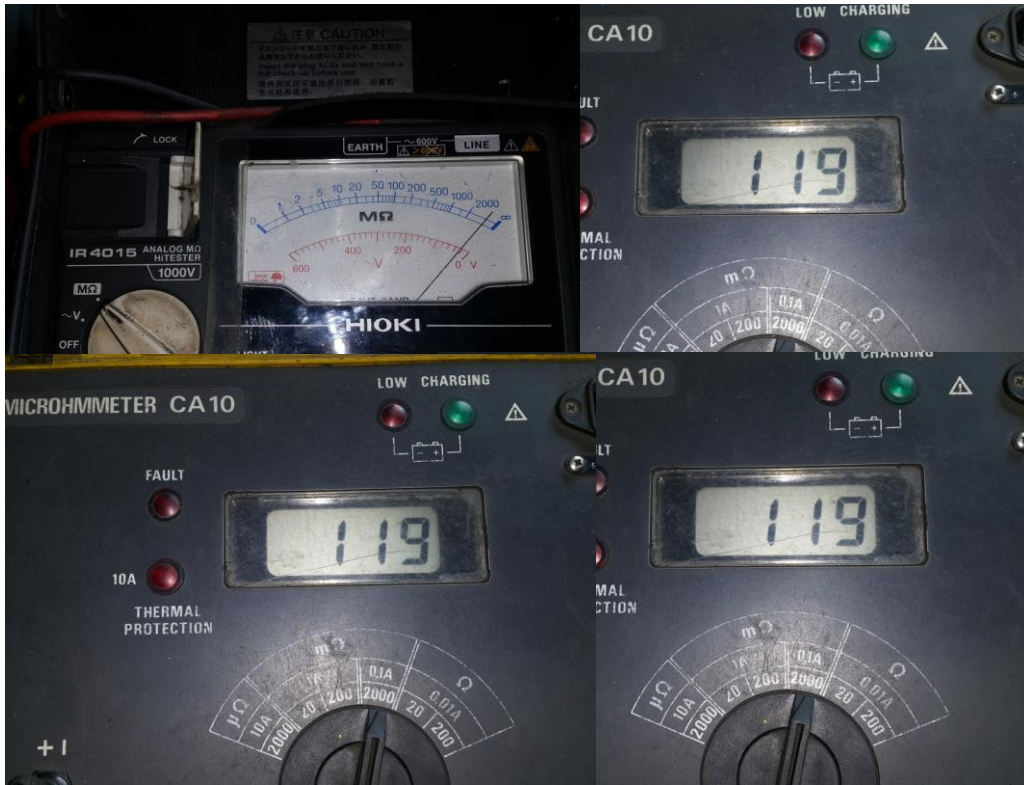
출고검사 MAIN

1차 절연저항 & 각 상별 권선저항

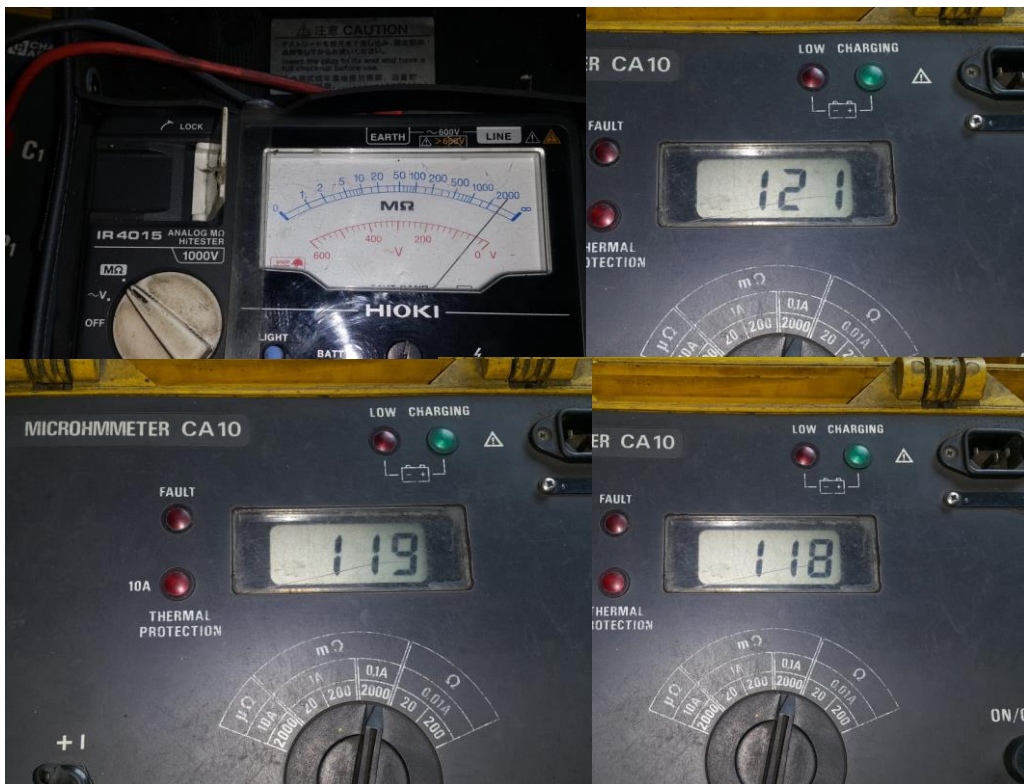
출고검사 MAIN

2차 절연저항 & 각 상별 권선저항

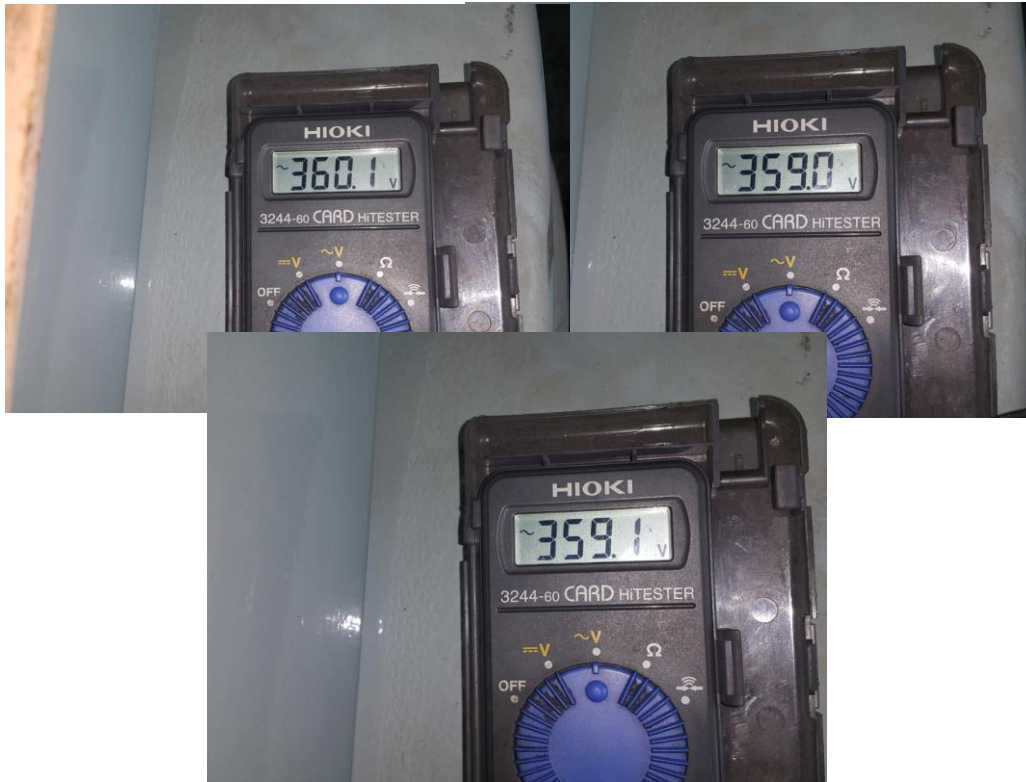
출고검사 MAIN

441V일때 2차 출력 전압

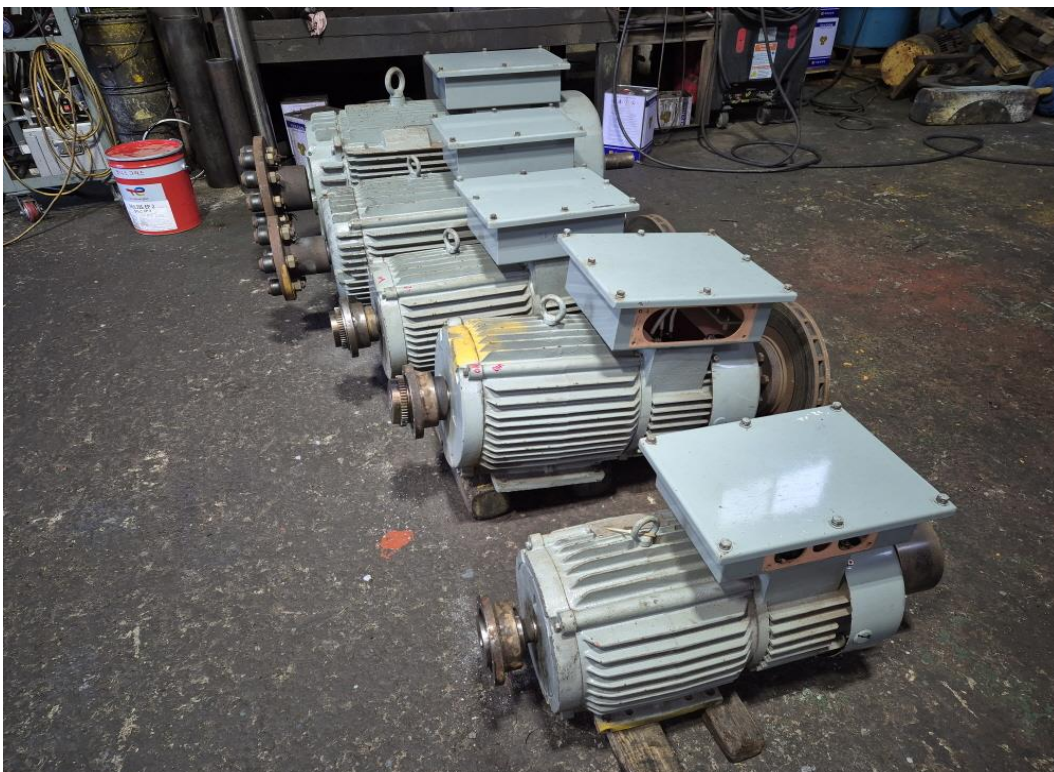
Ass'y

출고검사 후

나머지 MOTOR 동일한 조건으로 출고검사 됨으로 CHECK LIST 참조
