작업공정사진철

공사명: AC VECTOR SPINDLE MOTOR OVERHAUL

규격: 1PH6-206 93KW 1000~MAX 5000RPM

REPAIR 내역: 분해 및 불순물 CLEANSING DRYING
INSULATING VARNISH DIPPING DRYING
부하측 HOUSING METALLIZING 연마
BALANCING 및 UNBALANCE교정
BLOWER MOTOR 세척 실시
BEARING교환
출고검사 시운전 TEST

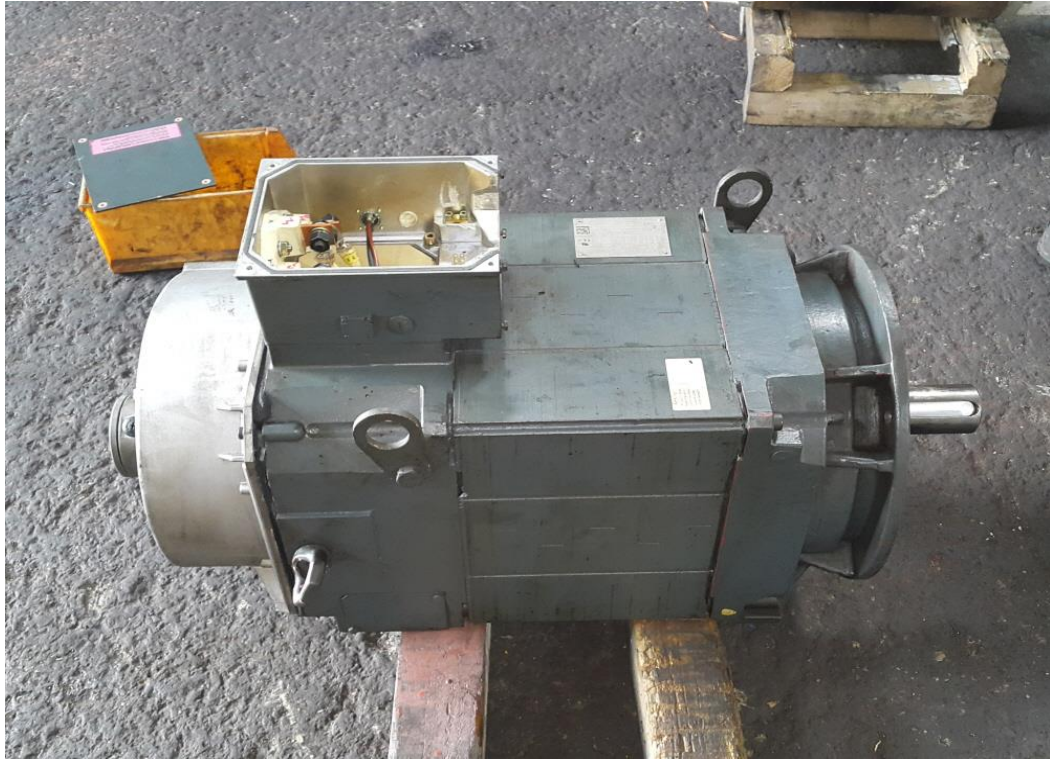
Ass'y

분해 전

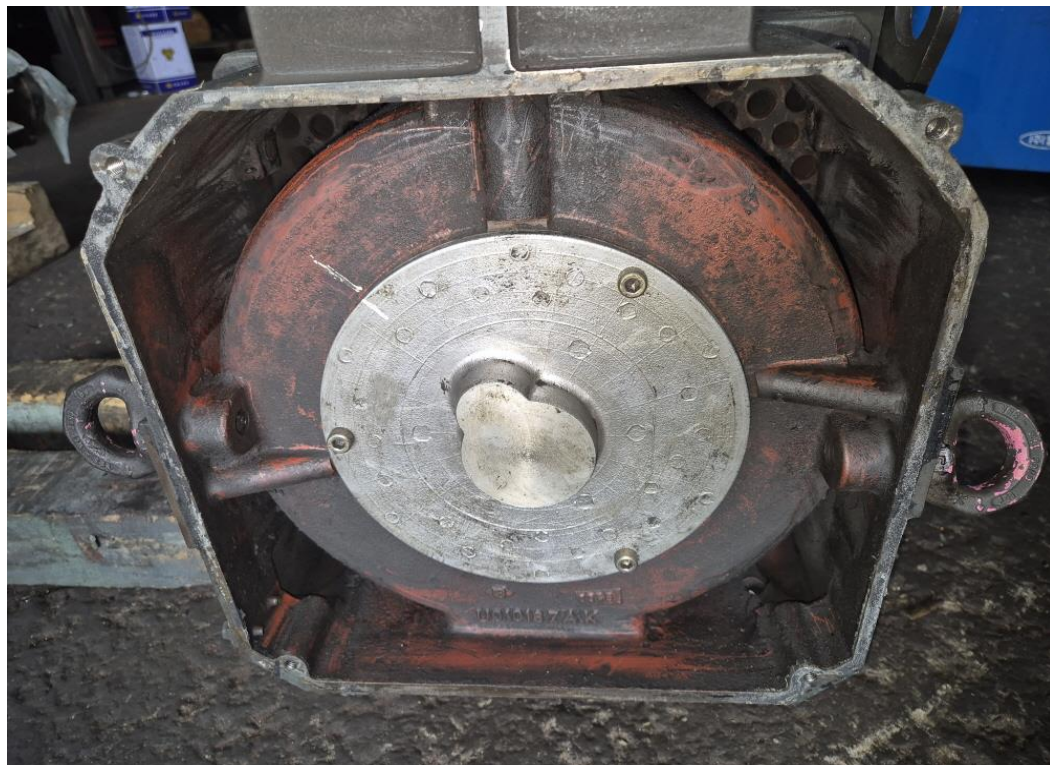
냉각구

분해 실시

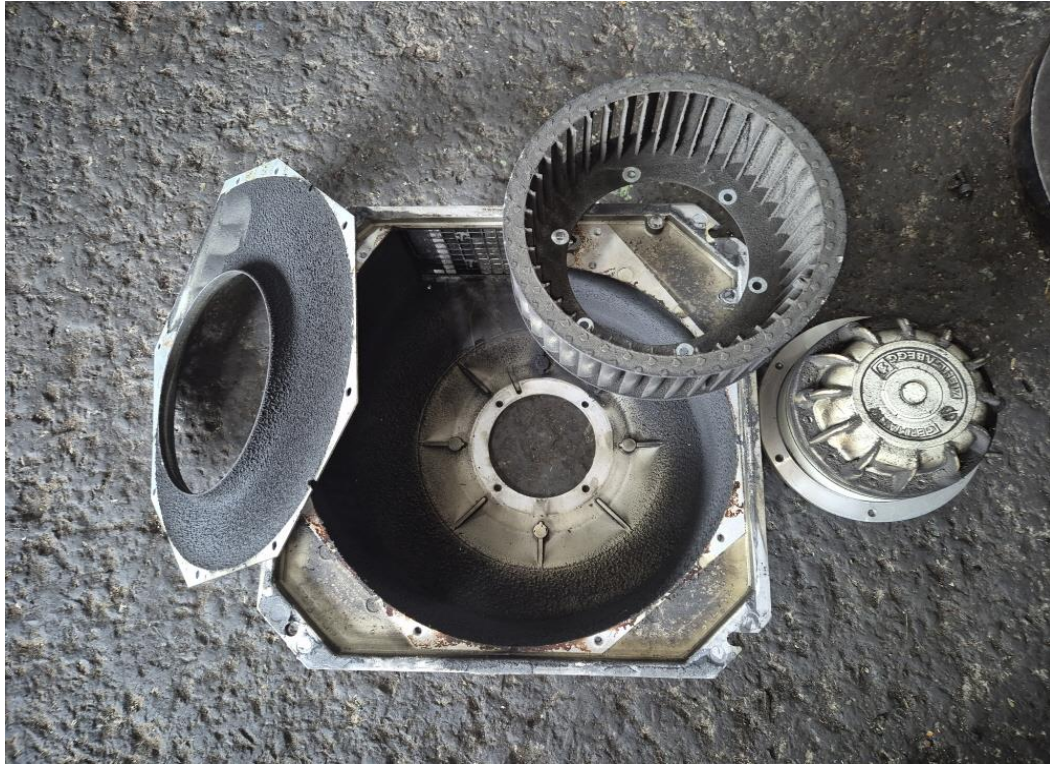
냉각 FAN

분해 실시

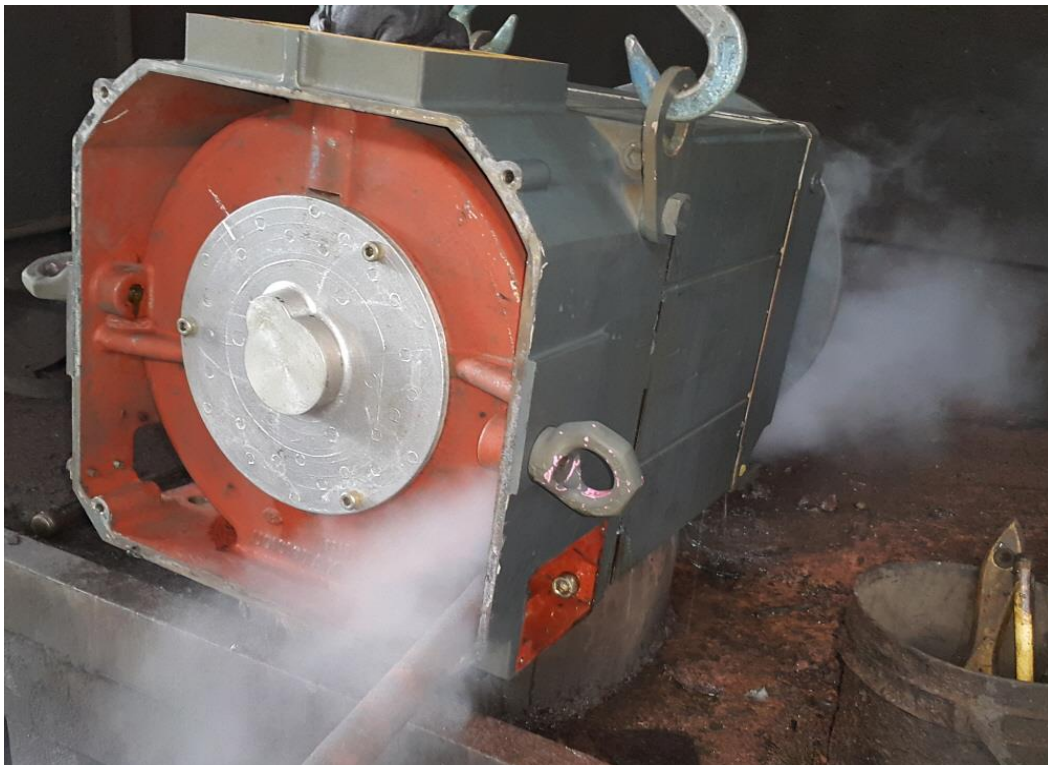
Ass'y 분해전

냉각구 및 권체 세척실시

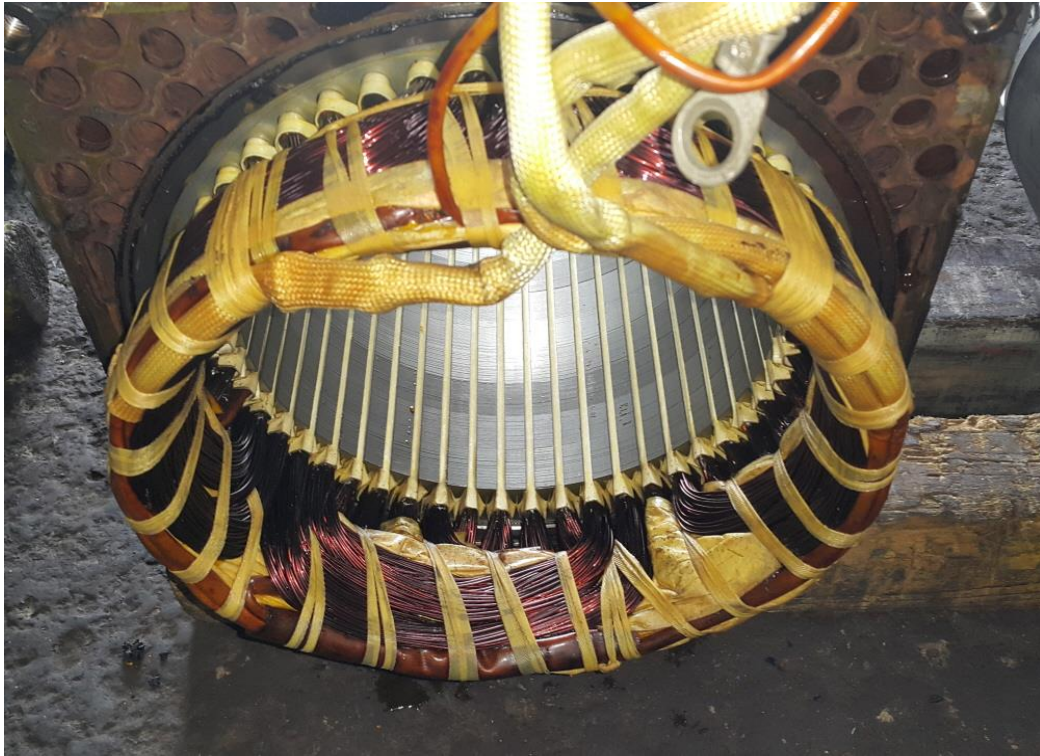
STATOR 권체

분해 후 권선상태 양호

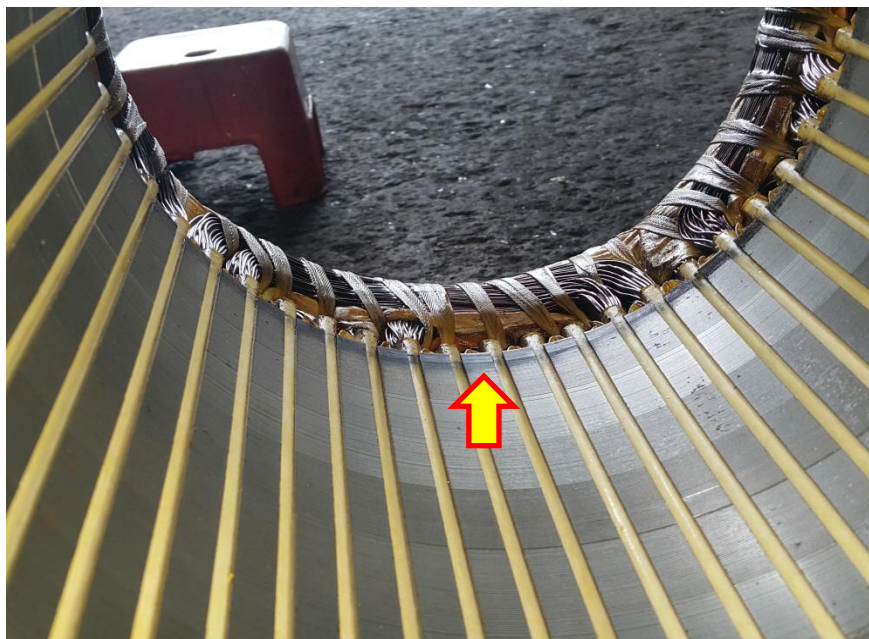
부하측

약간의 회전 마찰이 진행 중이었던 것으로 보임

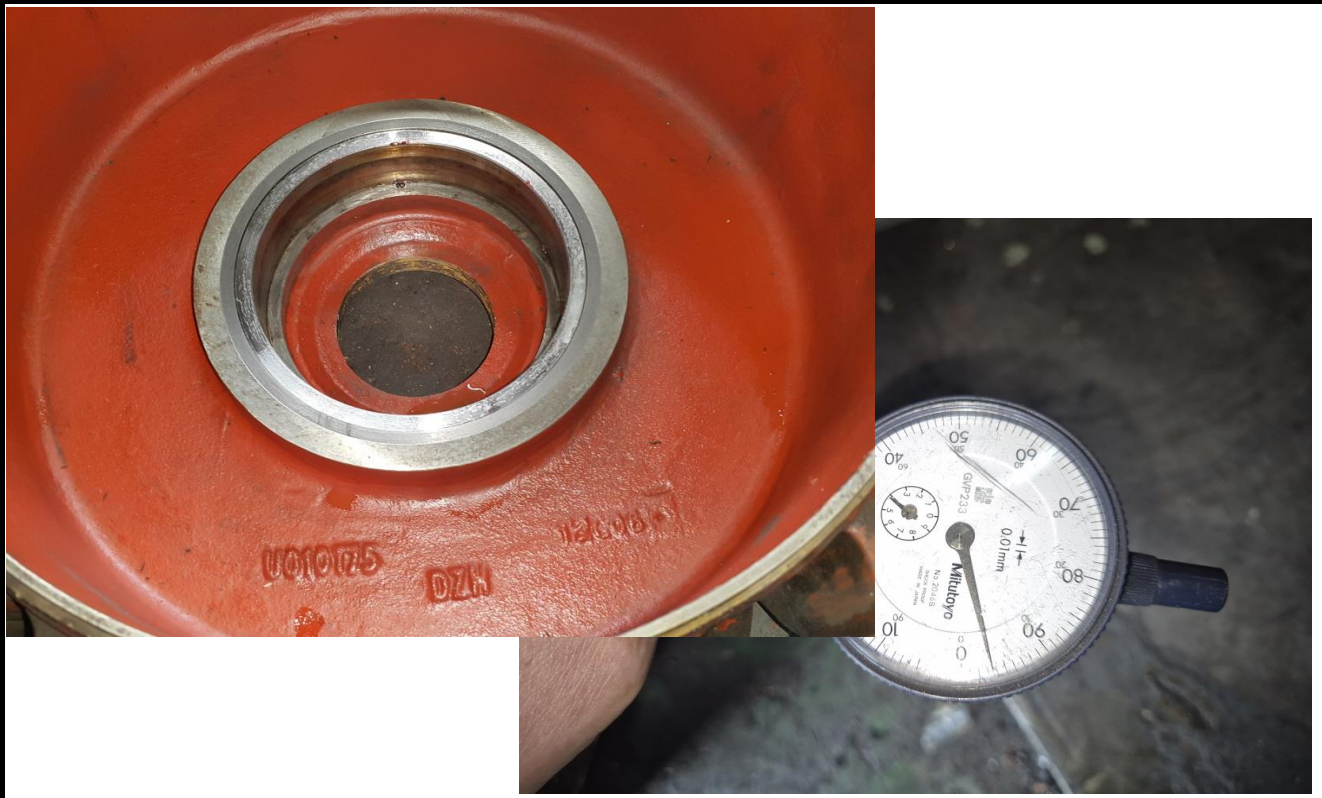
BRACKET	부하측 HOUSING 측정치 4/100로 불량
작업공정	AC SPINDLE MOTOR 입고검사

부하측 HOUSING METALLIZING 연마 후 검사 1/100

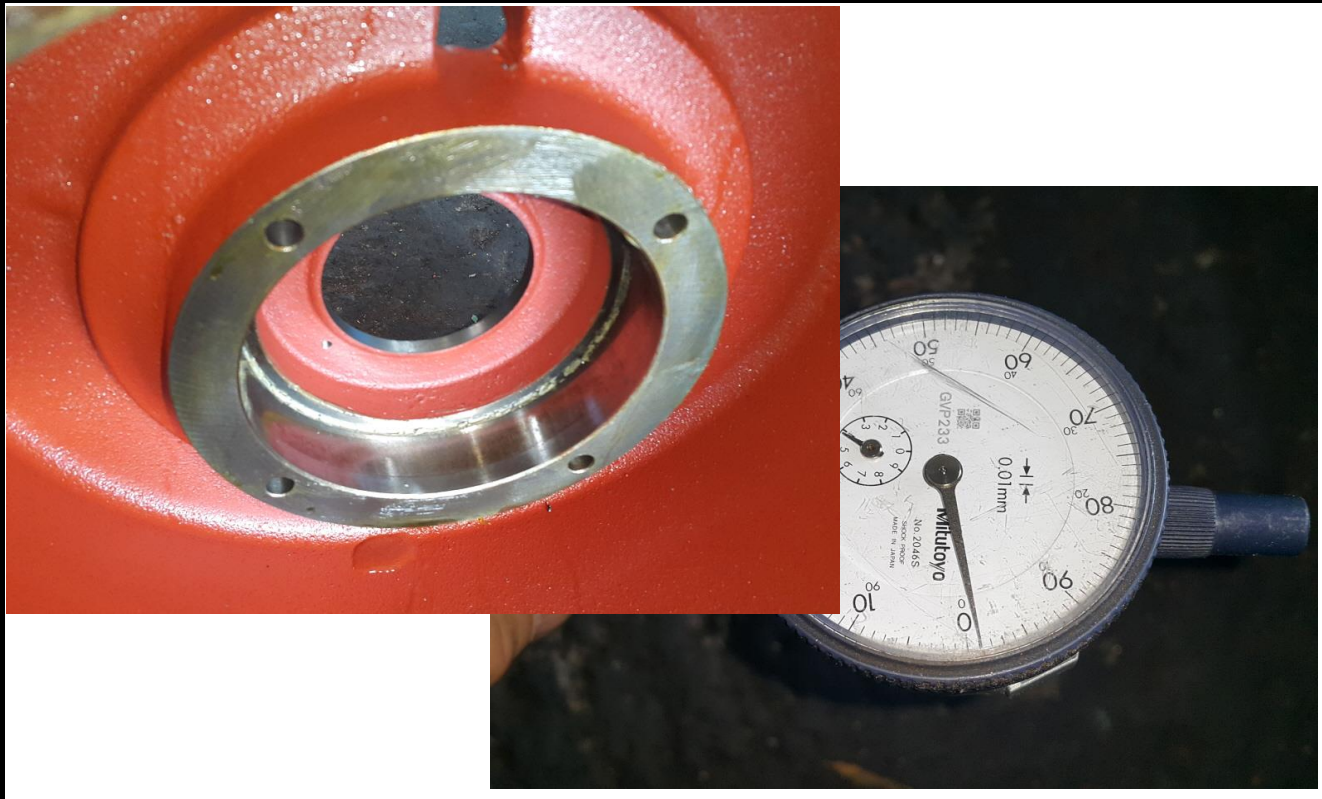
BRACKET	반 부하측 HOUSING 측정치 1/100로 양호

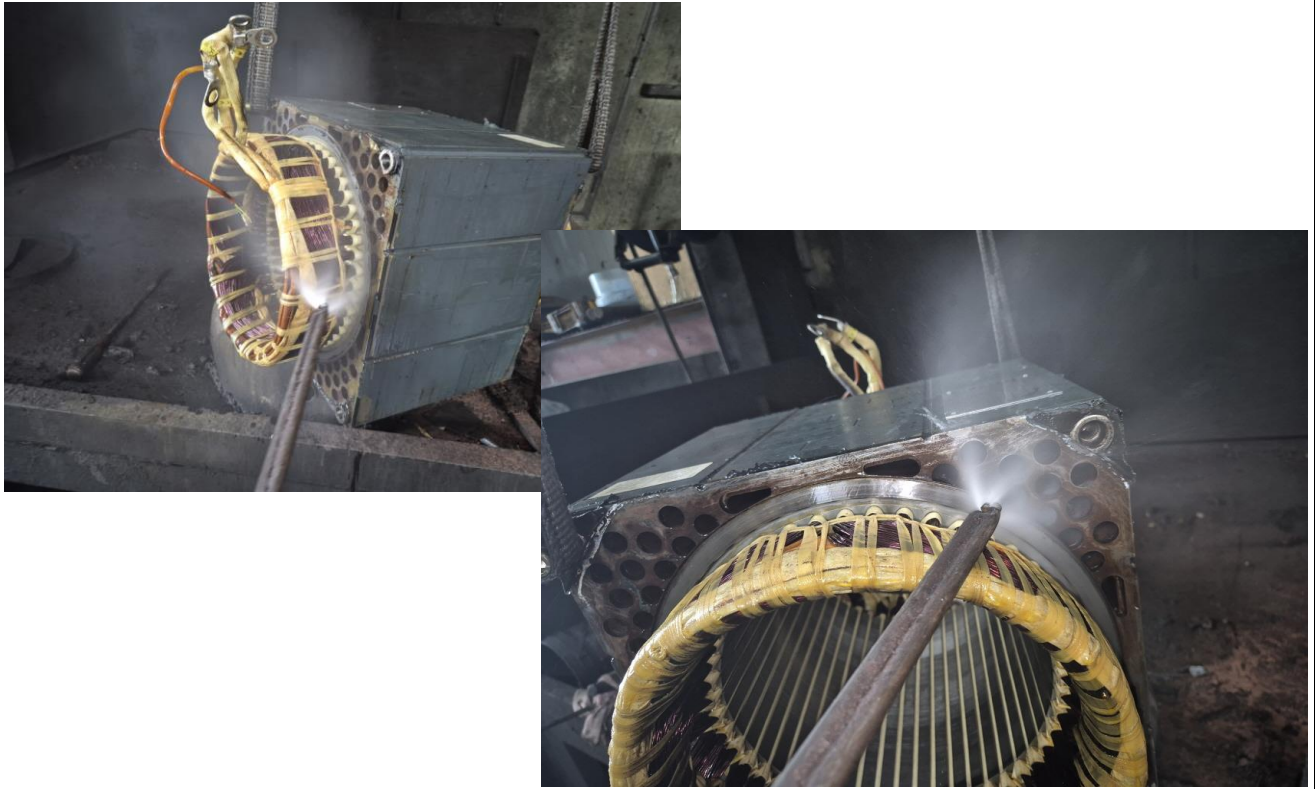
STATOR 권체

권선 및 냉각구 세척 실시

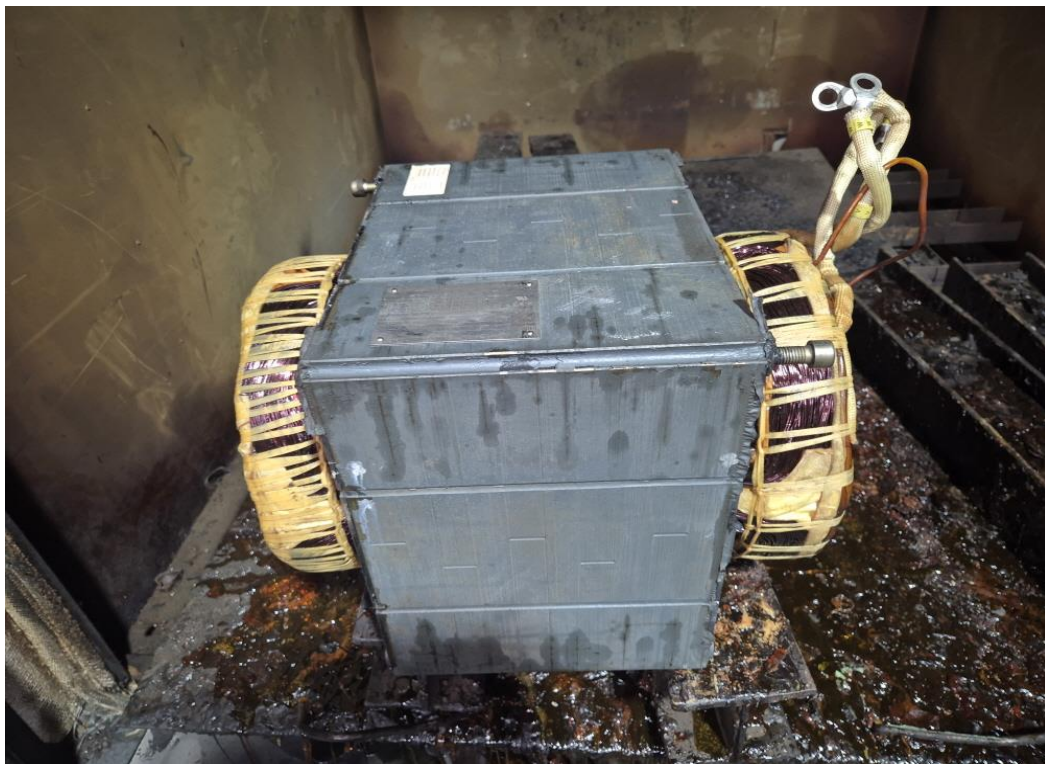
STATOR 권체

세척 후 건조실시

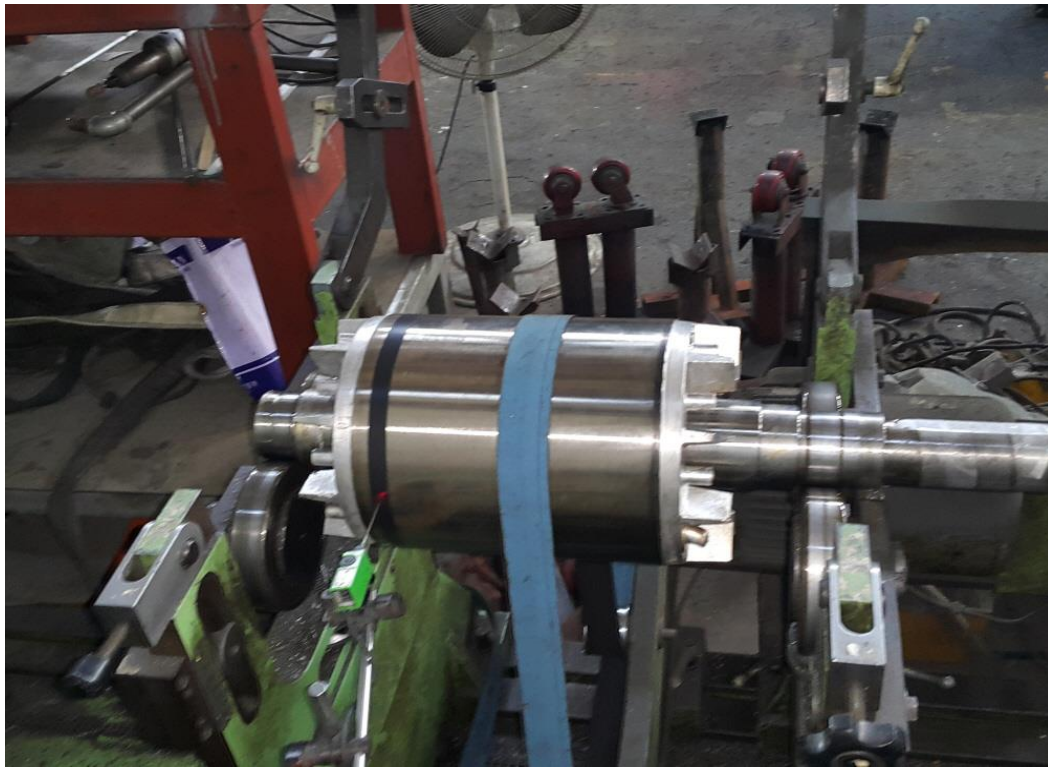
ROTOR

BALANCING 실시

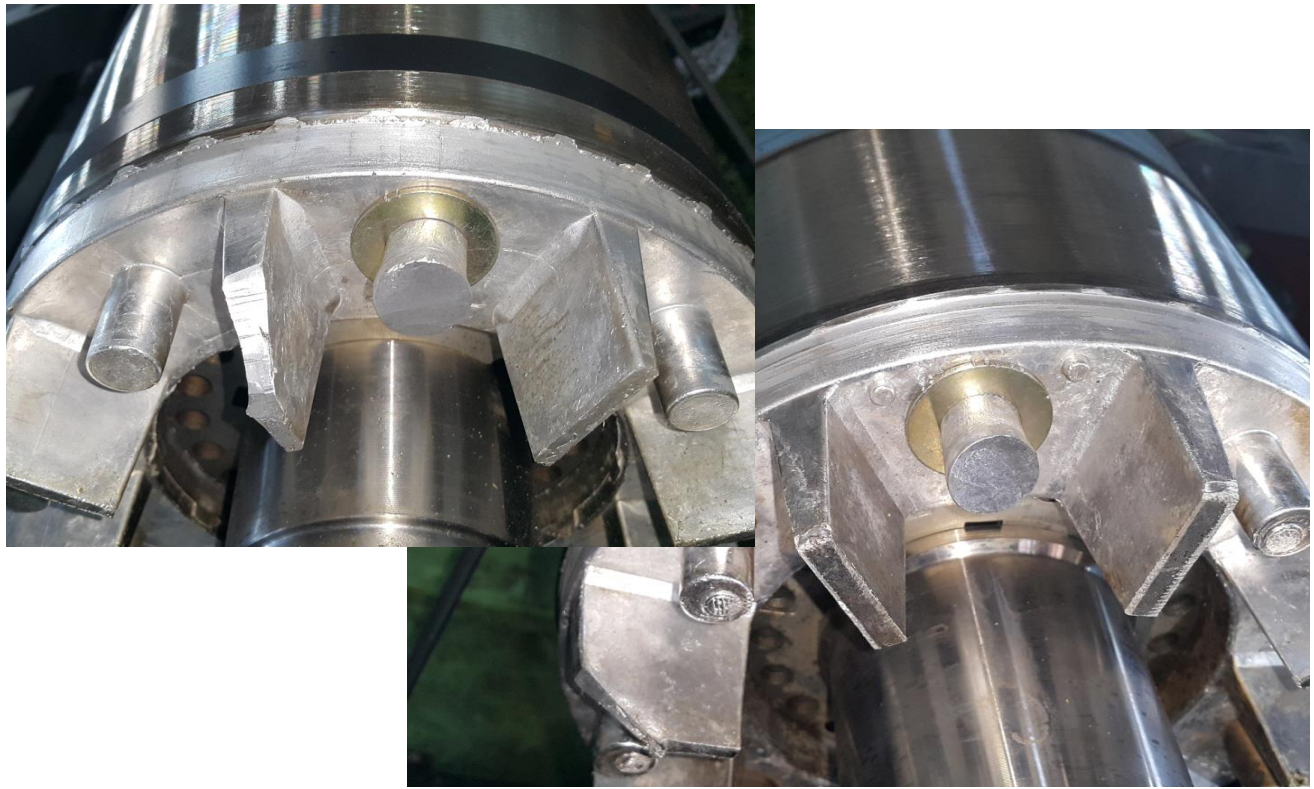
ROTOR	교정된 UNBALACE REPORT참조
작업공정	AC SPINDLE MOTOR OVERHAUL

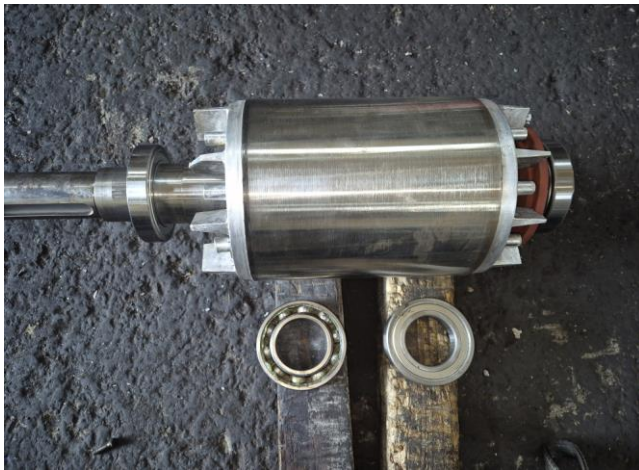
조립부품

BEARING교환 조립실시

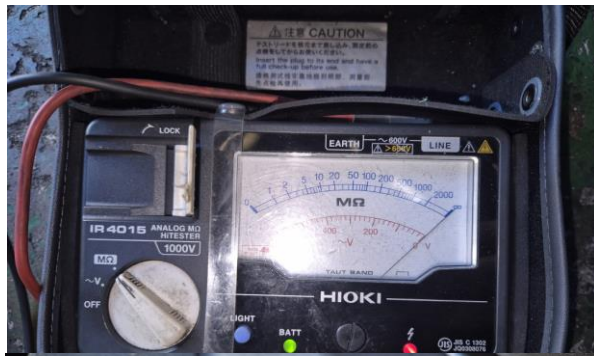
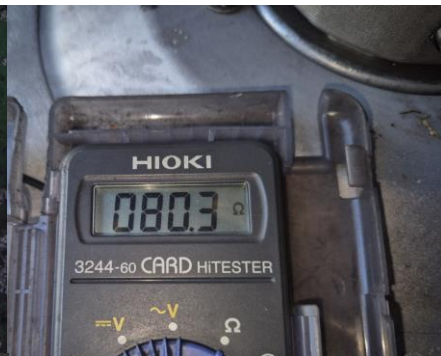
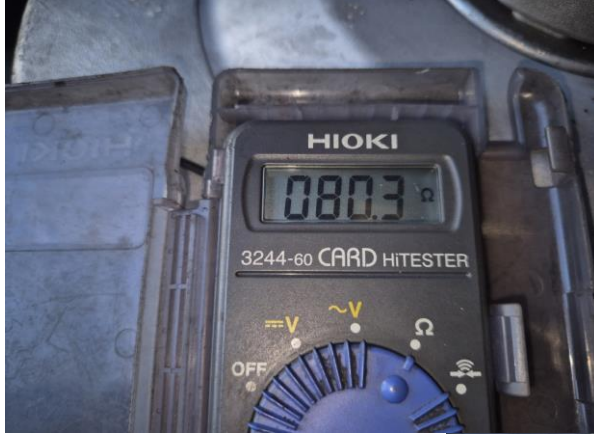
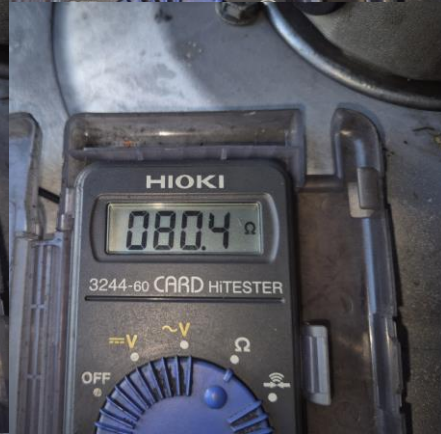
BLOWER

절연저항 & 각상별 권선저항

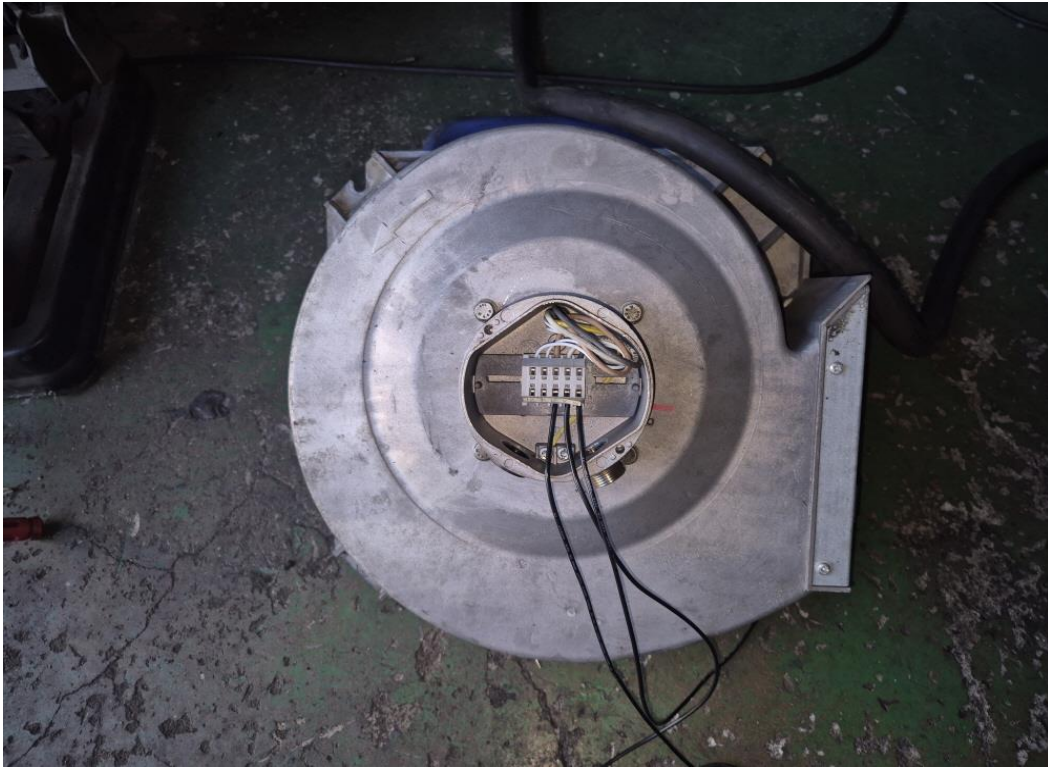
BLOWER

시운전 TEST실시

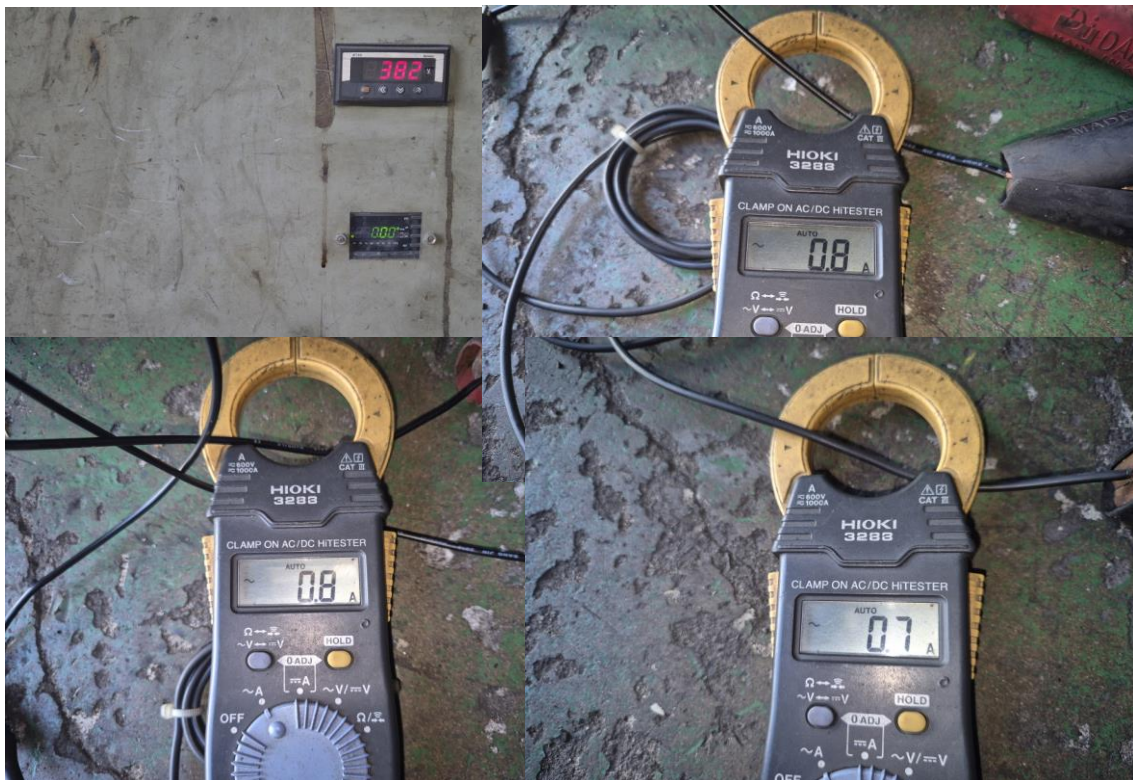
BLOWER

시운전 TEST실시 운전 CURRENT

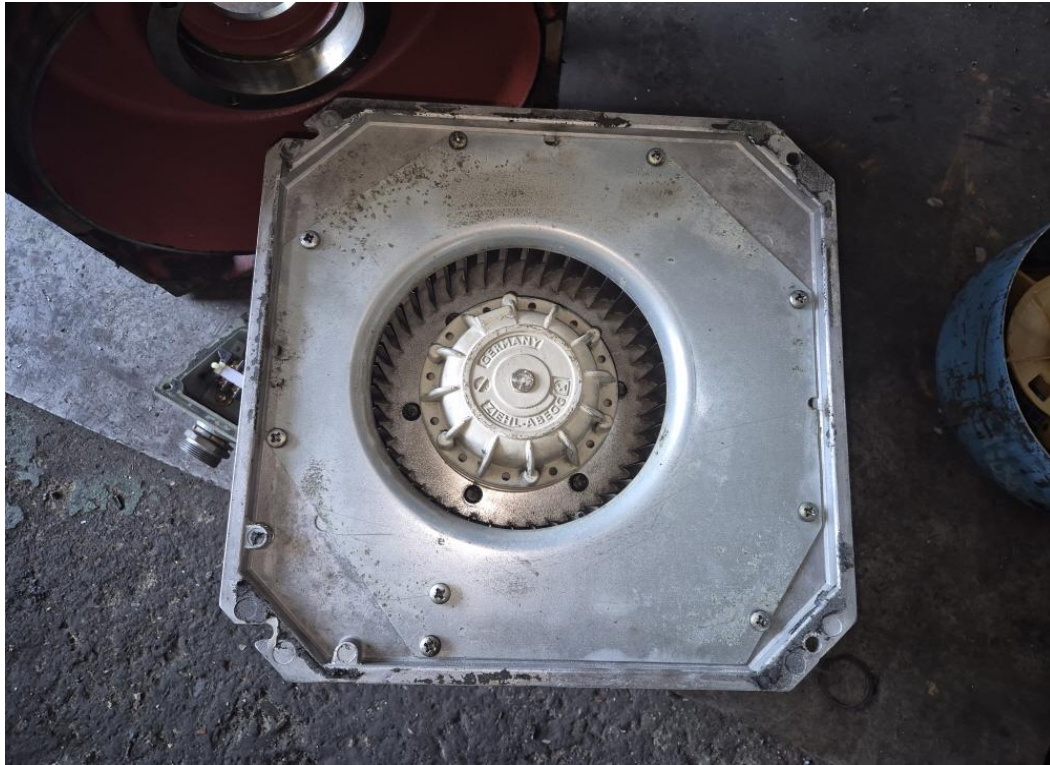
BLOWER

보수 후

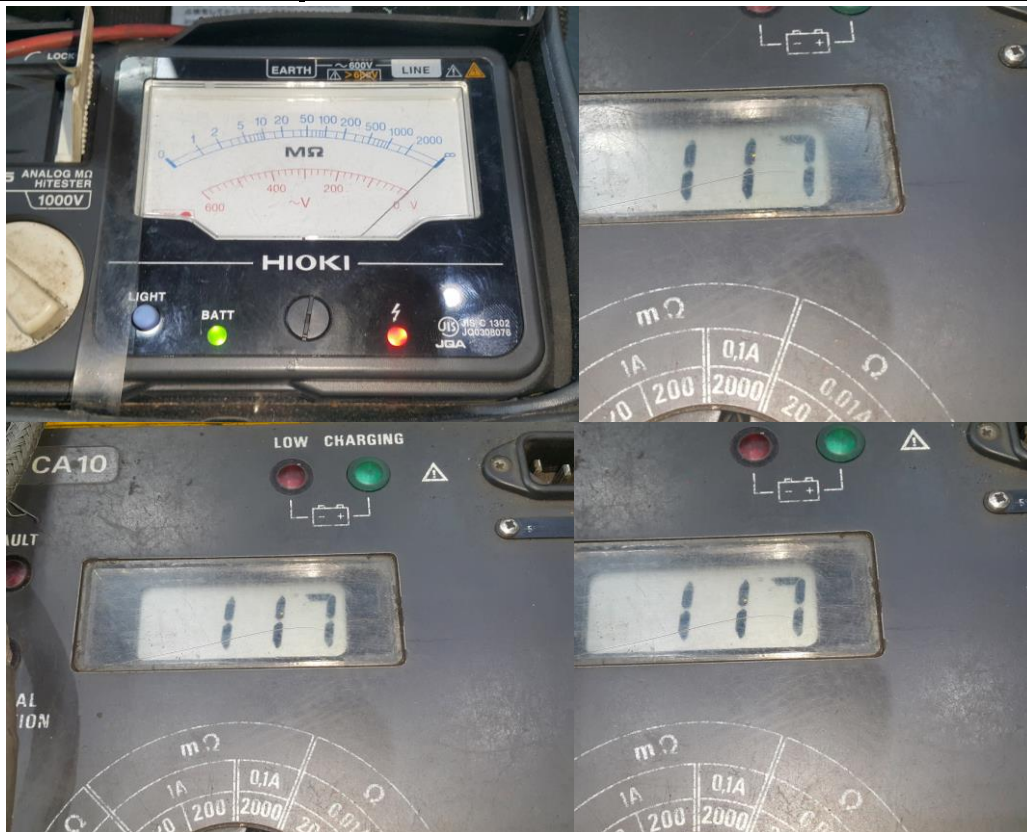
출고검사

SPINDLE 절연저항 & 각상별 권선저항

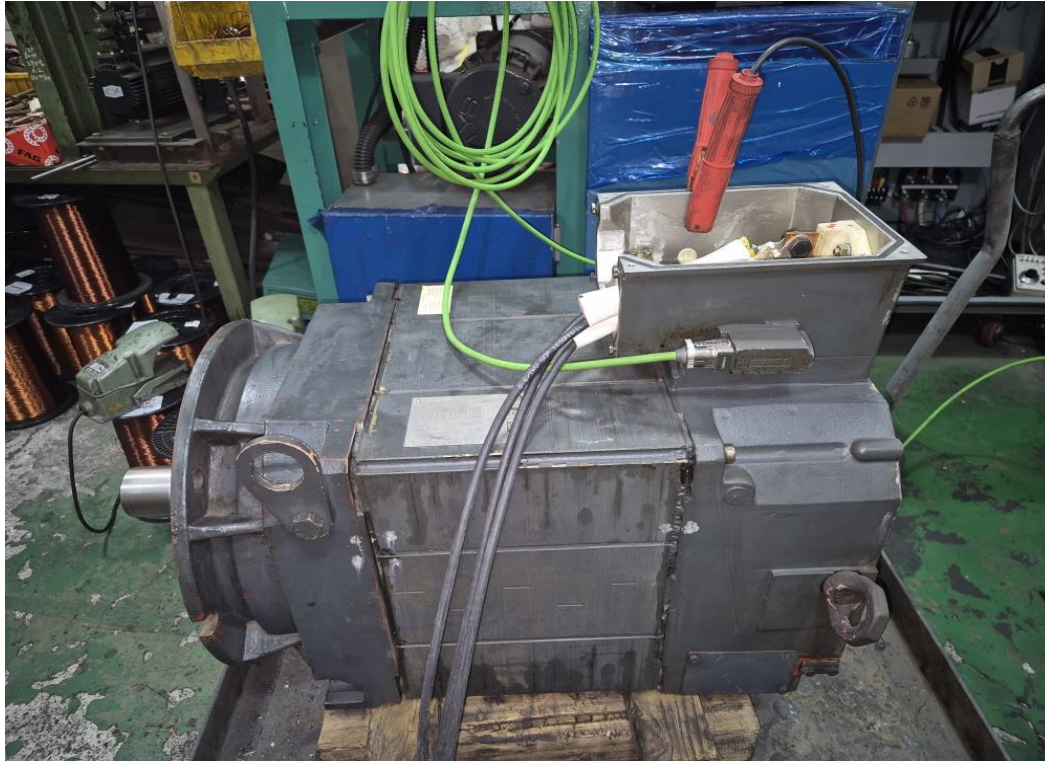
출고검사

시운전 TEST 실시
