# 작업공정사진철

공사명: AC VECTOR SPINDLE MOTOR OVERHAUL

규격: 1PH7-186 67KW 1000~1350, MAX 5000RPM

REPAIR 내역: 분해 및 불순물 CLEANSING DRYING  
INSULATING VARNISH DIPPING DRYING  
양측 HOUSING METALLIZING 연마  
ENCODER 물 유입으로 교환  
SMI MODULE 소손으로 교환  
BEARING교환  
출고검사 시운전 TEST

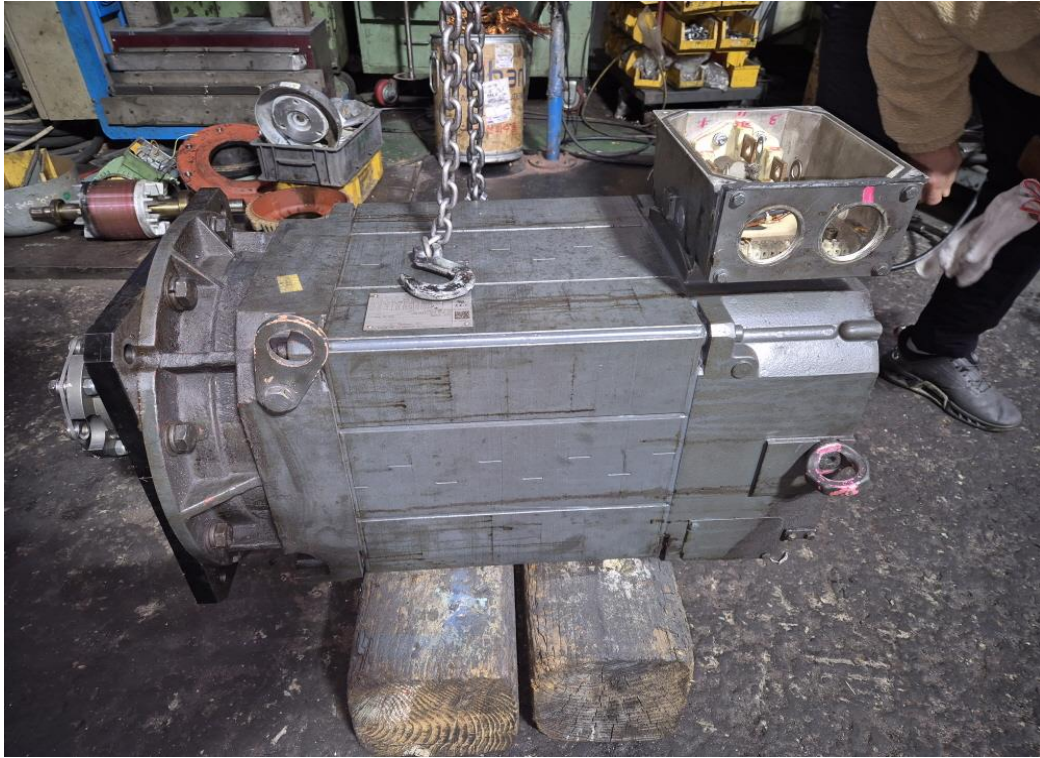
Ass'y

분해 전

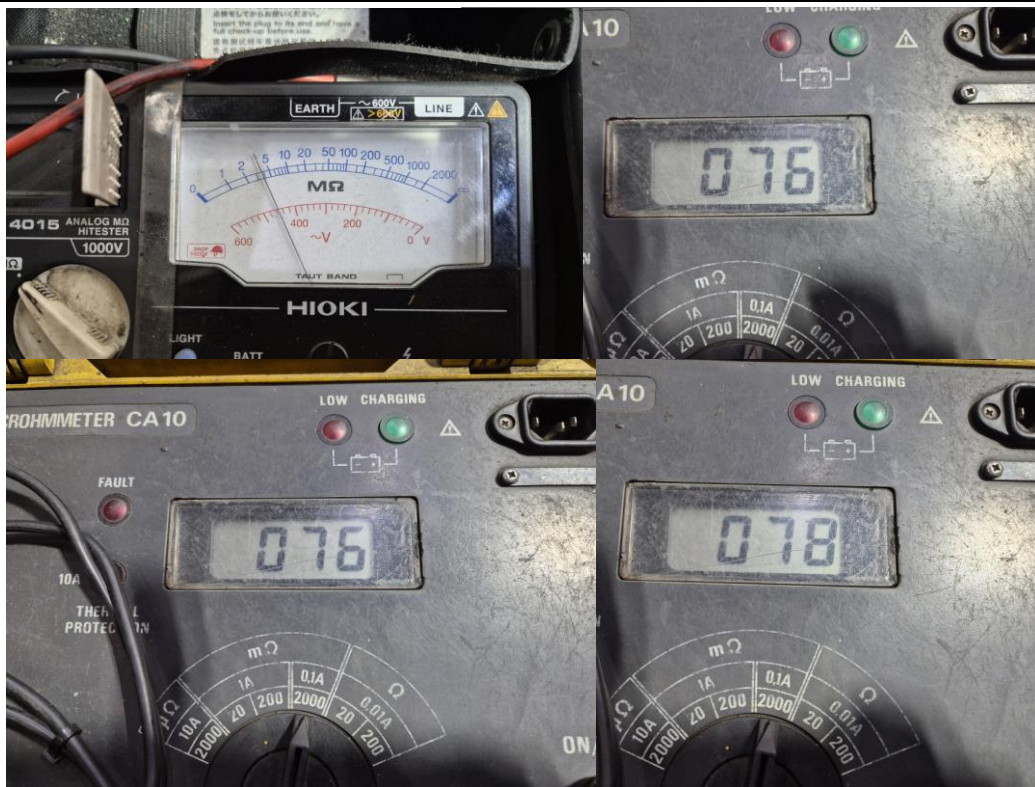
권선검사

절연저항 & 각상별 권선저항

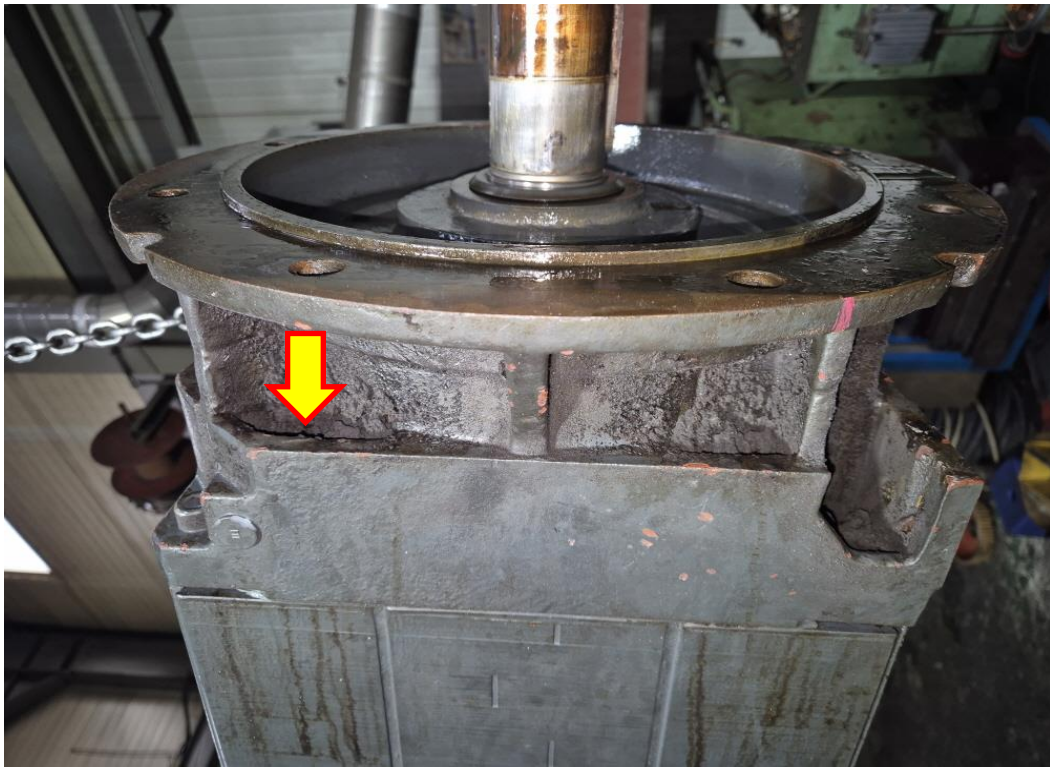
냉각구

냉각 흡입구 막힘

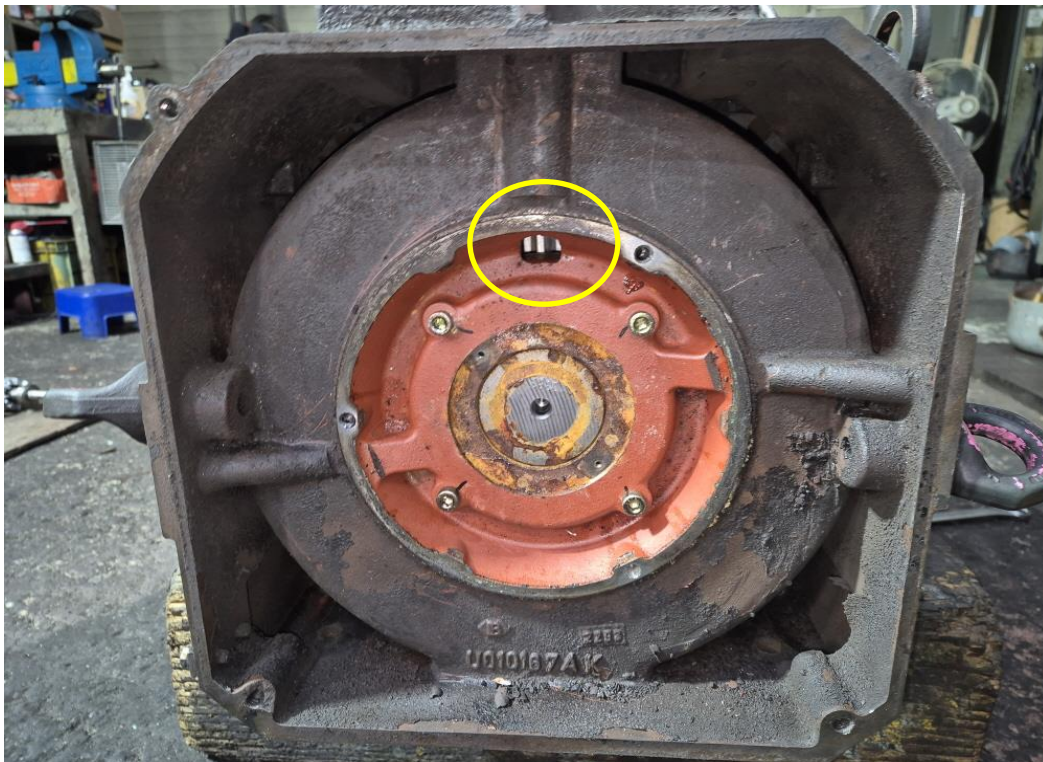
분해전

POWER BOX에서 ENCODER CABLE HOLE로 물이 유입되는 경로 로 예상 추정됨

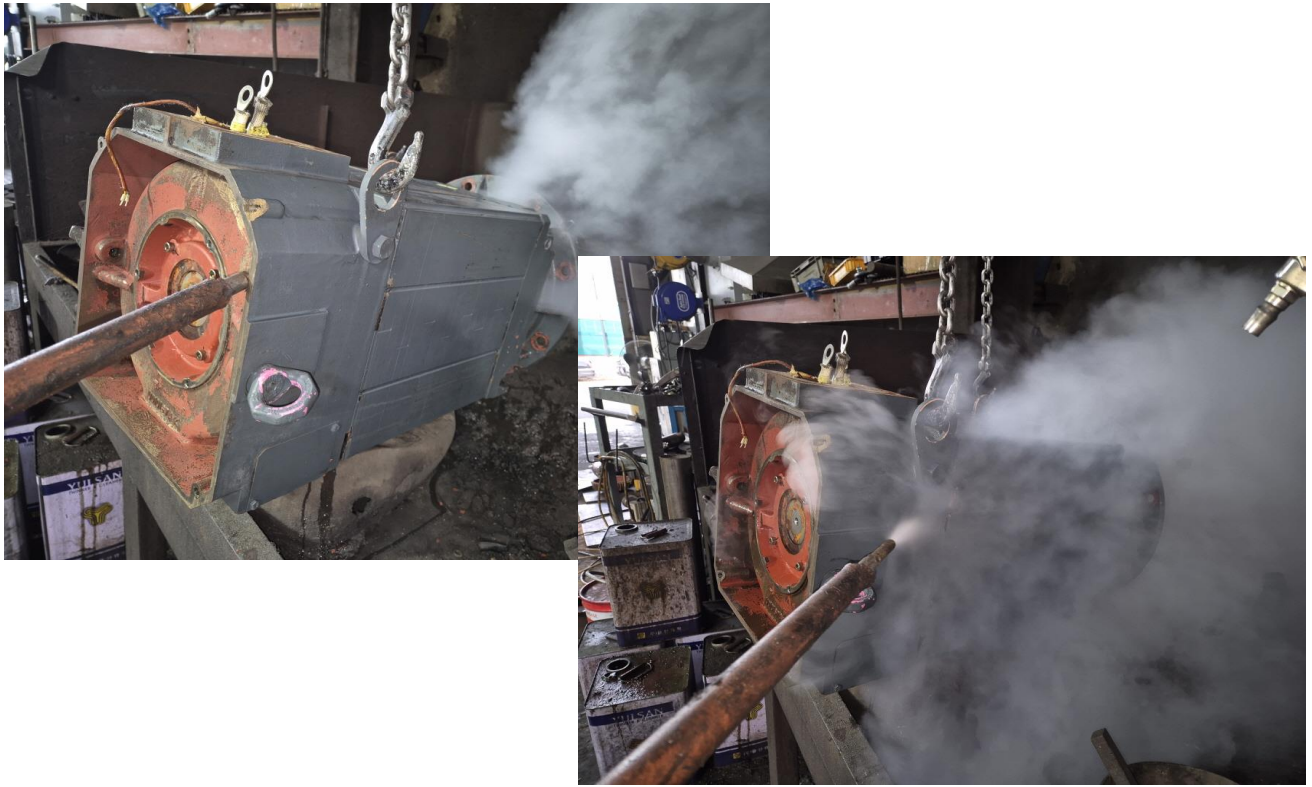
Ass'y 분해전

냉각구 및 권체 스팀세척 실시

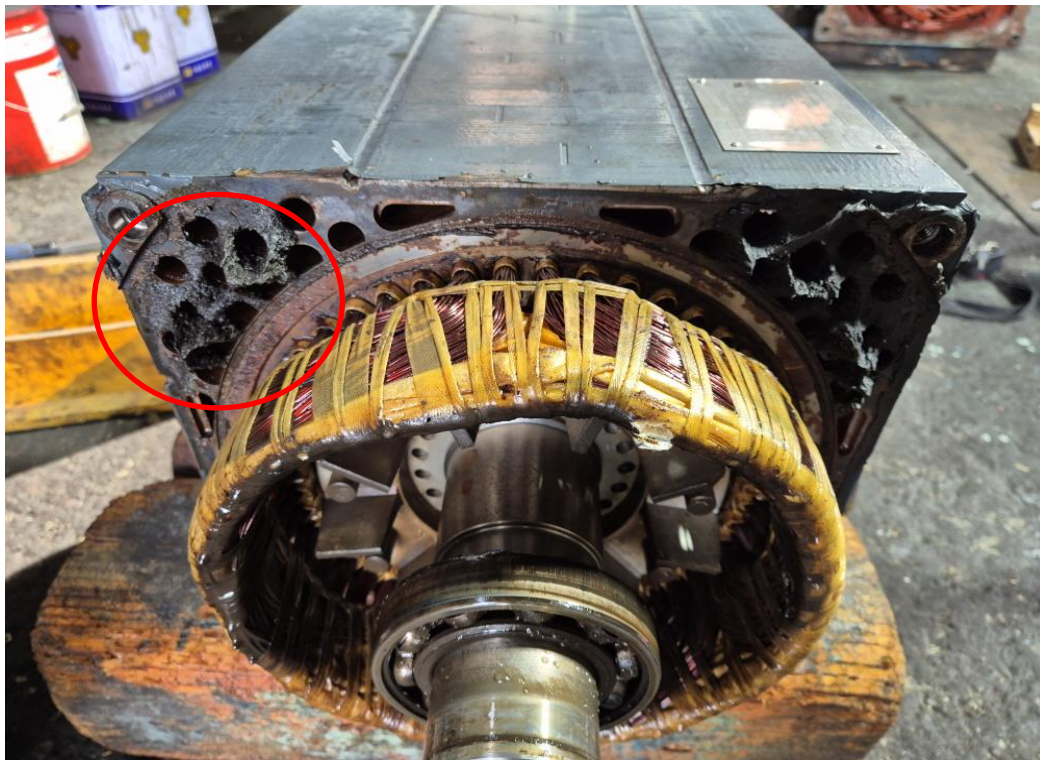
STATOR 권체

분해 실시

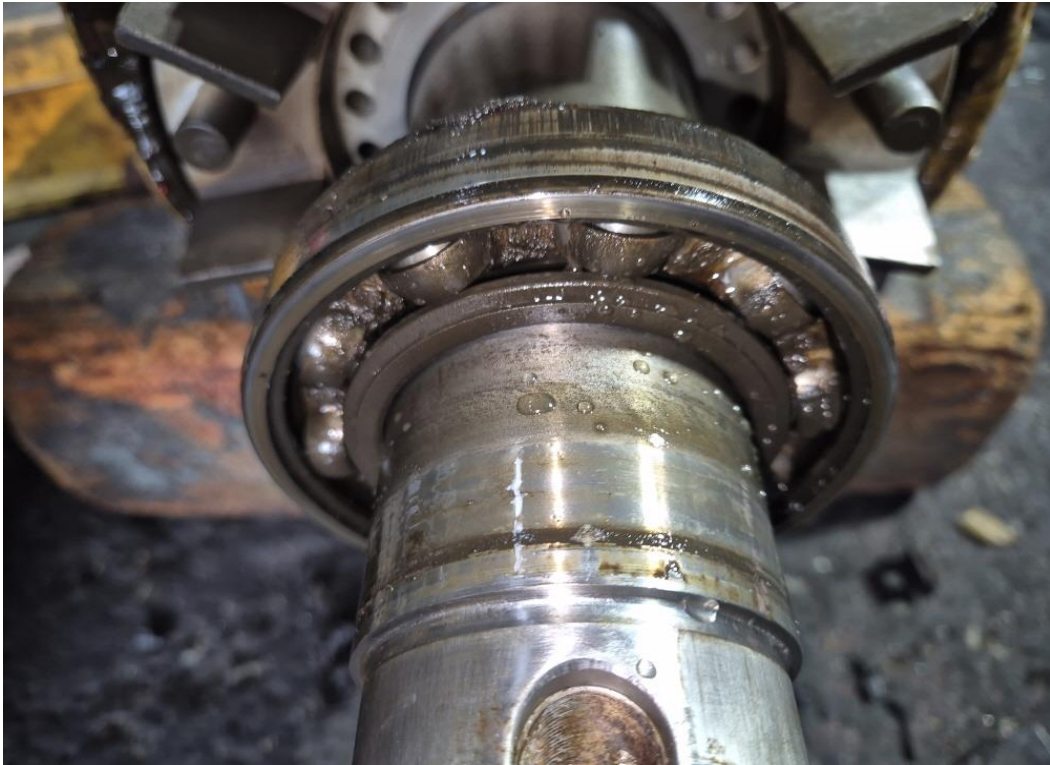
BEARING부

GREASE 말라 없음

BEARING교환 조립실시

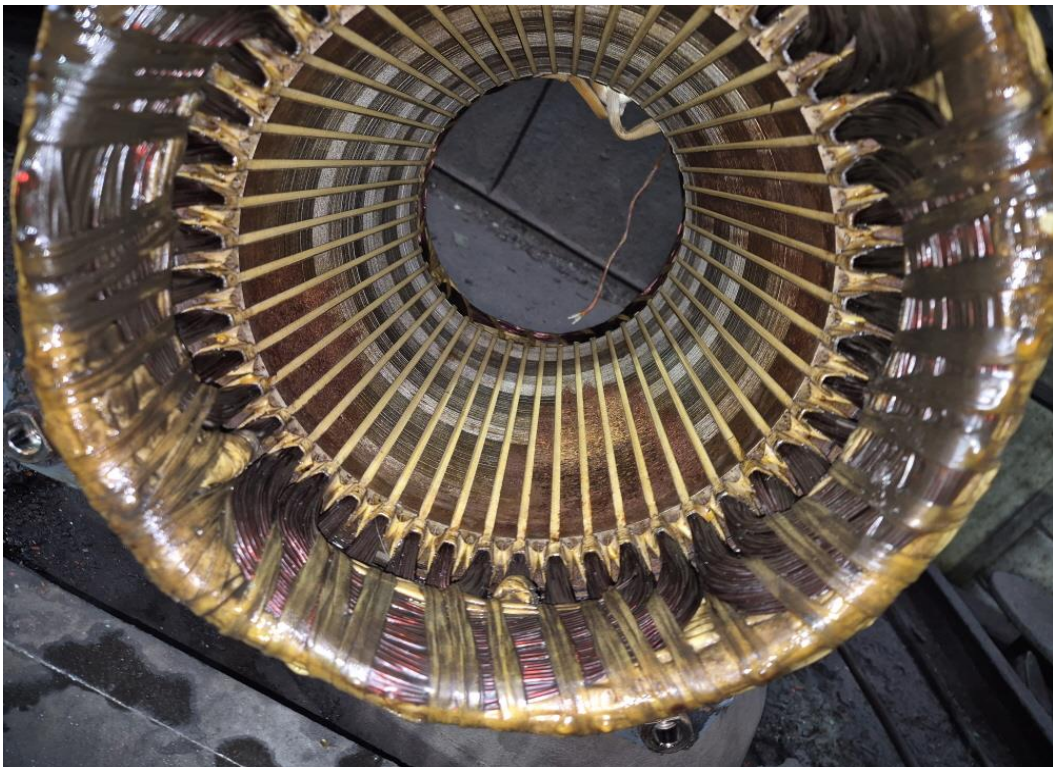
STATOR 권체

권선상태 양호하나 물 유입이 있었던 것으로 보임

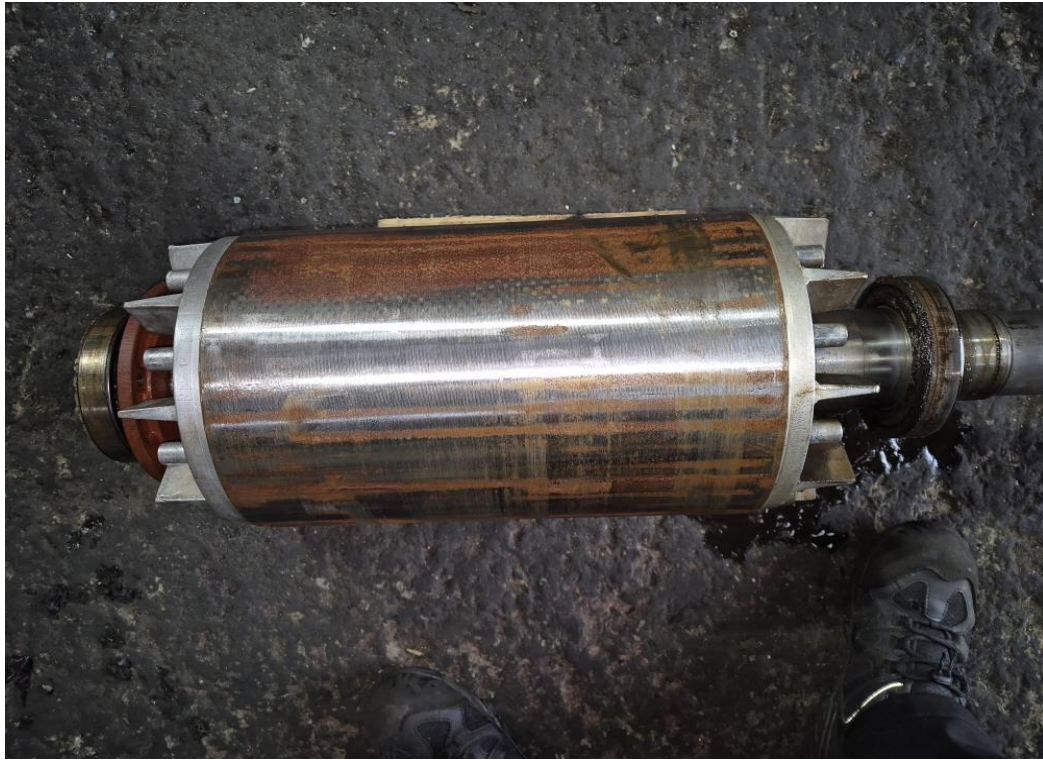
ROTOR

MOTOR 내부로 물 유입이 있었던 것으로 보임

녹제거 및 방청도장 실시

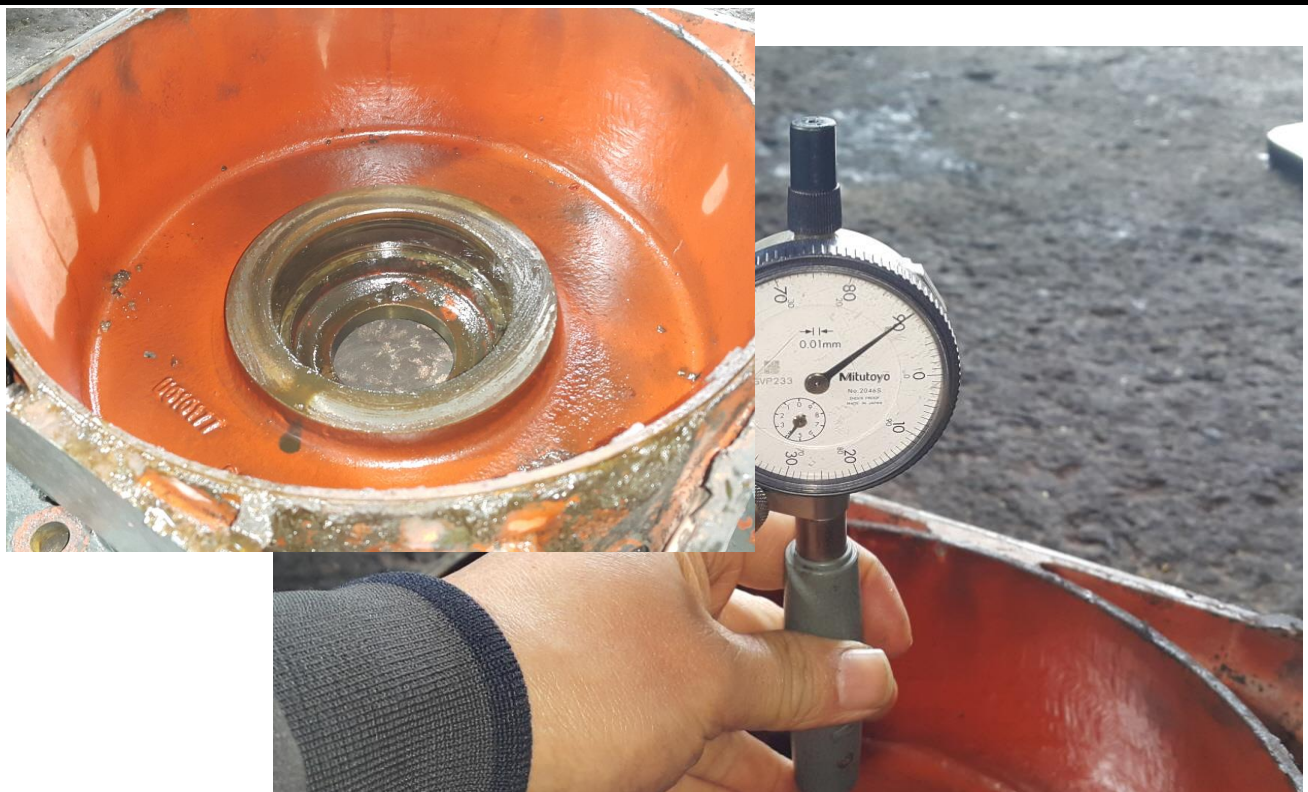
BRACKET

부하측 HOUSING 측정치 10/100으로 불량

부하측 HOUSING METALLIZING 연마 후 검사 0/100

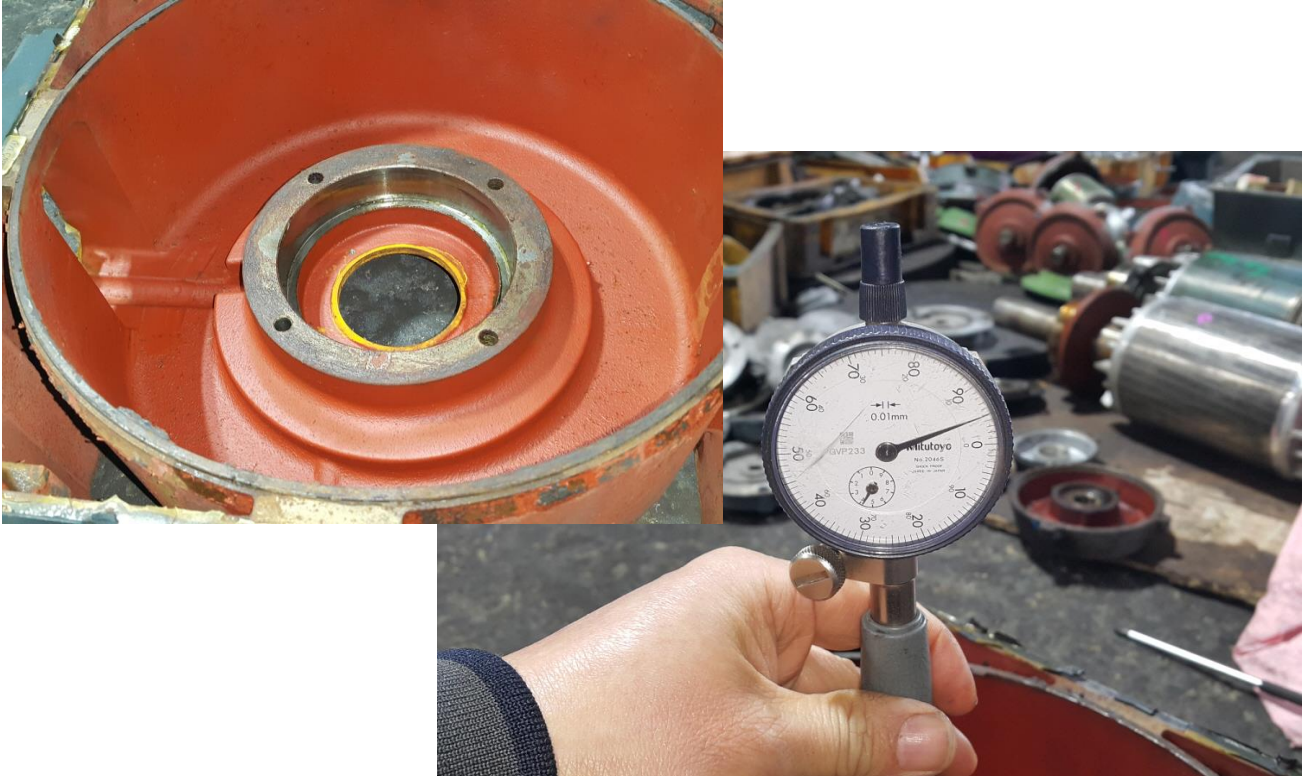
BRACKET	반 부하측 HOUSING 측정치 5/100로 불량
작업공정	AC SPINDLE MOTOR OVERHAUL

반 부하측 HOUSING METALLIZING 연마 후 검사 0/100

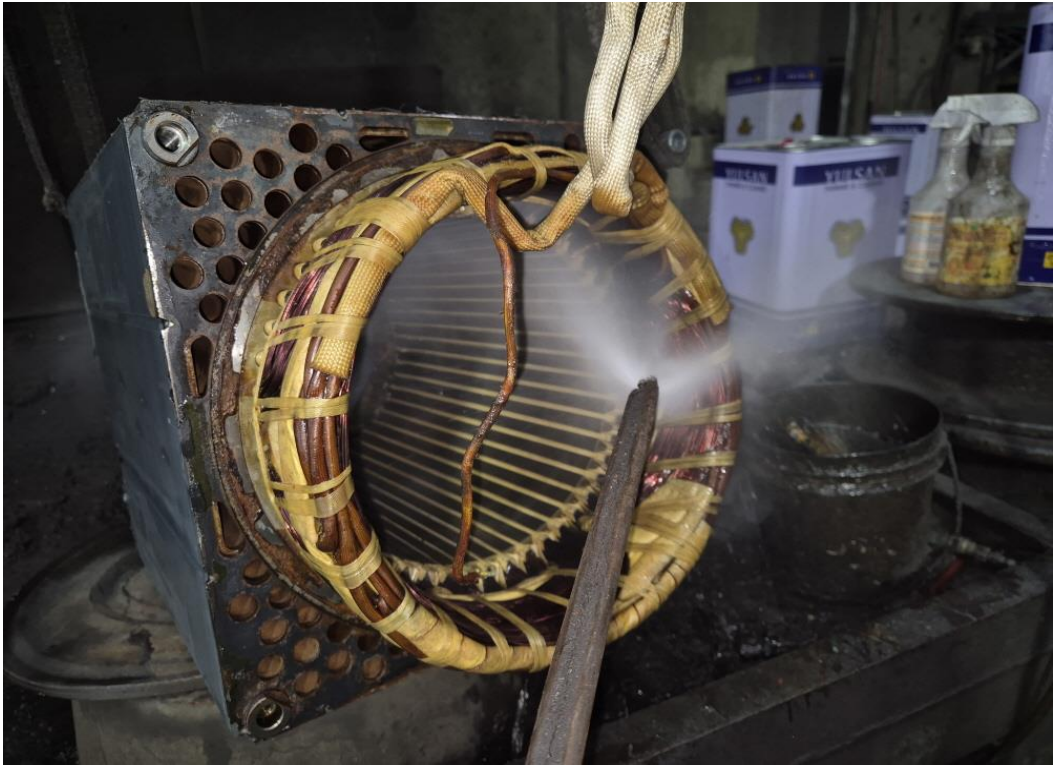
STATOR 권체	권선 및 냉각구 세척 실시

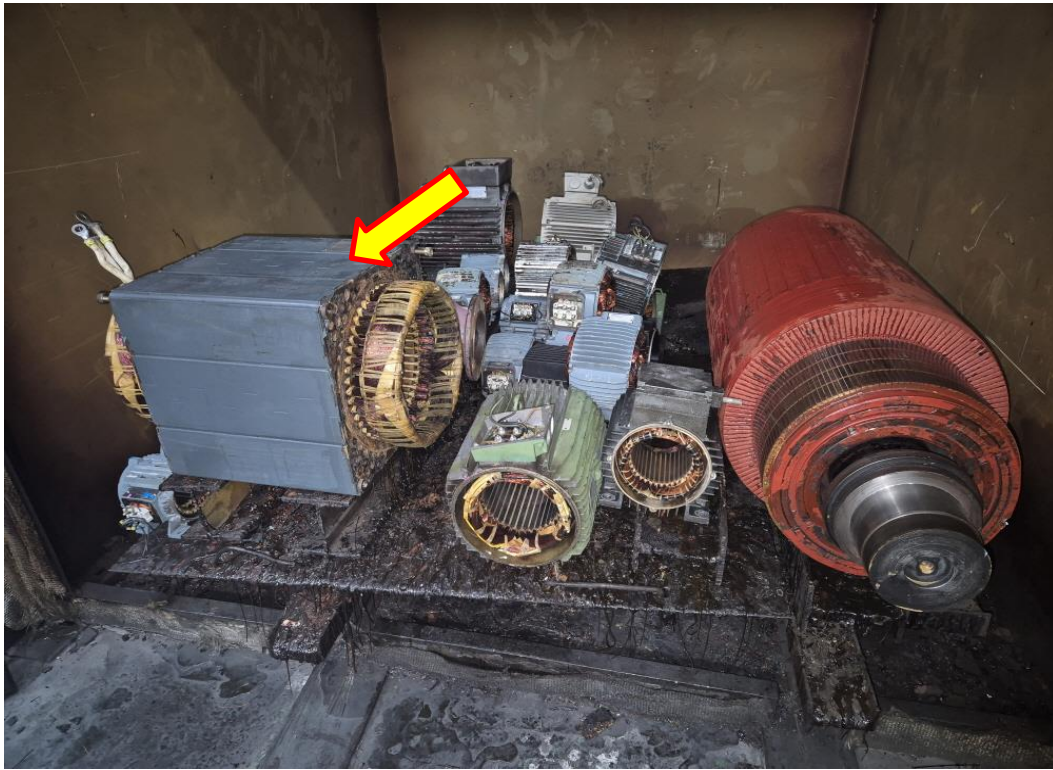
STATOR 권체

세척 후 건조실시

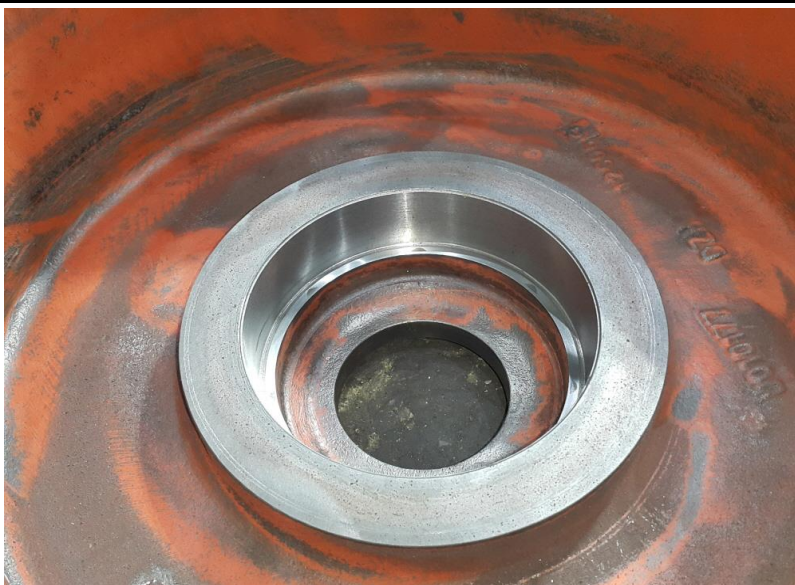
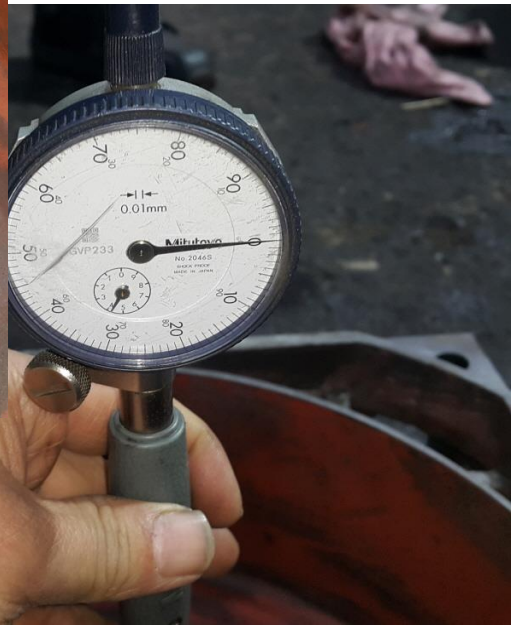
BRACKET

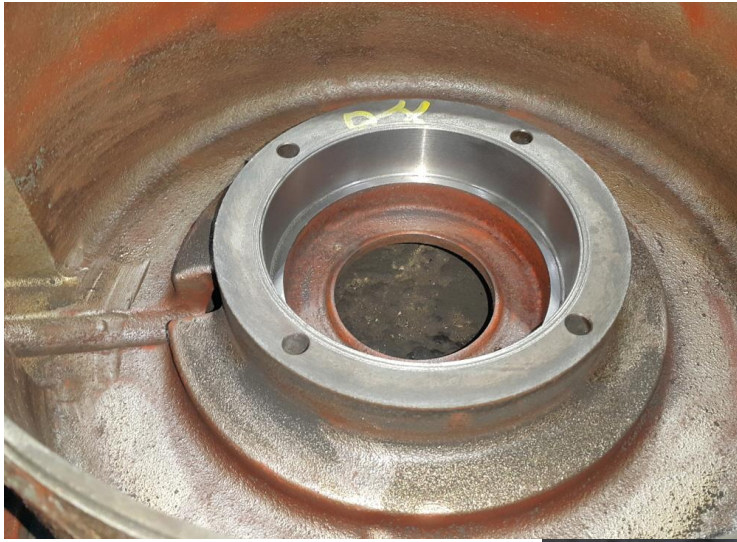
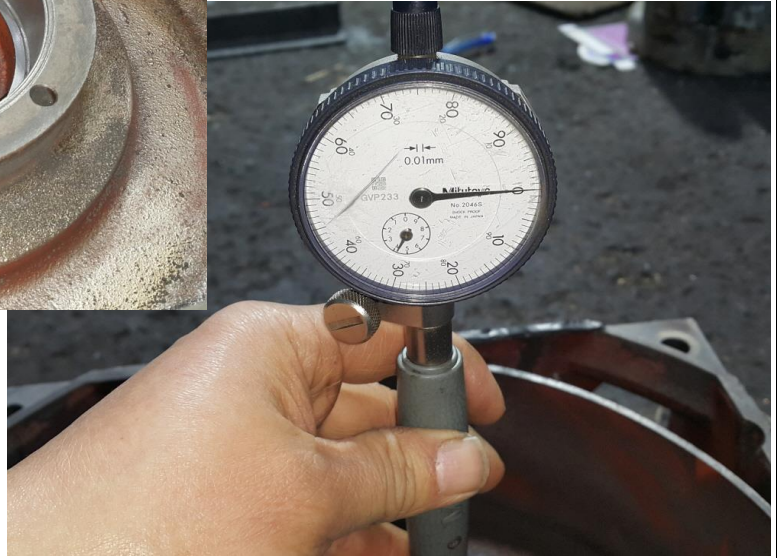
BRACKET

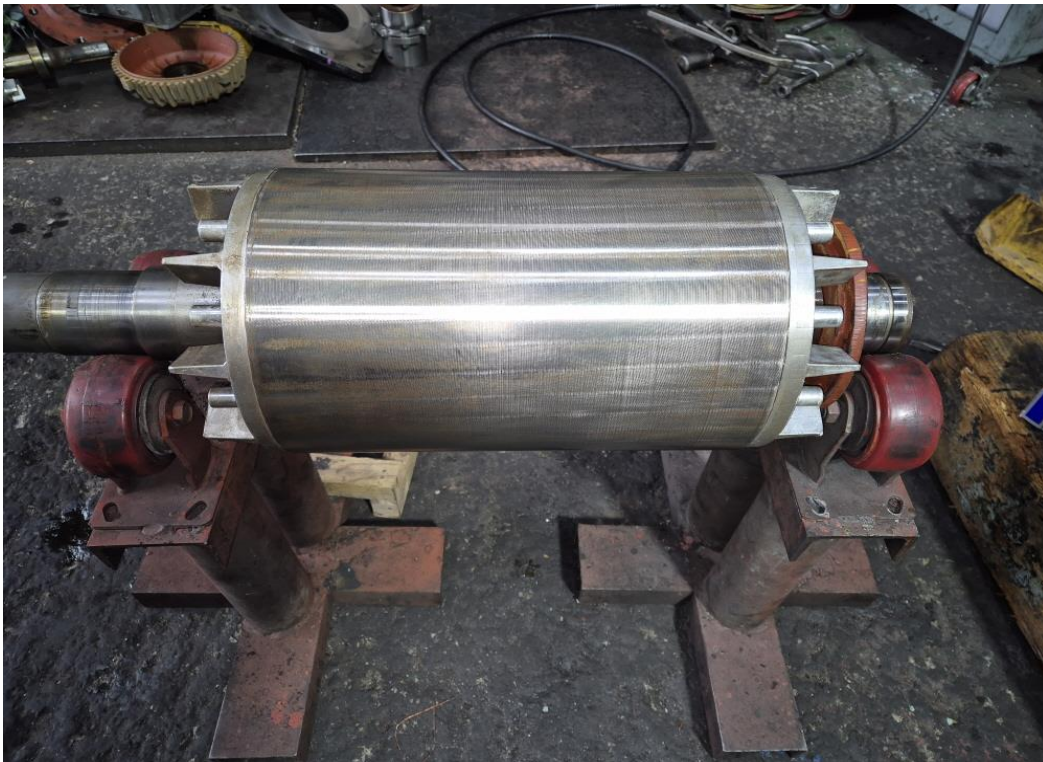
ROTOR

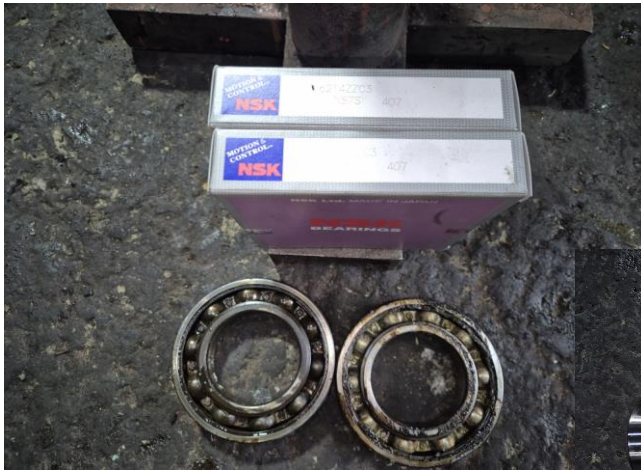
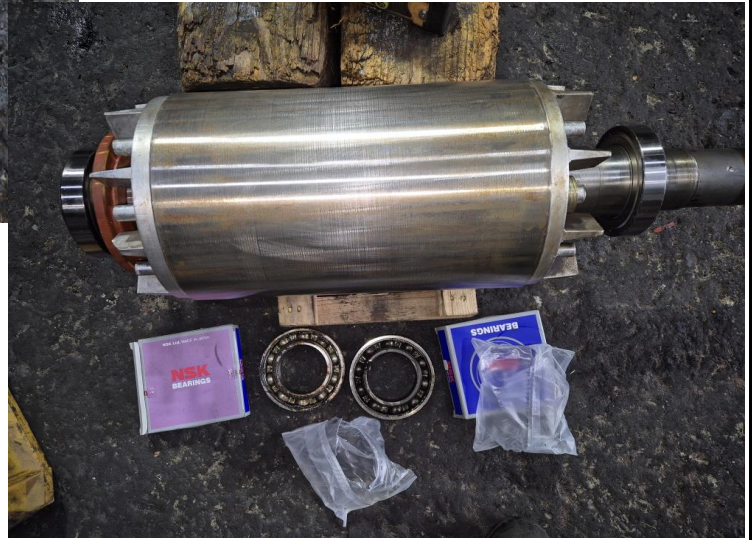
소모부품

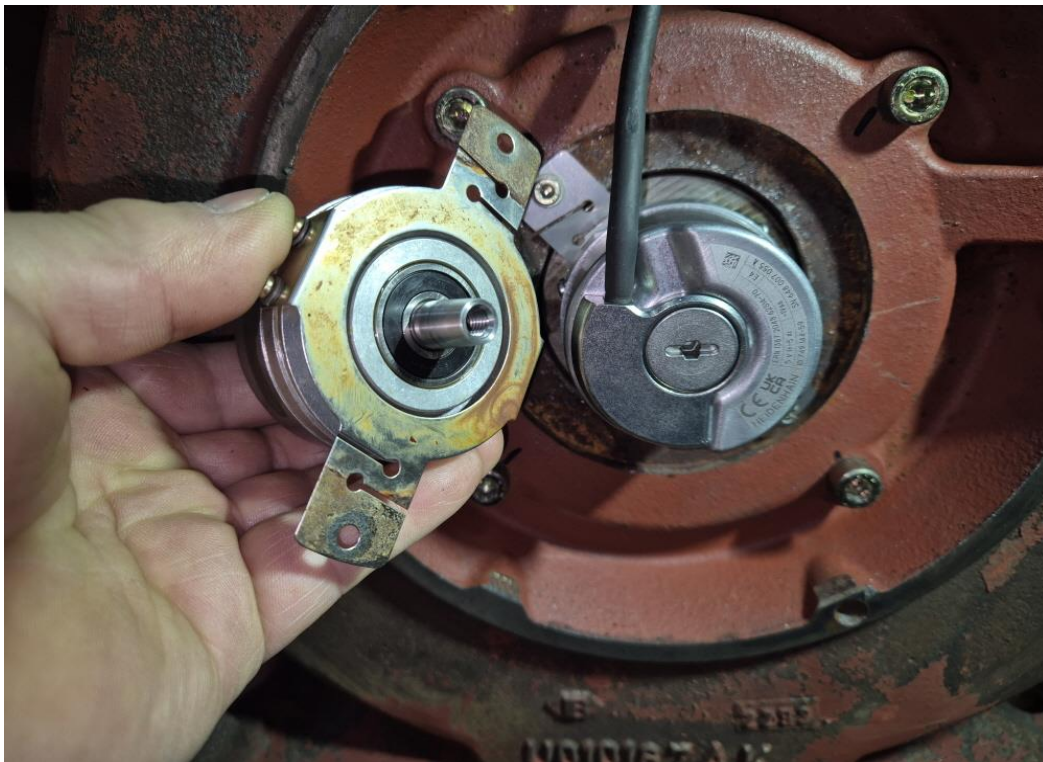
ENCODER

물 유입으로 교환

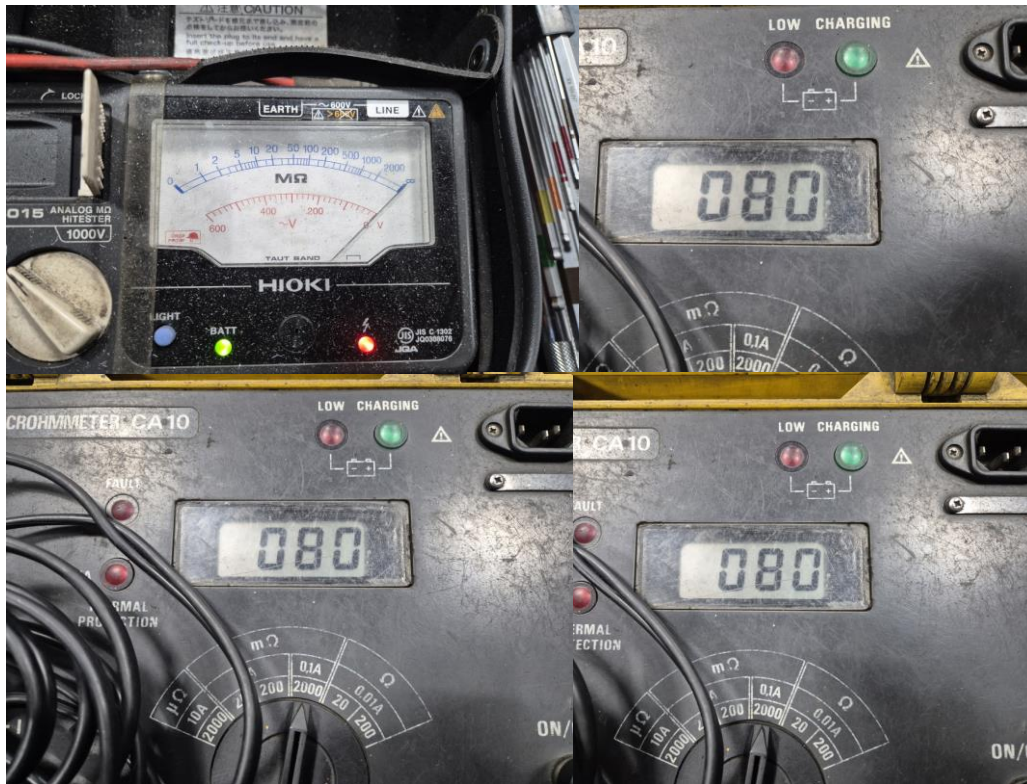
출고검사

절연저항 & 각 상별 권선저항

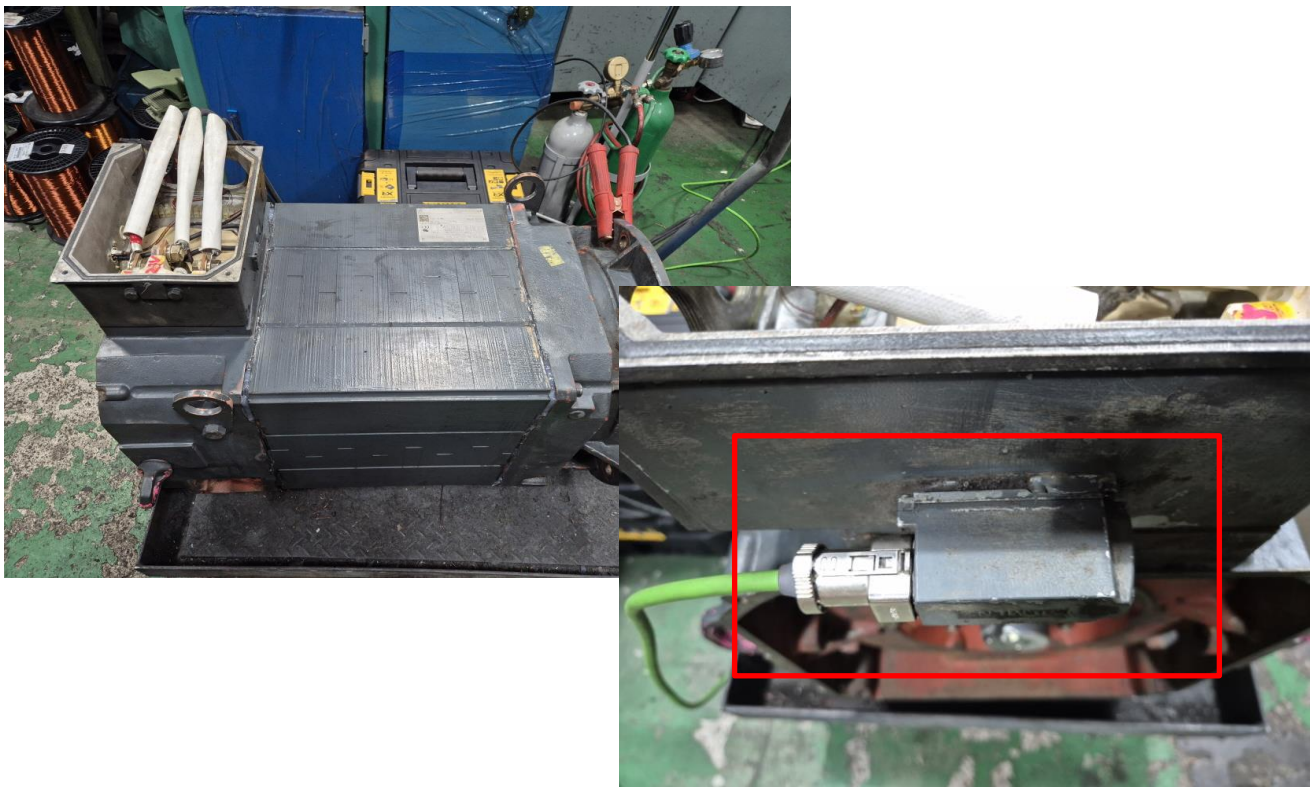
시운전 TEST실시

SMI MODULE에 MOTOR관련 DATA 소실로 운전 불가 상태입

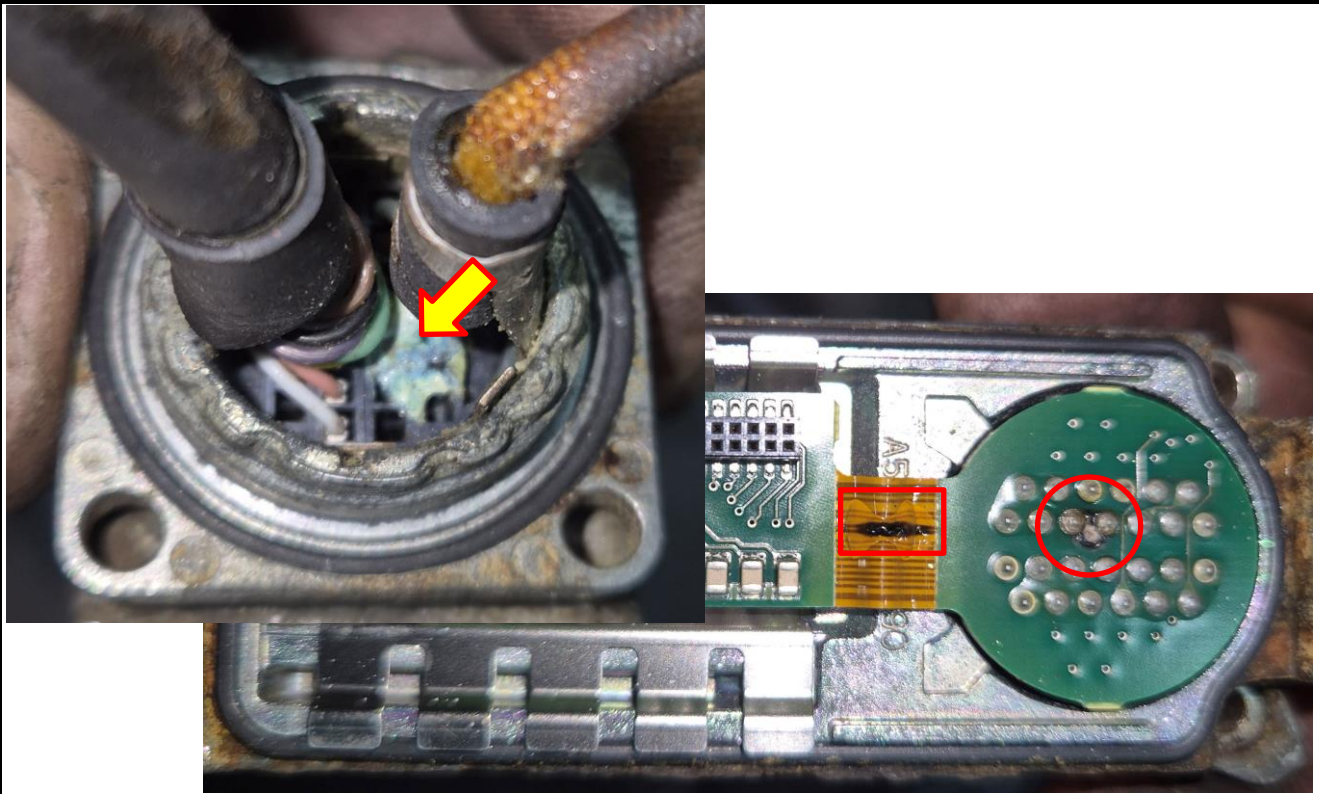
SMI MODULE 분해

물 유입으로 부식되어 전도 소손된것이 아닐까 예상 추정됨

Ass'y 교환 후 시운전 TEST 실시

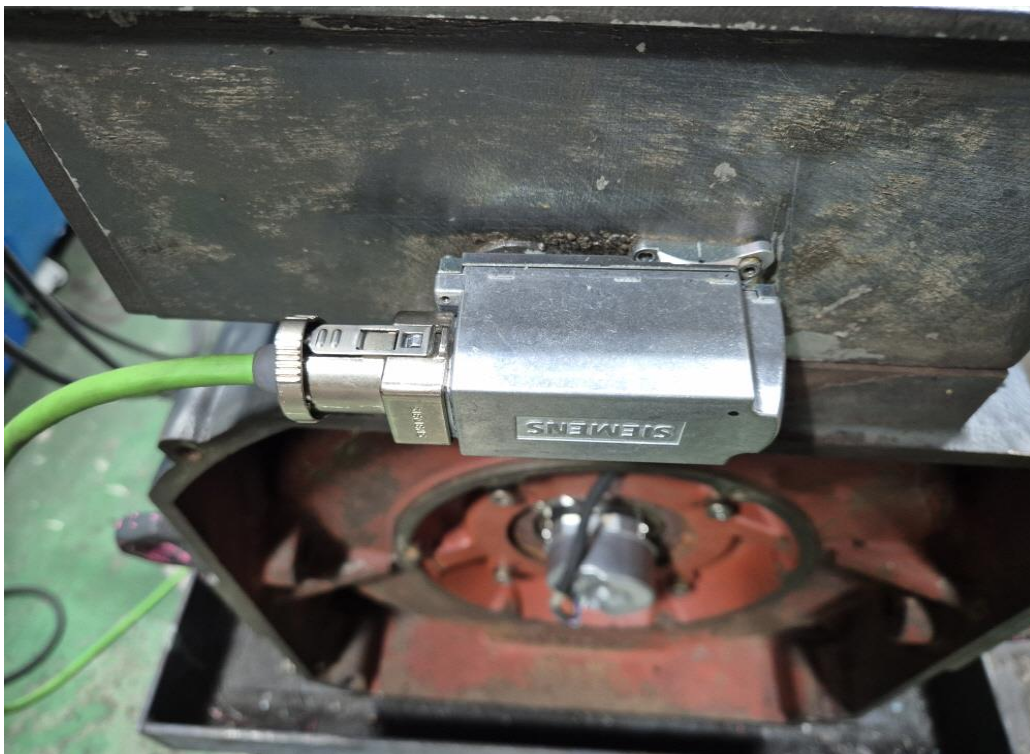
SMI MODULE
